TCEQ Dam Inspection Report

DAM: Franklin County Dam

OWNER: Franklin County Water District

INSPECTION DATE: September 13, 2005 PREVIOUS INSPECTION DATE: May 7, 2002

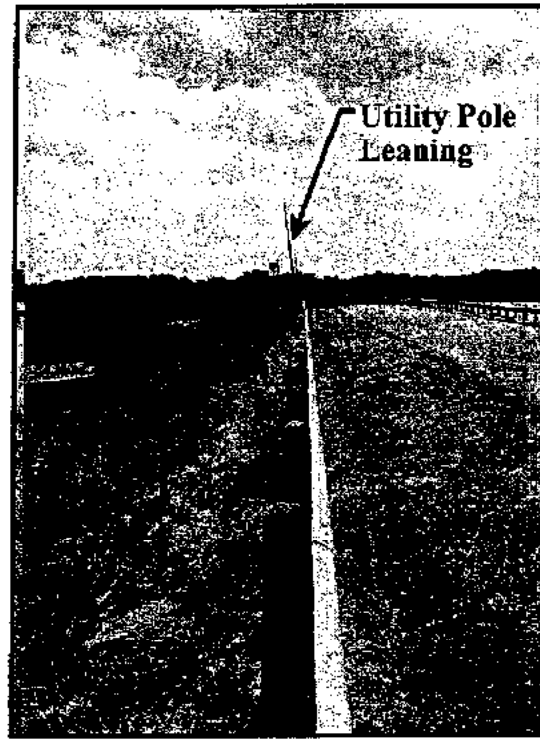
1. The crest of the dam was in good condition. Also serving as a major road (Highway 3007), the 25-foot wide paved crest had a straight alignment, and no significant ruts or depressions were noted along its roughly 5250-foot length. Additionally, the guardrails adjacent to the road along each edge of the crest showed no indication of alignment problems.
2. It should be noted that one of the utility poles that runs along the eastern edge of the crest was severely leaning towards the downstream embankment [Photo 1]. Located near the mid section of the dam's northern half, the slanted utility pole was located just above an area of the downstream slope where a slide had occurred.

4. Near the mid section of the dam's northern half, a slide approximately 10 foot wide by 6 foot deep was noted about midpoint on the slope, just below the previously noted leaning utility pole [Photo 1]. Small slides (some reoccurring slides) were seen across the downstream embankment with a higher concentration near the middle of the dam [Photo 11].

Photo 1: Utility pole leaning (≈ 11 degrees from vertical) towards downstream slope just above a noted slide

3. The continual deterioration of the downstream embankment should be addressed. With the steep slope that presently exists, the historic problem with slides will persist indefinitely. Many past slides have been fixed, yet many have reoccurred in the same location(s). The application of fly ash/lime mix with geo-fabric has been attempted in the past to combat the slides; however, these efforts have not proven effective. The specific clay material that composes the downstream slope is highly susceptible to cracking from dry conditions, and this allows rain water to penetrate into the dam. This wet, saturated soil then loses its cohesion due to the steep downstream slope and slides. A minimum slope of at least 3H:1V is recommended for the downstream embankment as a long term solution to the slide problems. This work should be undertaken under the supervision of a Registered Texas Professional Engineer (RTPE) with experience in the repair of dams. It is also recommended that a cost analysis be prepared for repeated slope repair versus permanent slope repair as an aid to the dam owner. All plans should be submitted to TCEQ for review and approval before any work starts.

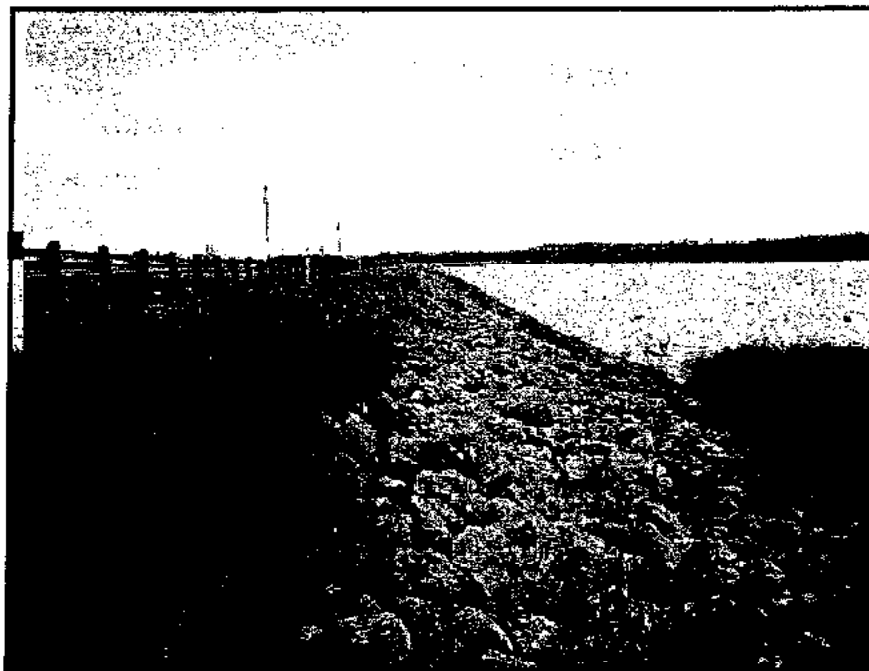
1. The overall condition of the upstream embankment was fair. The slope varied from 3 horizontal to 1 vertical (3H:1V) to 2H:1V across most of the upstream embankment [Photo 2]. It reached almost a 1H:1V slope in some areas near the crest.
2. Large rip-rap protected the entire shoreline, as well as the majority of the upstream slope. Some of the shale rip-rap stones were severely weathered and cracked and would break apart when struck with a survey rod [Photo 3].
3. There was a pocket in the rip-rap at one spot along the shoreline of Lake Cypress Springs;

Photo 2: Upstream embankment and rip-rap

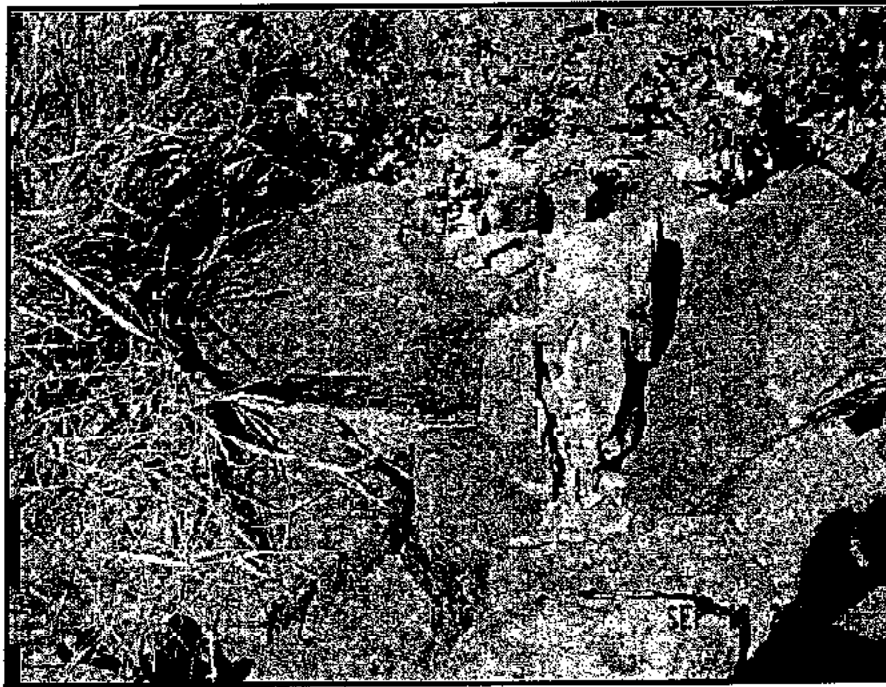
Photo 3: Weathered rip-rap on upstream slope was easily fractured when struck with a survey rod

4. The upstream slope rip-rap is intact, yet very weathered in places. Some of the rock is deteriorating and becoming brittle with age, and its effectiveness in a major flood event is questionable. The condition of the rip-rap should be regularly checked as part of the routine maintenance and monitoring plan, and action to replace the deteriorated rip-rap should be considered.

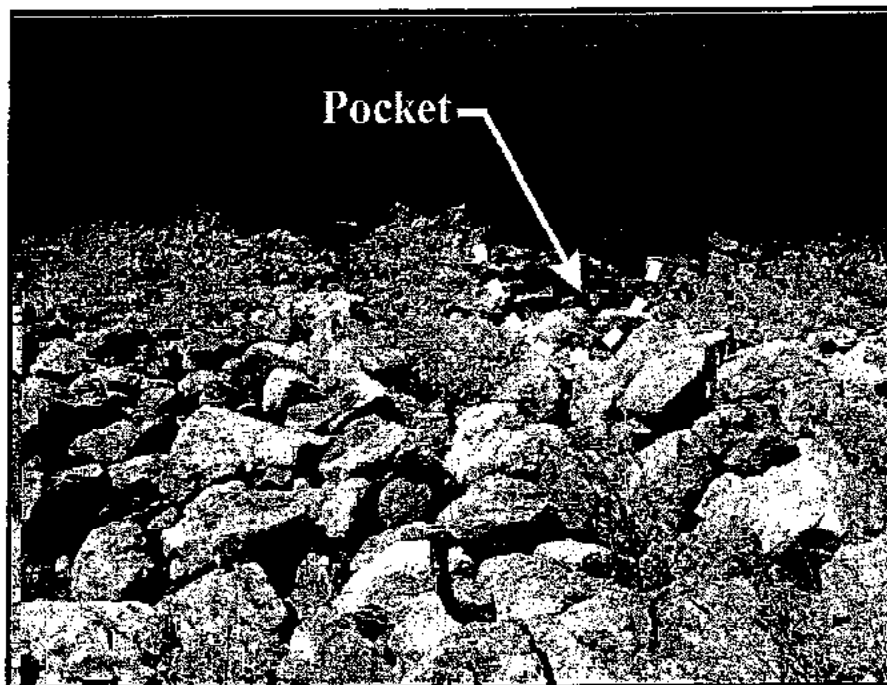
however, it did not appear to be moving out and away from the crest [Photo 4].

Photo 4: Pocket in rip-rap on upstream slope; it did not appear to be moving

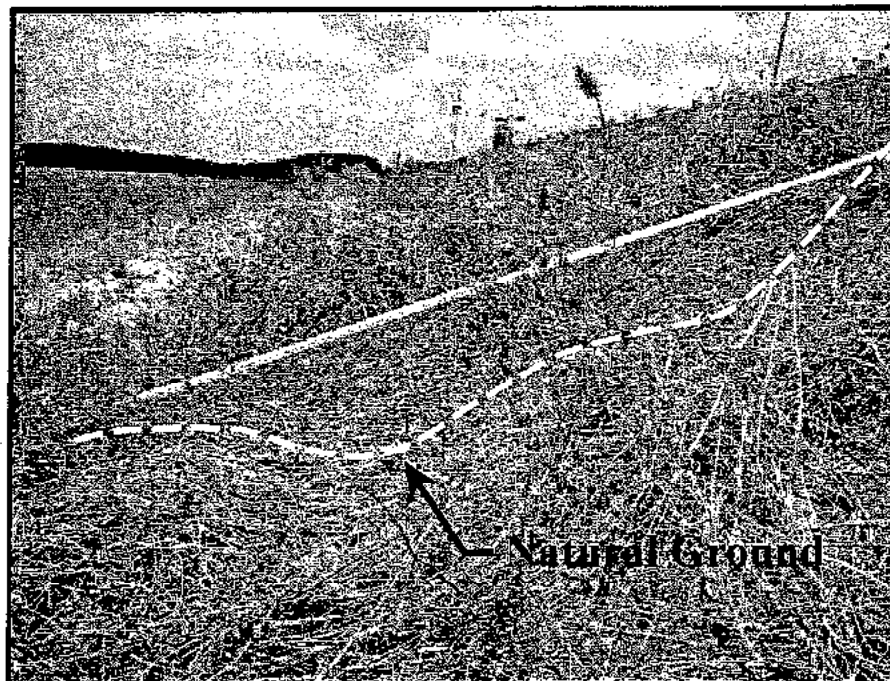
4. Many small trees and brush were growing through the voids in the rip-rap [Photo 5].
5. Numerous small sloughs, holes, and undulations were characteristic of the entire upstream embankment [Photo 6].
6. Additionally, quite a few small rodent burrows were noted [Photo 7].

Photo 6: Survey rod laying on the upstream slope; note the separation between natural ground

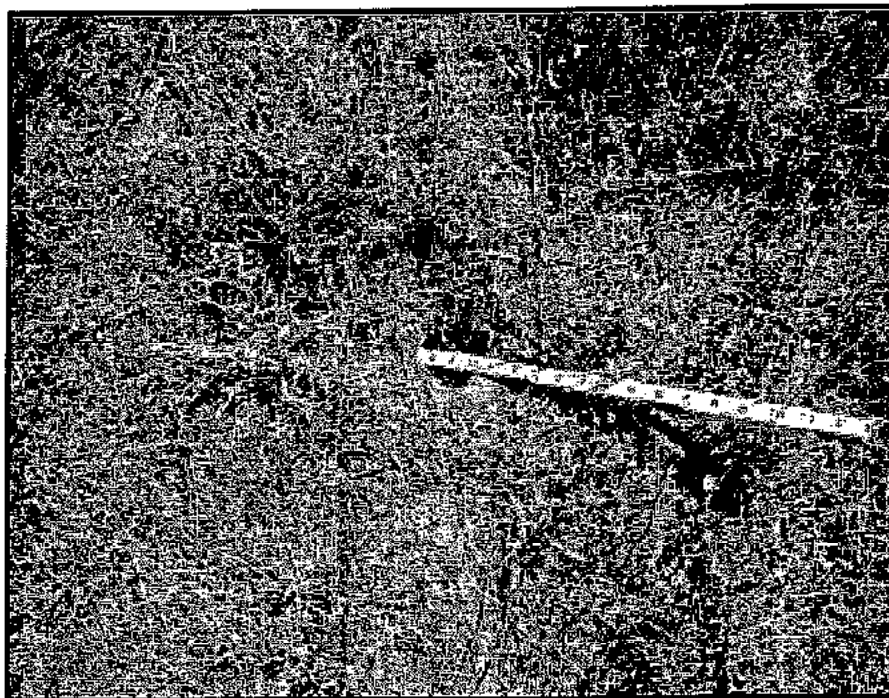
Photo 7: Animal burrow on upstream embankment

6. Reshape and repair the areas that have been damaged by animal burrows with well compacted non-dispersive clay material.
7. All of the bare, eroded areas on the downstream embankment should have a vegetative cover reestablished.

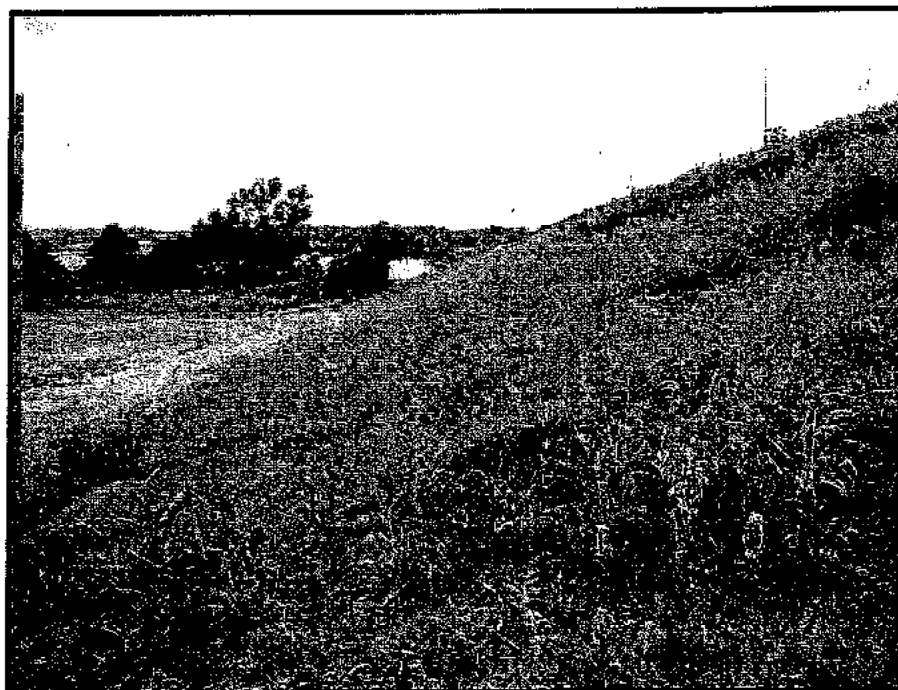
2. Although vegetation seemed to be prevailing over much of the downstream slope [Photo 8], it was bare in some areas. Small trees and brush were observed across most of the downstream embankment; however, a herbicide had obviously been applied in conjunction with an ongoing maintenance plan. The vast majority of this undesired vegetation was either dead or dying off, yet the clearing phase had not been initiated at the time of the inspection.

Photo 8: Prevailing vegetation on downstream slope

5. It is recommended that the downstream slope not be mowed any longer, as this action is likely doing more damage than good. Still, tree and shrub growth should be controlled.

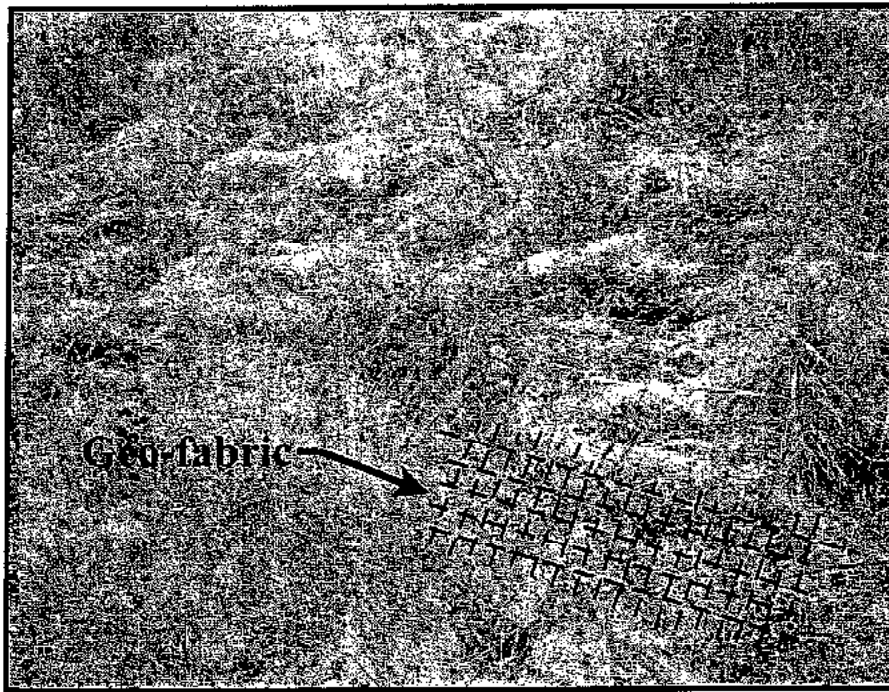
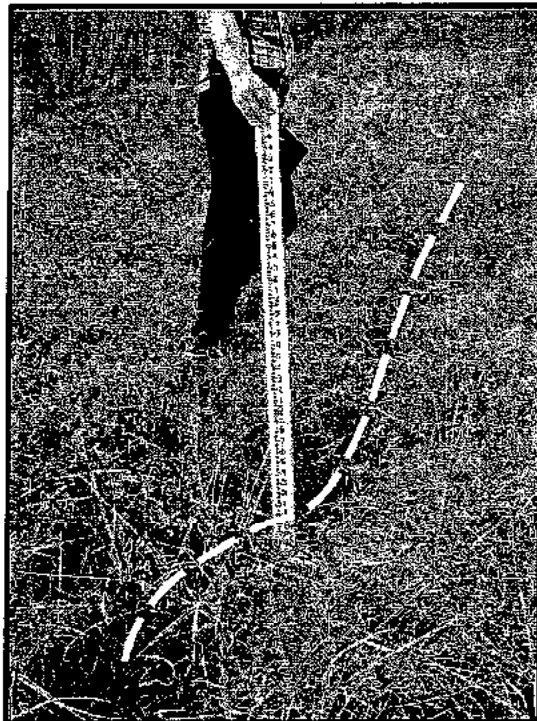
3. Many small sloughs, holes, undulations, and gullies were characteristic of the entire downstream embankment [Photos 9 & 10]. It should be noted that a geo-fabric had been placed on old slide areas on the downstream slope, in an effort to promote vegetative growth and combat the continual erosion.

Photo 9: Holes and undulations across downstream embankment

Photo 10: Erosion gully (\approx 1 foot deep) on downstream embankment

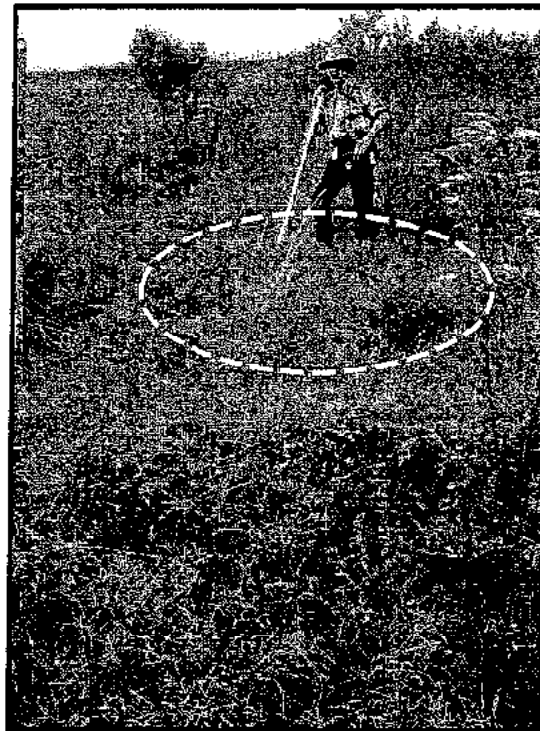
Photo11: Inspector standing on top of slide

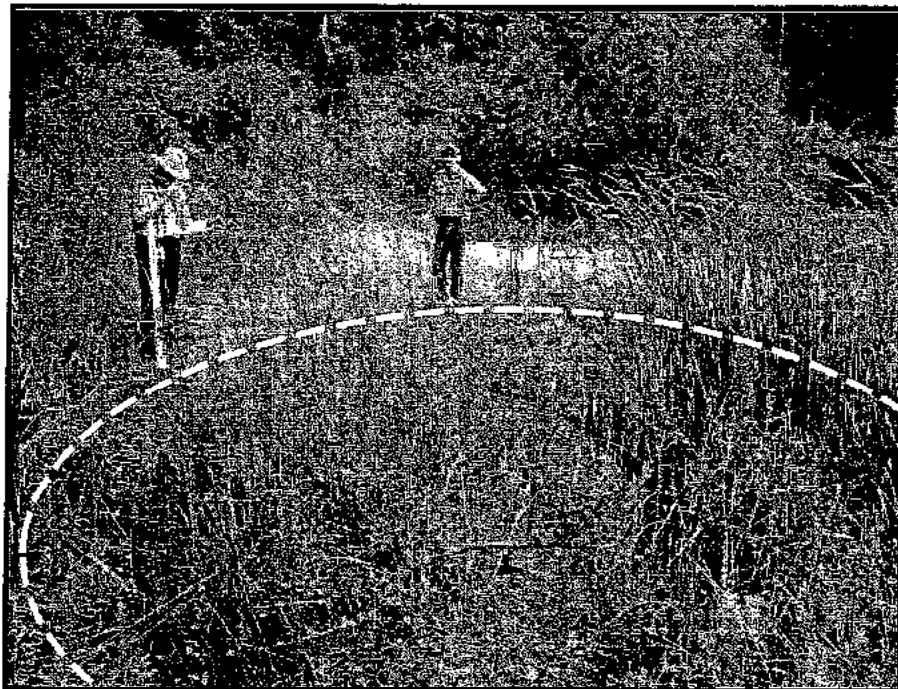
1. In both the left and right downstream groins, near the toe of the dam, minor seepage was noted.
2. At the north end of the downstream area, a standing marsh was witnessed [Photo 12]. It could not be determined if the water was due to seepage, a covered toe drain, or possibly a spring.

Photo 12: Standing marsh at north end of downstream area

1. The District's maintenance and monitoring plan should be continued and should include monitoring of the seepage areas.
2. An official Emergency Action Plan (EAP) is not presently on file with the TCEQ for this dam; however, it is rated significant-hazard. It is strongly recommended that an EAP be prepared and kept current. An EAP should provide a systematic means to: identify emergency conditions threatening a dam; expedite effective response actions to prevent dam failure; and prevent or reduce the loss of life and property damage should dam failure occur. This plan can be a positive step by the dam owner to accomplish safety objectives, protect the investment, and reduce potential liability. The following website gives guidelines for developing an EAP: www.fema.gov/fima/damsafe/eap_toc.shtml. Note that these guidelines were developed for larger dams, nevertheless, they provide a general overview of the EAP's purpose. A proposed EAP should be submitted to the TCEQ Dam Safety Program for

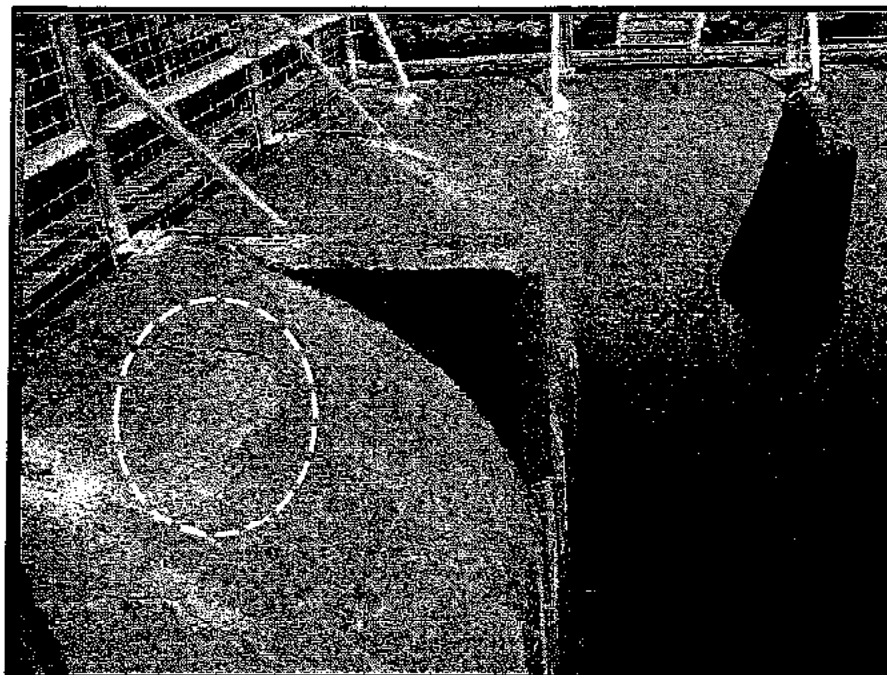
1. The morning glory spillway inlet was in good condition [Photo 14], and only minor spalling of the concrete was detected. Still, Lake Cypress Springs was roughly two feet below the spillway drop inlet elevation, and the operation of the spillway was not witnessed.
2. The service spillway drop inlet, the instrumentation and control room, and the low flow intake valves [Photos 15 & 16] were all well maintained and secure with the necessary fencing, locks, etc.
3. The fish screen was intact and in good condition [Photo 16]. The fish screen and walkway to the morning glory had been painted the day before.
4. The condition of the service spillway outlet could not be assessed, as it was beneath the water level of Lake Bob Sandlin located immediately downstream.

Photo 14: Morning glory service spillway drop inlet; note the minor concrete spalling

3. The long term effects of the service spillway's surging action should be investigated. The interior of the spillway conduit was first inspected in 1977 for deterioration, and it should be examined again. When it was first inspected, the dam had only been in operation for about six years, and the continual vacuum breaking had already caused a couple of joints in the conduit to begin offsetting roughly an inch. The dam is now 35 years old, and the damaging effects of the routine vacuum breaking/cavitation on the structural integrity of the spillway conduit should be assessed. It is recommended that the interior of the conduit be inspected. A diver and/or video camera could be utilized for this purpose. If it is determined that appreciable damage has been done, a piping condition may exist from water leaking through the conduit joints, and a plan should be initiated to remedy the situation.

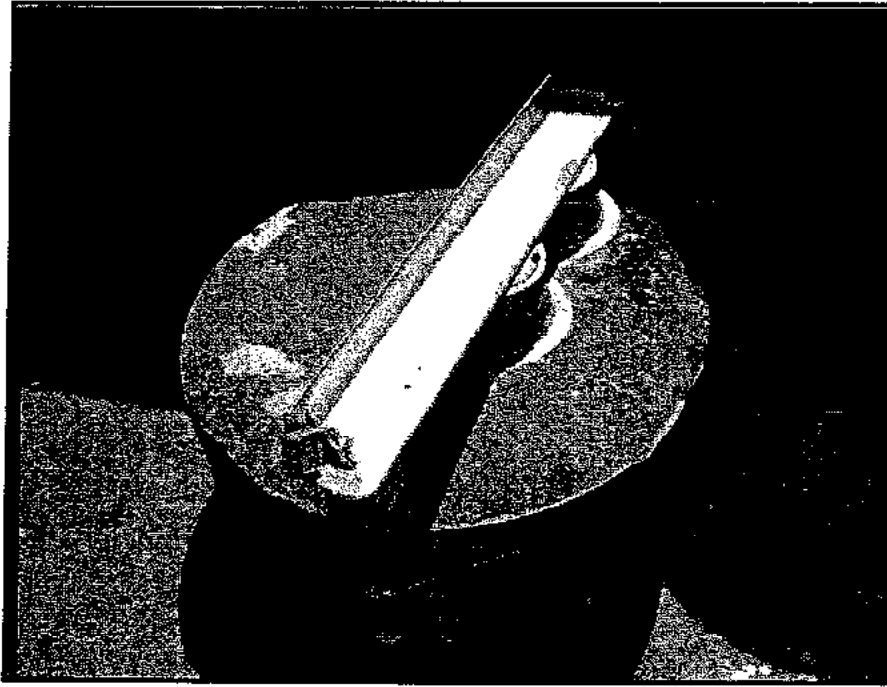
Photo15: Low flow intake valves and pad lock

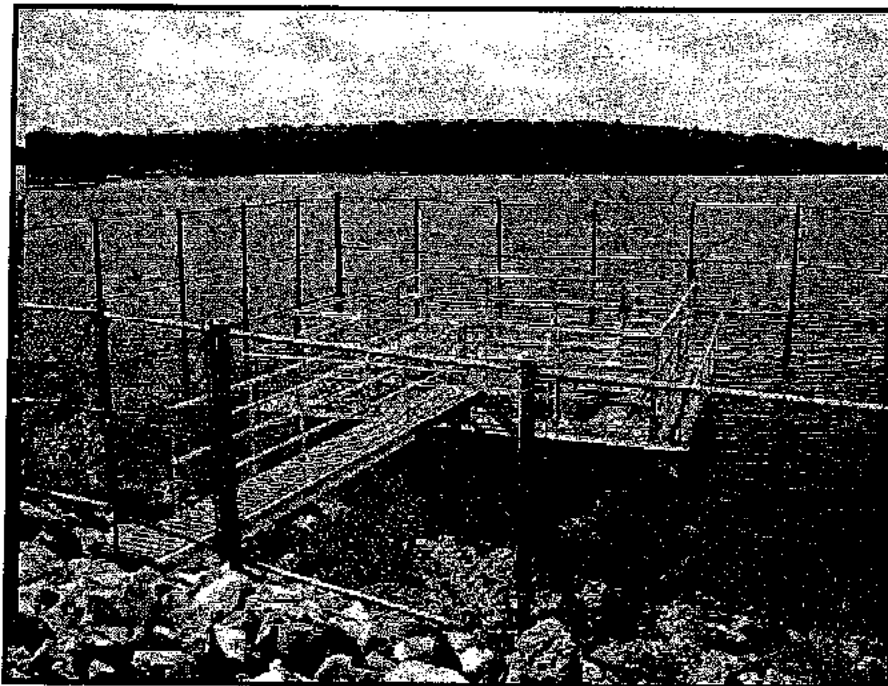
Photo 16: Service spillway morning glory intake structure, access platform(s), and fish screen; note locked gate
