# Franklin County Dam Preliminary Engineering Report: Development of Alternatives to Restore Downstream Slope

FRANKLIN COUNTY WATER DISTRICT

TUESDAY, FEBRUARY 18, 2020

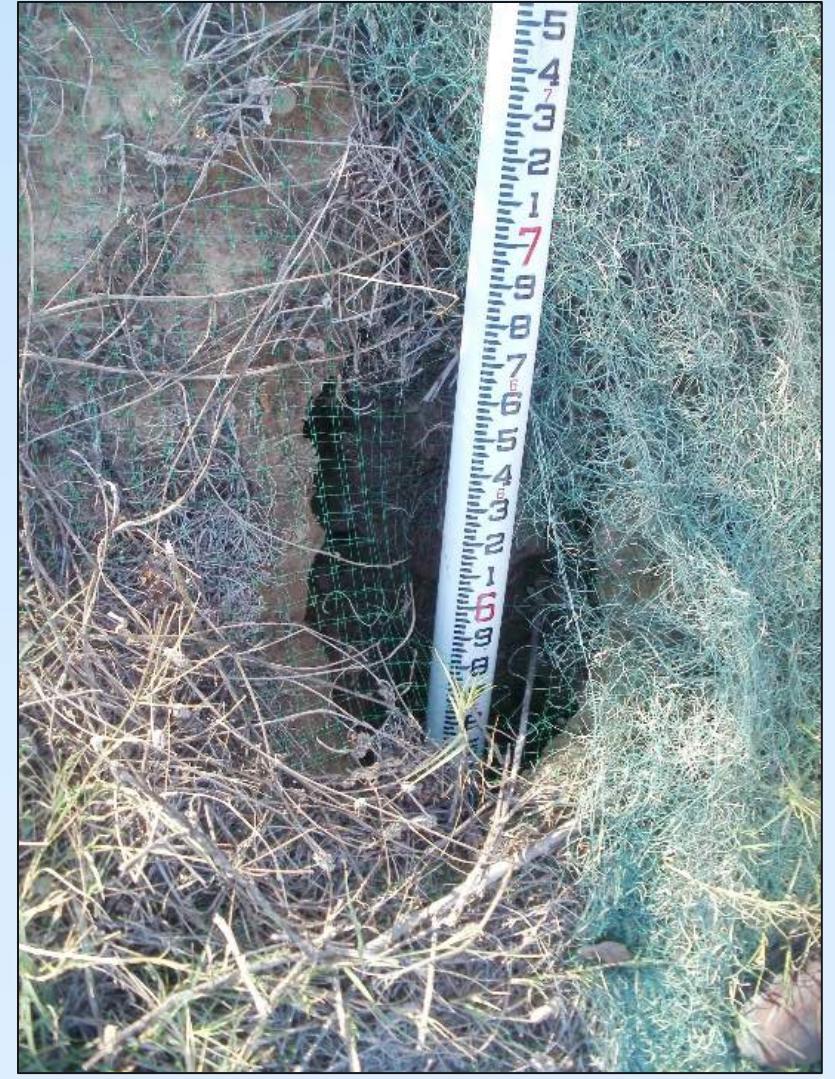
# Perform interim surficial repairs to downstream slope to facilitate maintenance

- Erosion holes pose significant challenges to maintenance of dam
- Options for filling these holes will be developed and evaluated based on data gathered during strategic exploration and instrumentation program

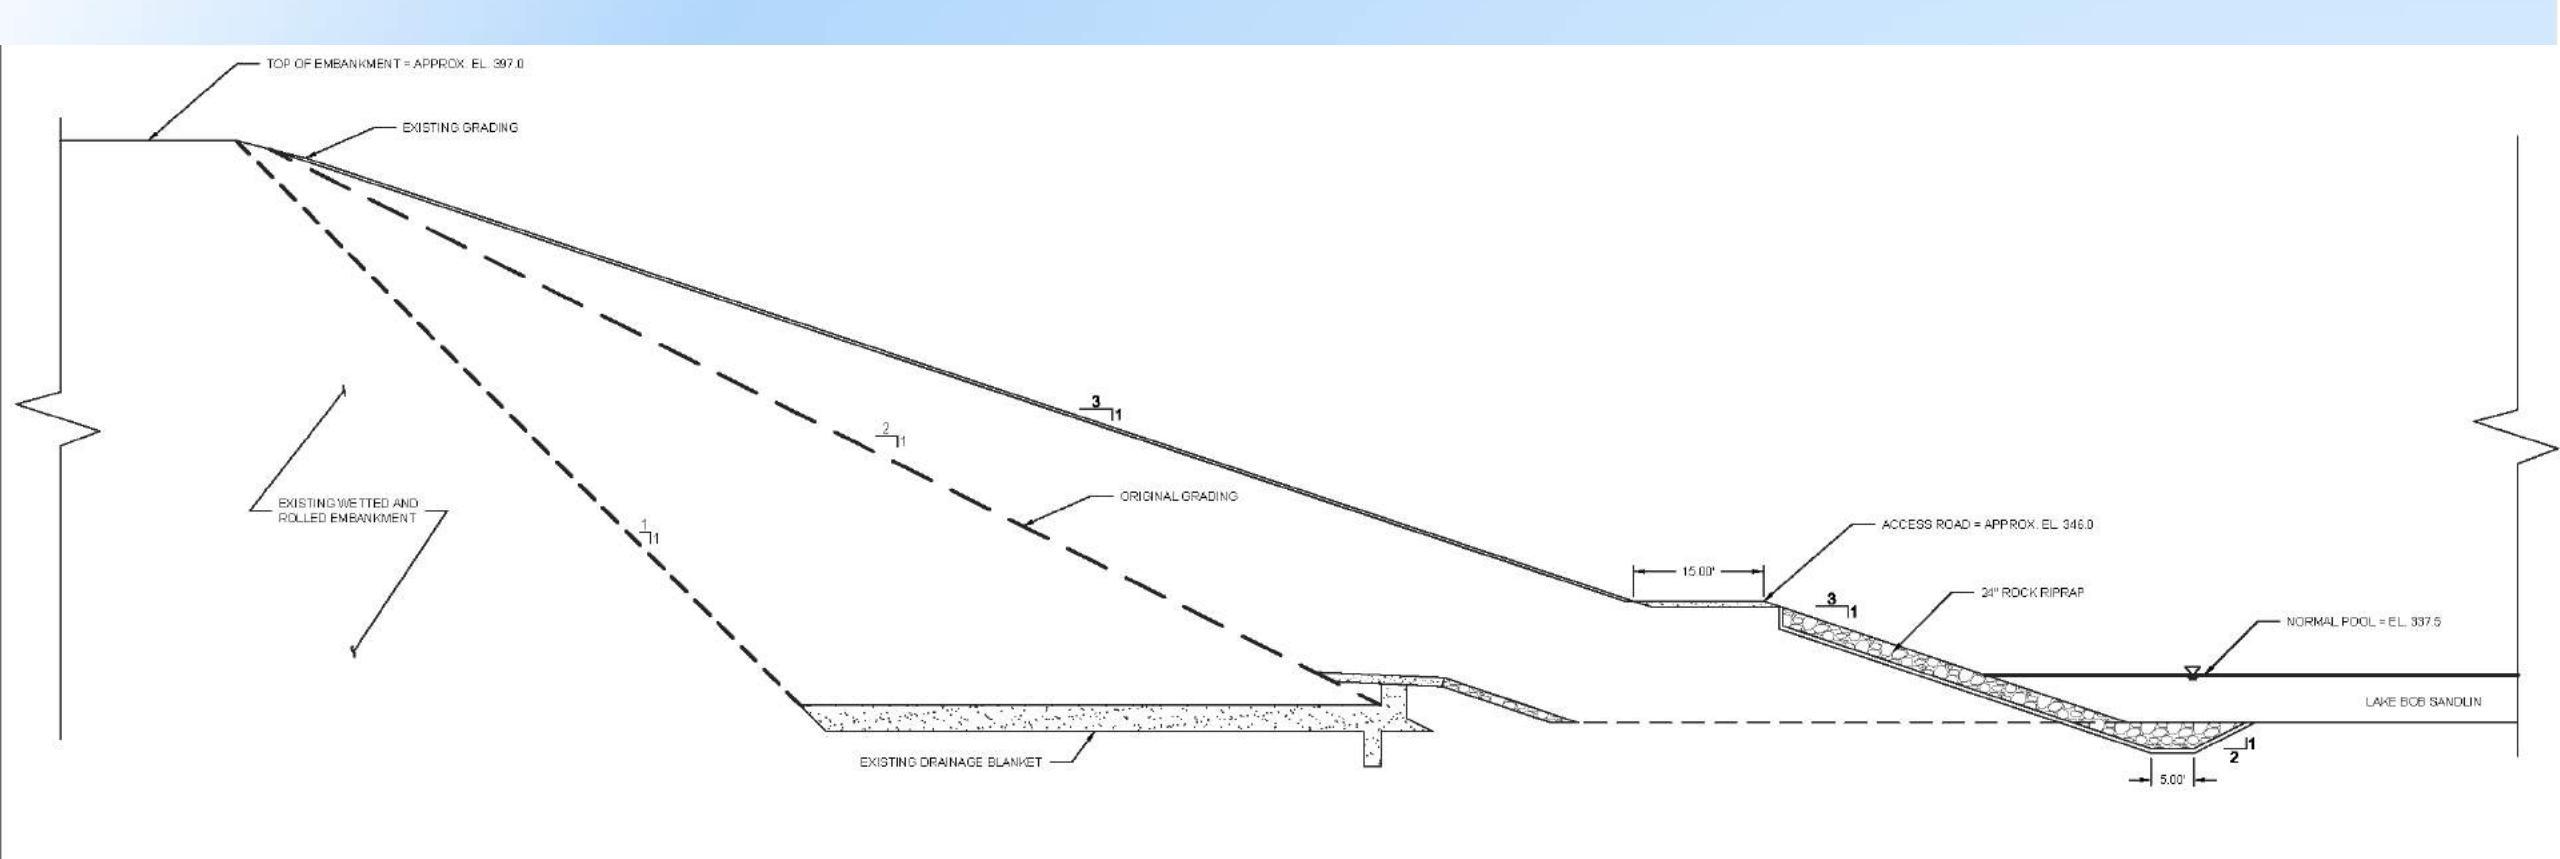
## **Existing Embankment Profile**

- Dispersive soils
- Crack Development
  - Drying
  - Differential settlement
  - Shear displacement
- Seepage
  - Insufficient foundation cutoff
  - Absence of impermeable foundation layer in right abutment
  - Along spillway conduit (no core material or filter around conduit)

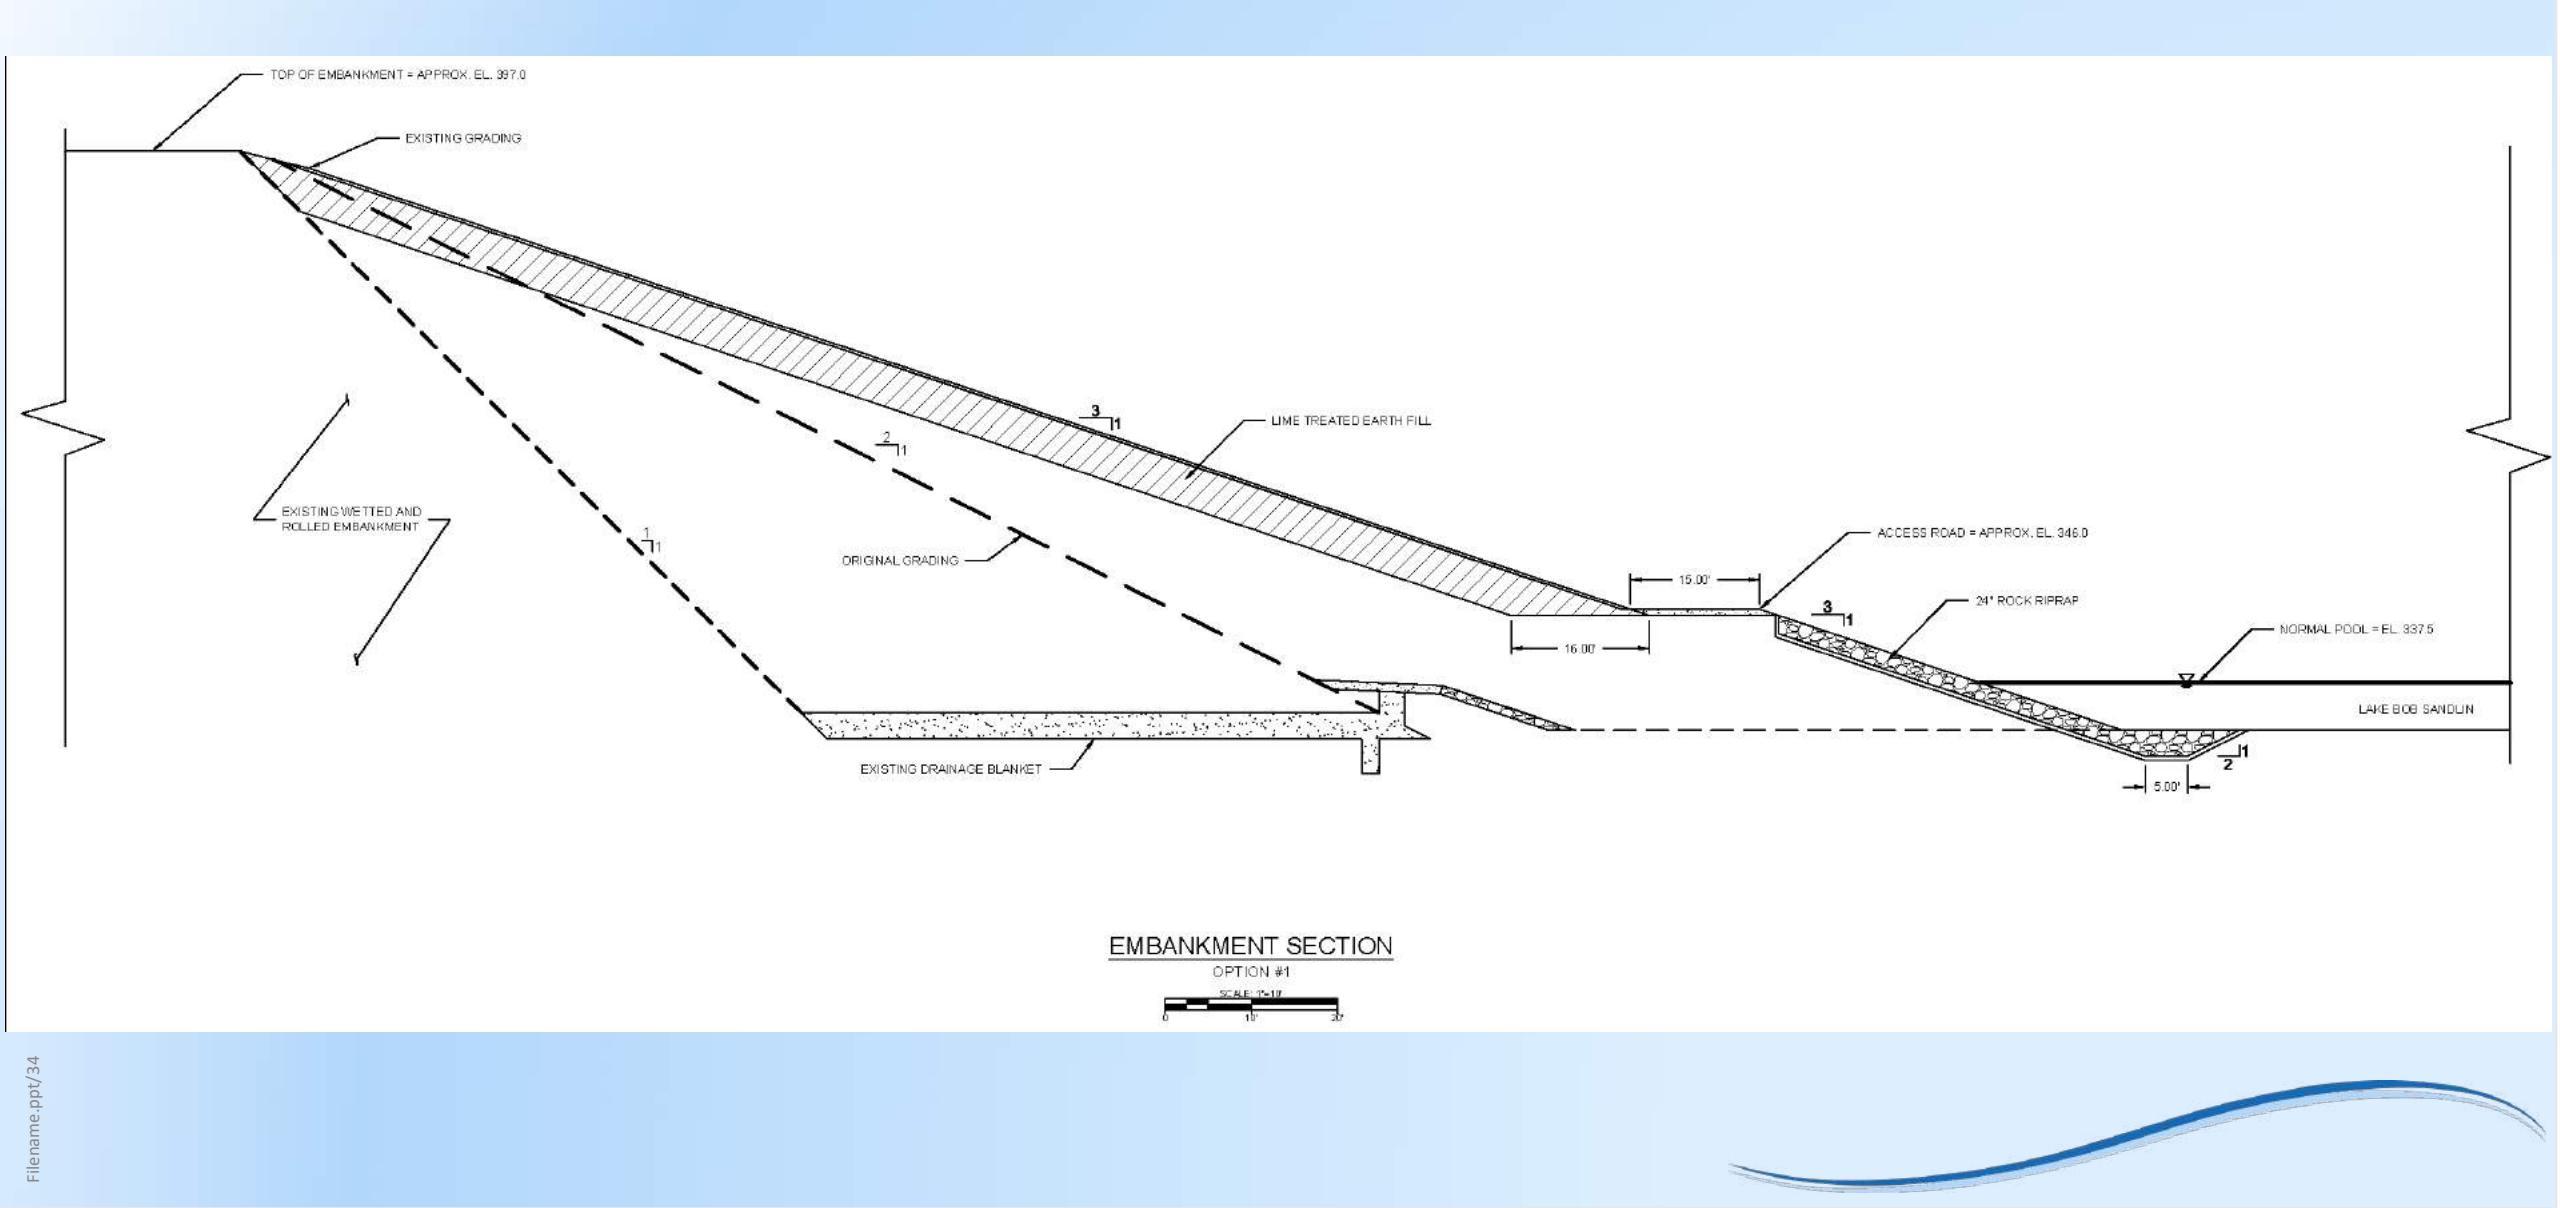
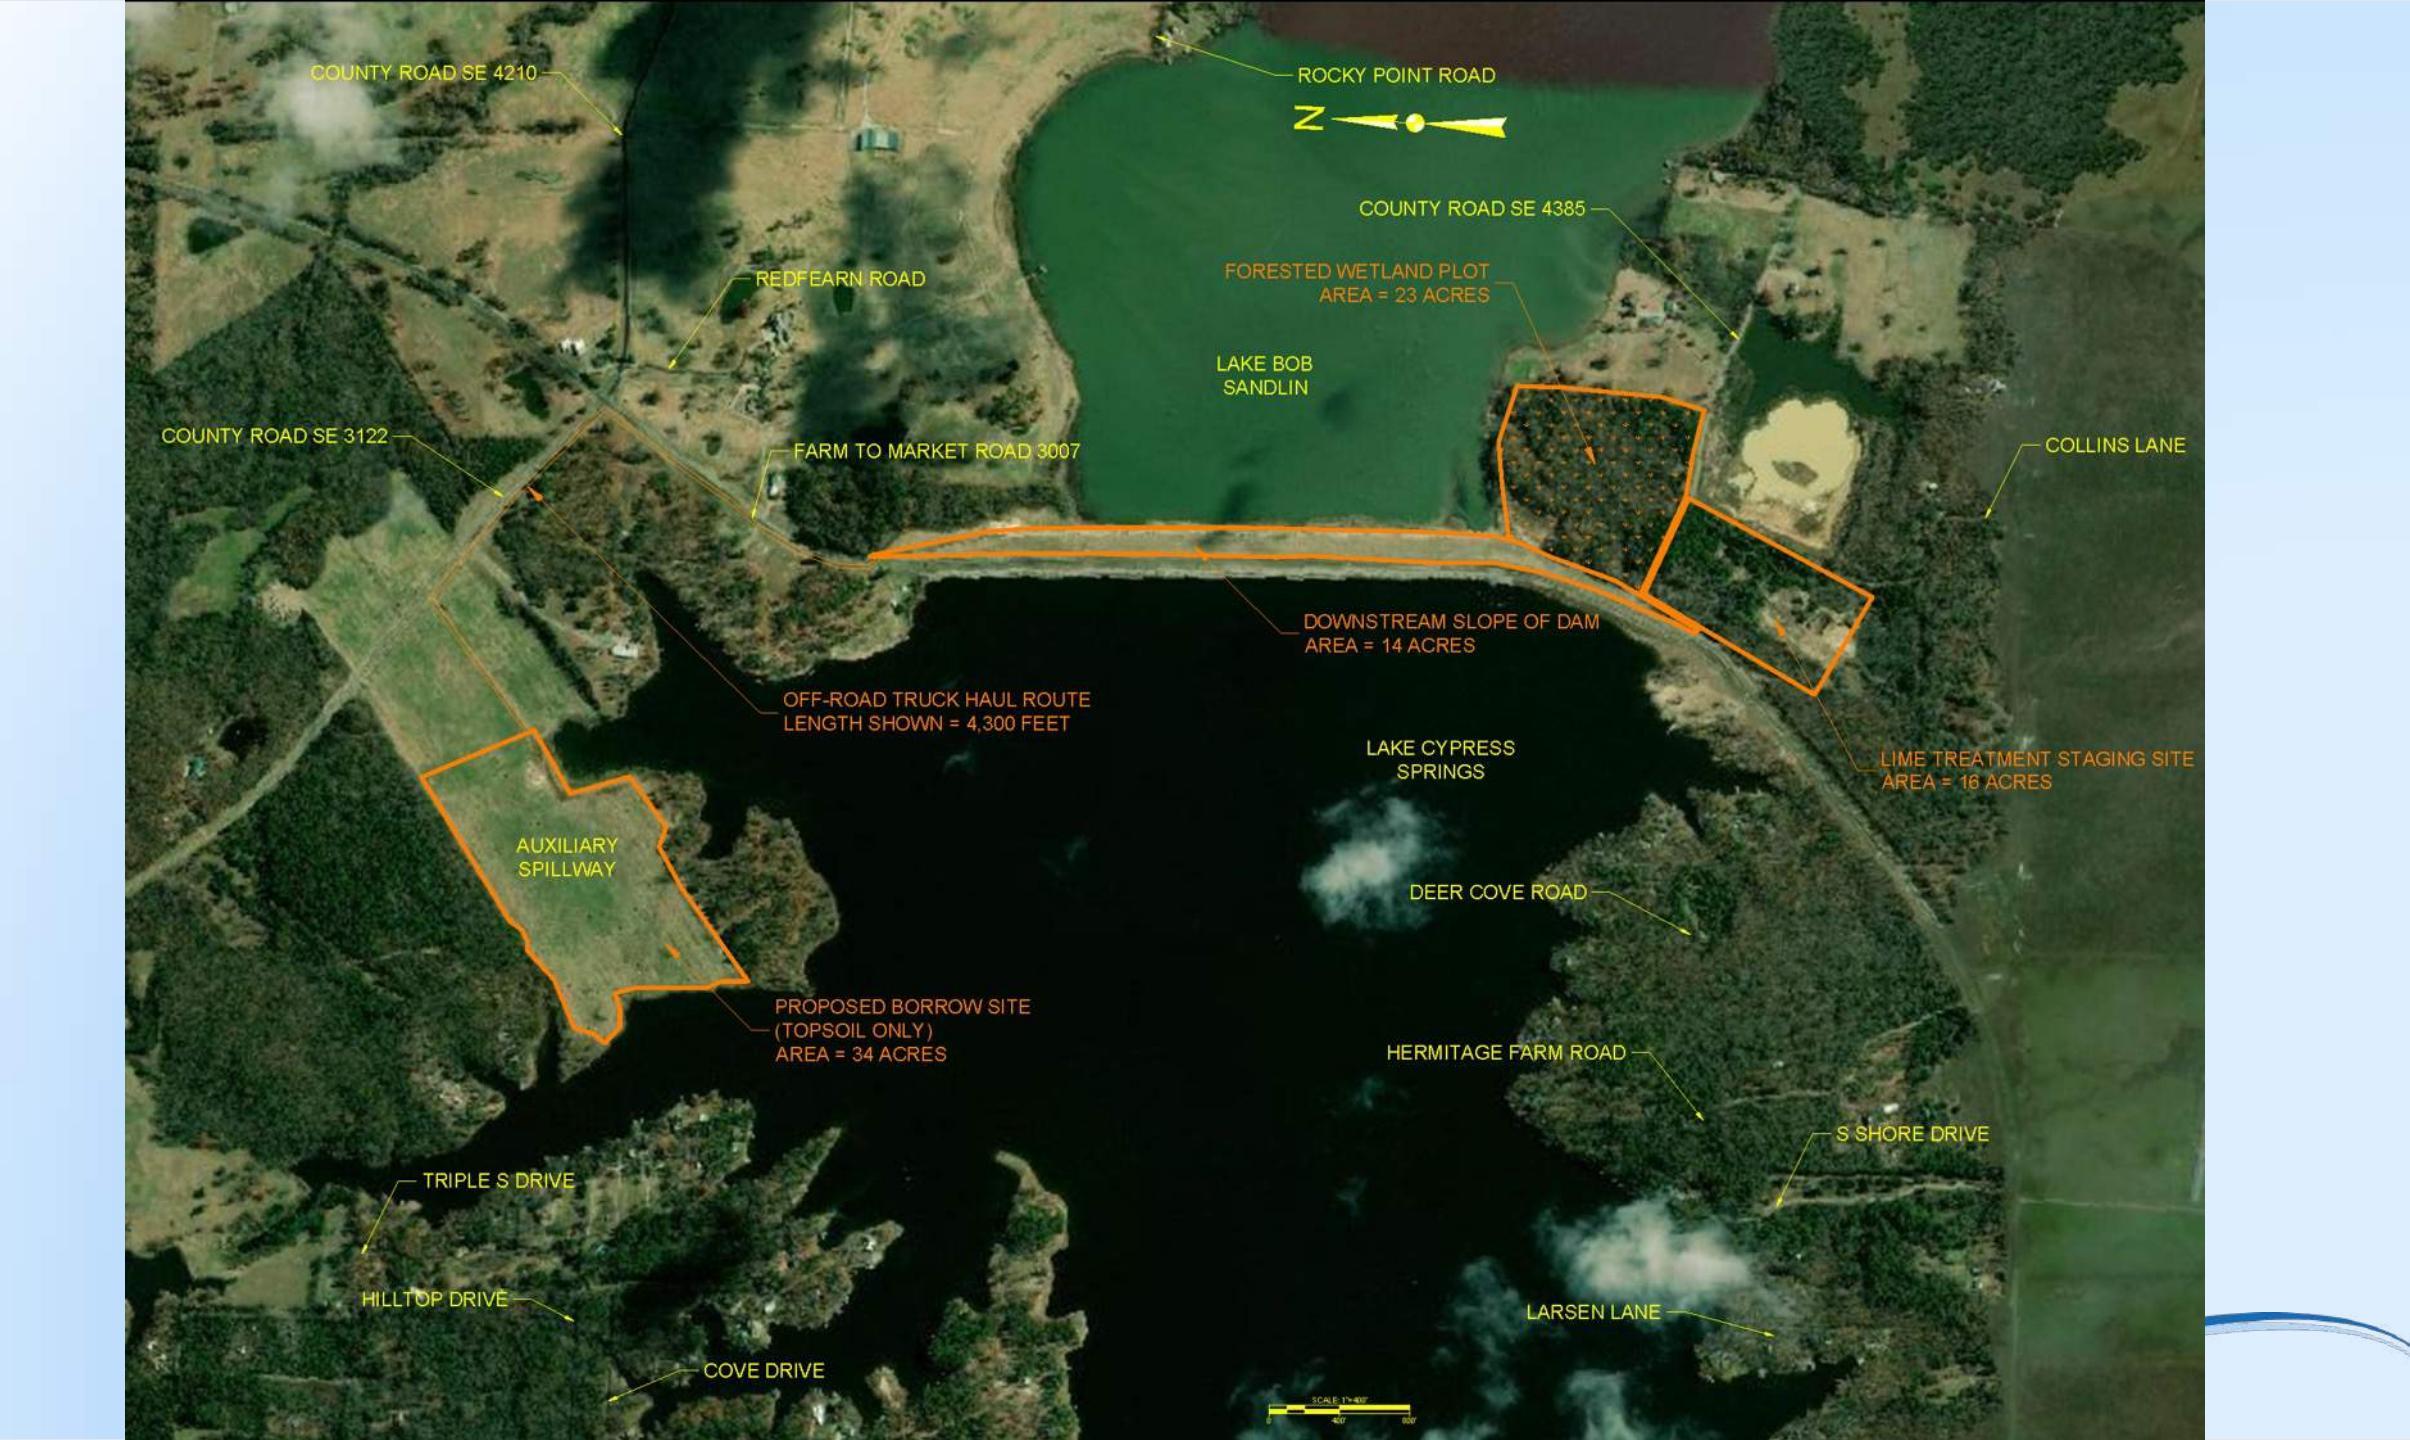
### **Option 1 Profile**

- The lime-treatment process can be very dusty
- Lime-treated soils can impede the ability to establish permanent turf
- Additional topsoil thicknesses are recommended over areas associated with the lime-treatment process to facilitate the establishment of adequate vegetative cover

- Remove and replace the materials associated with the 2008-2010 slope modifications
  - Augment the removed materials with lime and place the augmented soil as engineered fill
  - Or, reconstruct the embankment utilizing non-dispersive soils from an acceptable borrow source
- In conjunction with replacement of embankment soils, install a chimney filter/drain between the original downstream slope and the new soil embankment

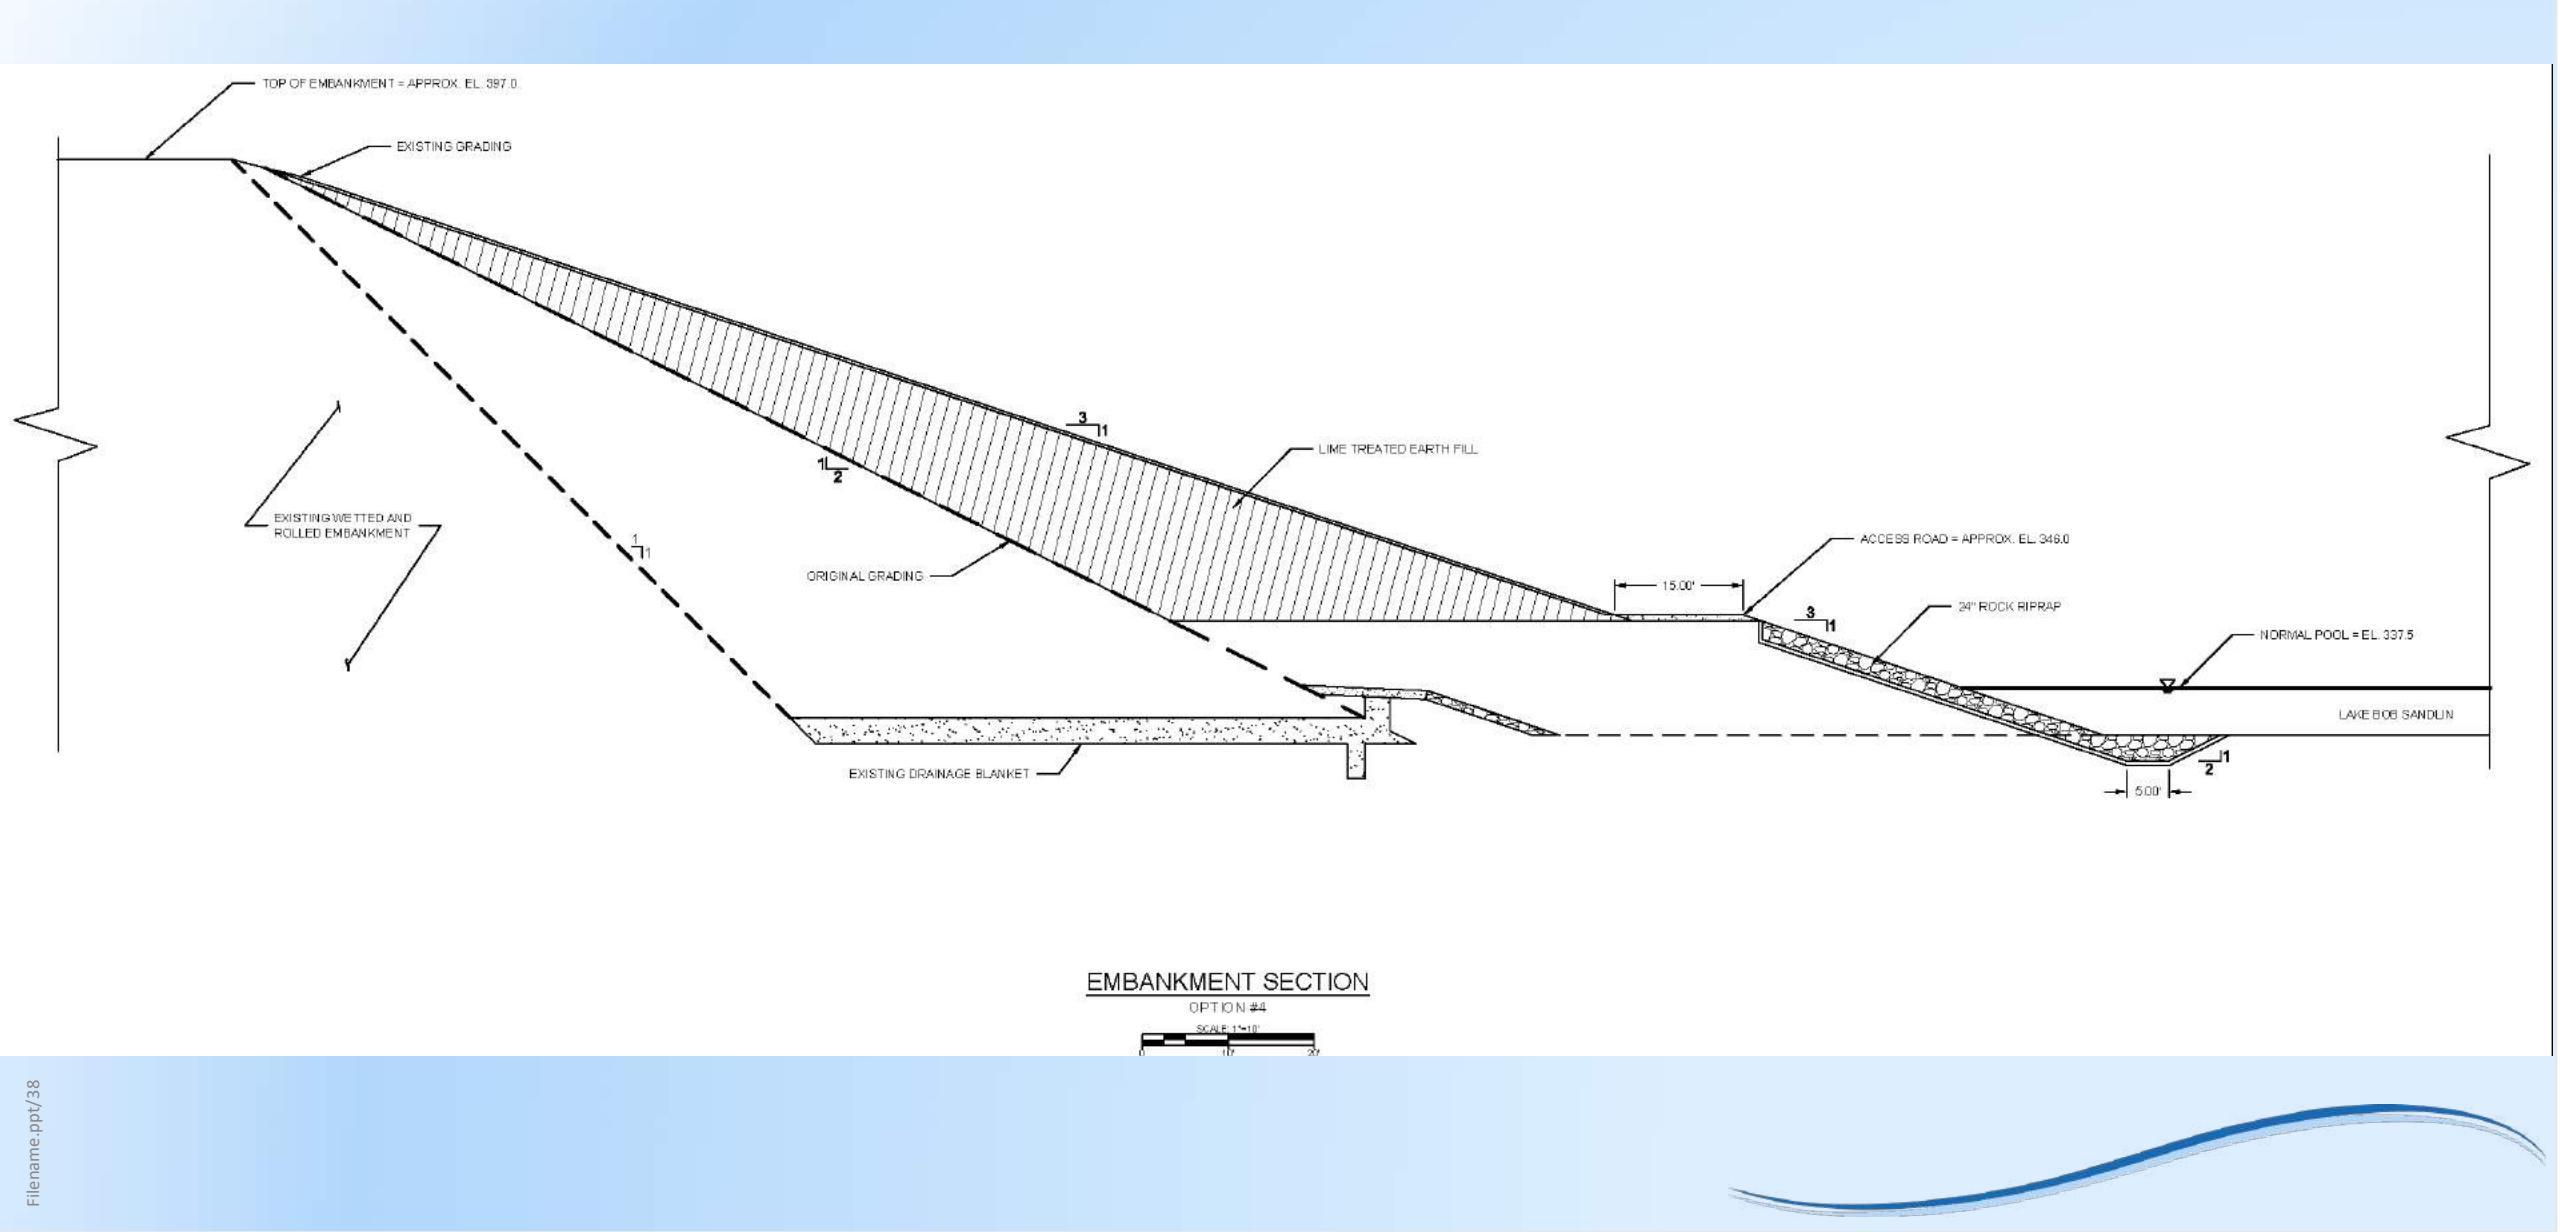
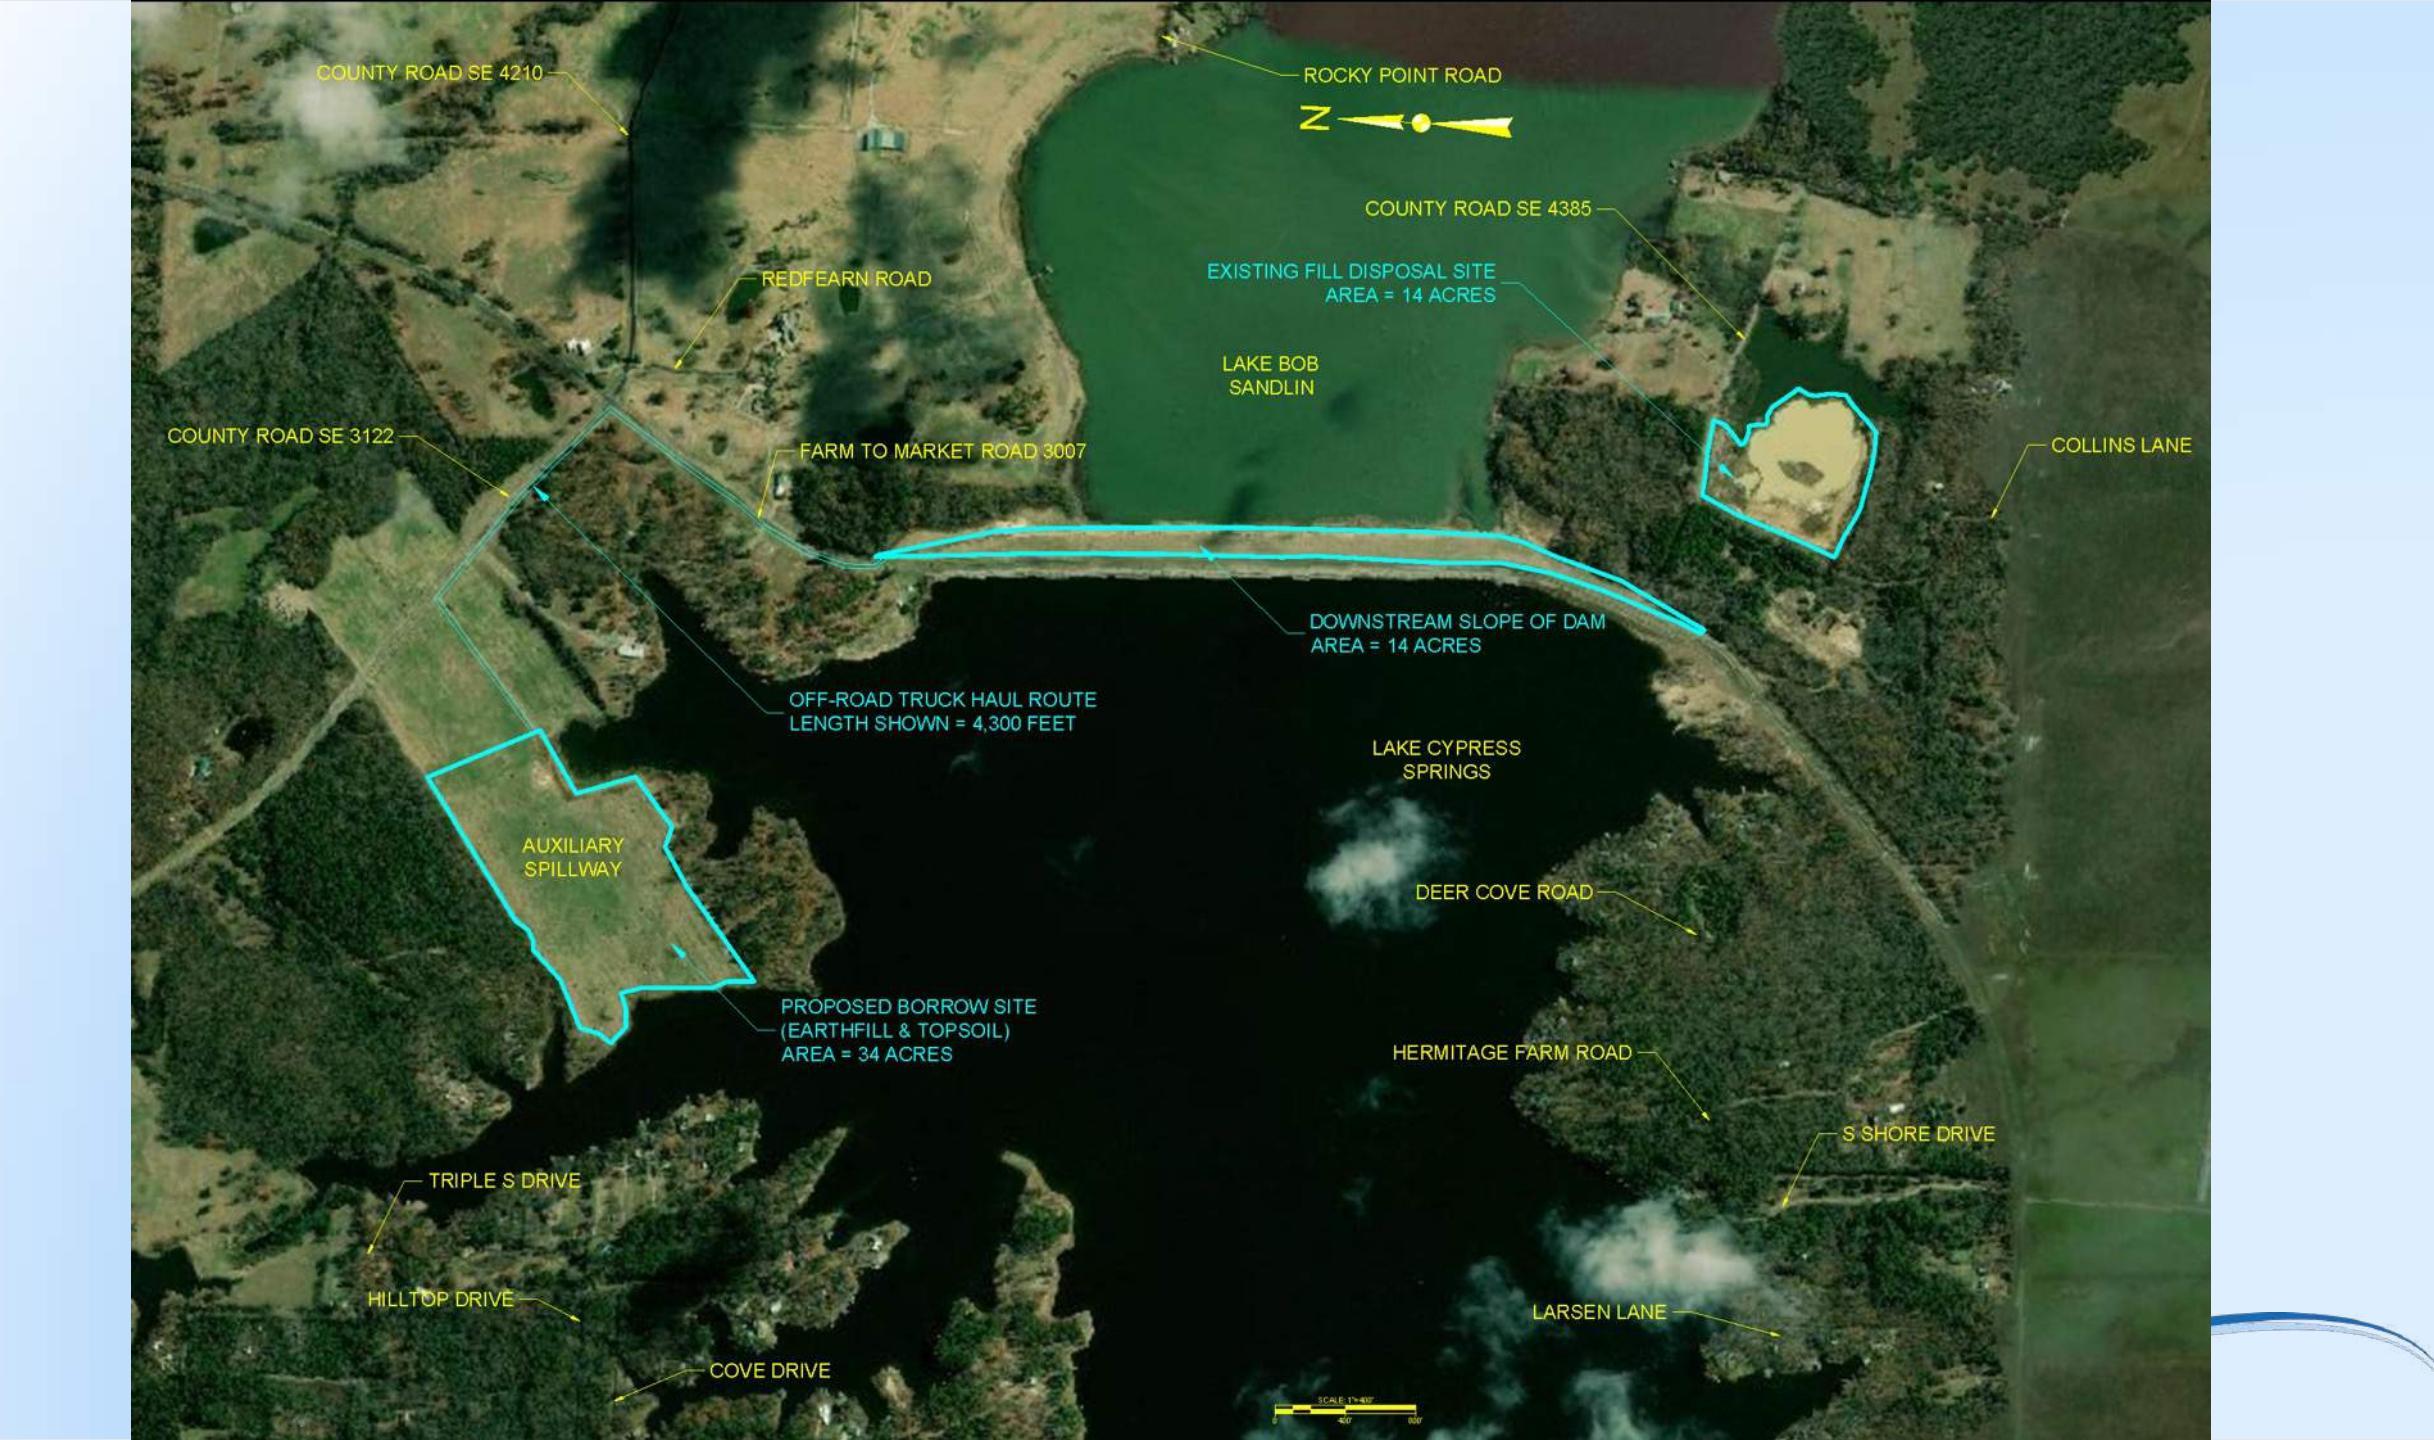
### **Option 2 Profile**

- Need to identify a large quantity of non-dispersive soils
- Potentially long haul distance to import non-dispersive soil material
- Depending on depths of non-dispersive borrow soils, larger disturbed areas would need to be re-vegetated
