Franklin County Water District Development of Alternatives to Restore Downstream Slope, Franklin County Dam

PRELIMINARY ENGINEERING REPORT

FINAL | February 2020

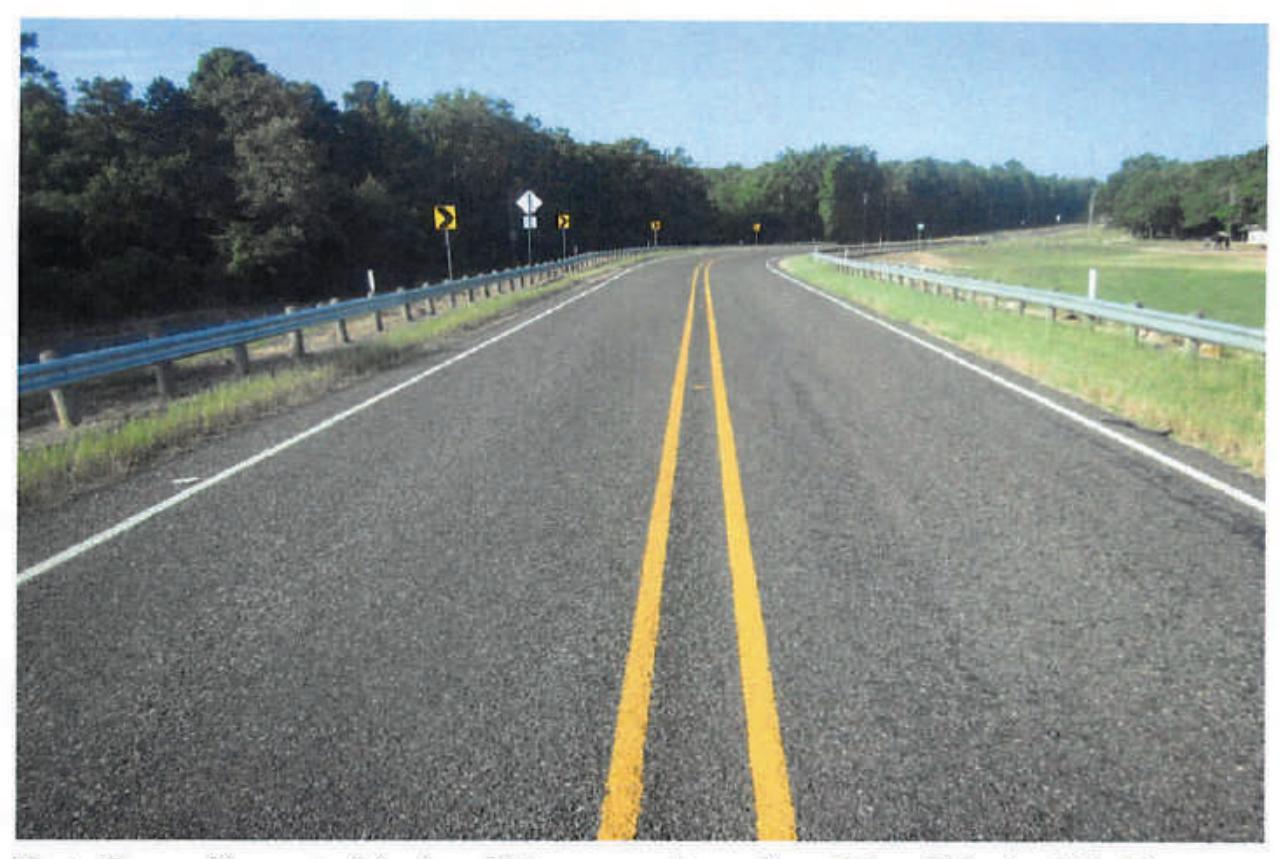
Photo No. 3. The crest of the dam, FM 3007, was in good condition. This view is looking toward the right end of the dam.

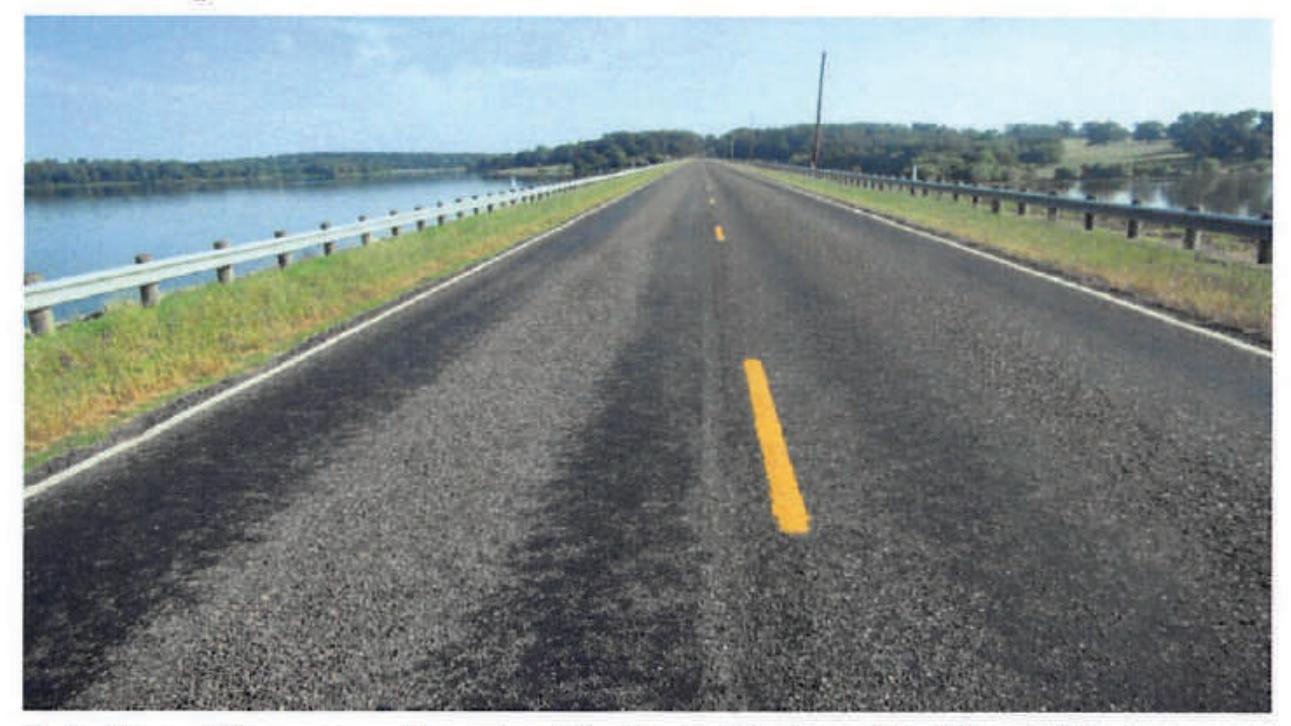
Photo No. 4. The crest near the center of the dam looking toward the left end of the dam.

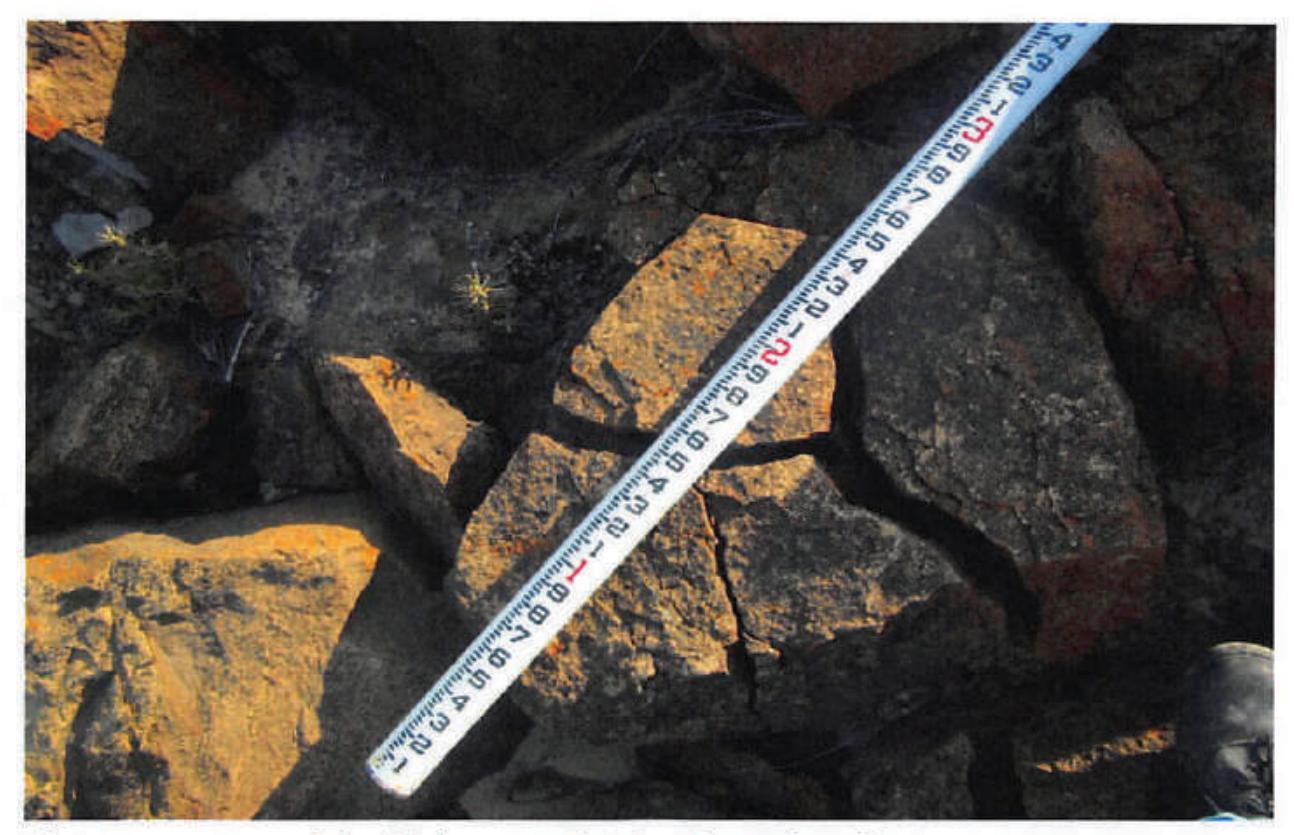
Photo No. 21. Some of the old riprap was deteriorating and cracking.

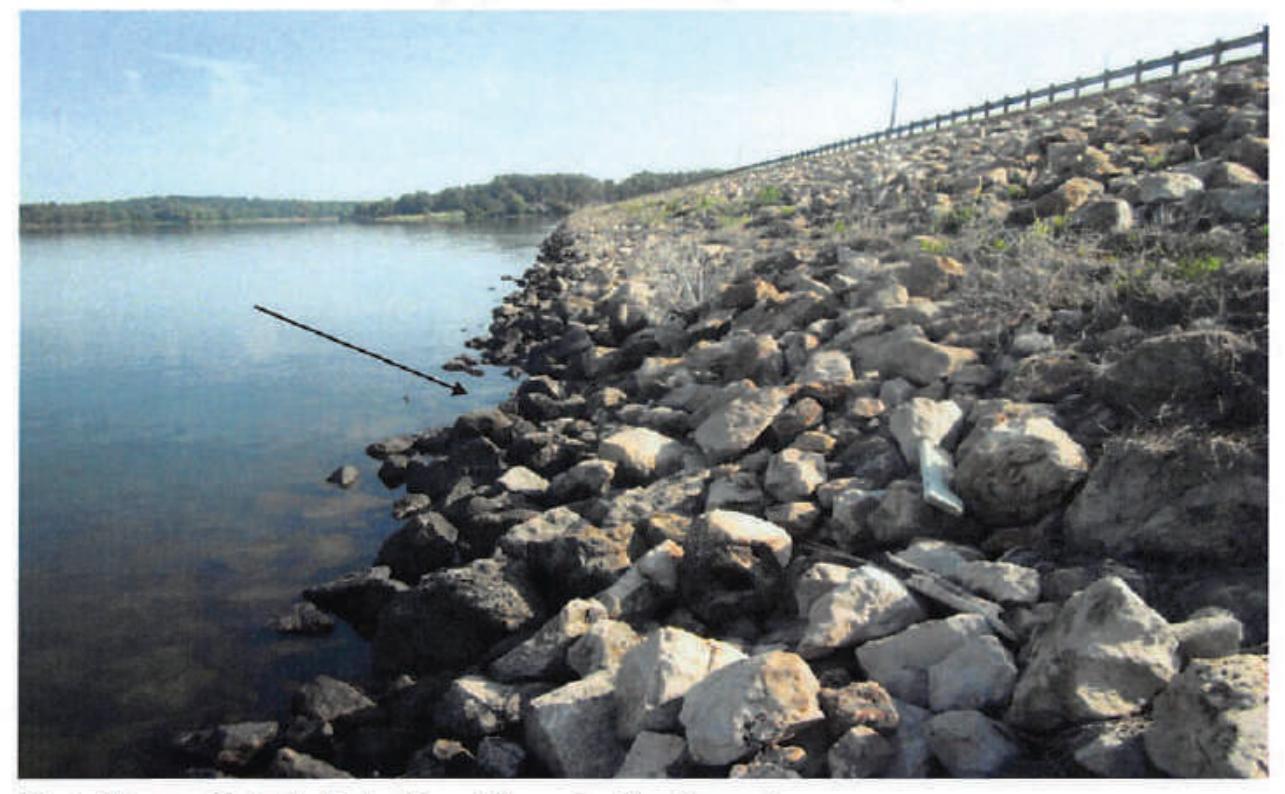
Photo No. 22. Note the indention at the water line (arrow).

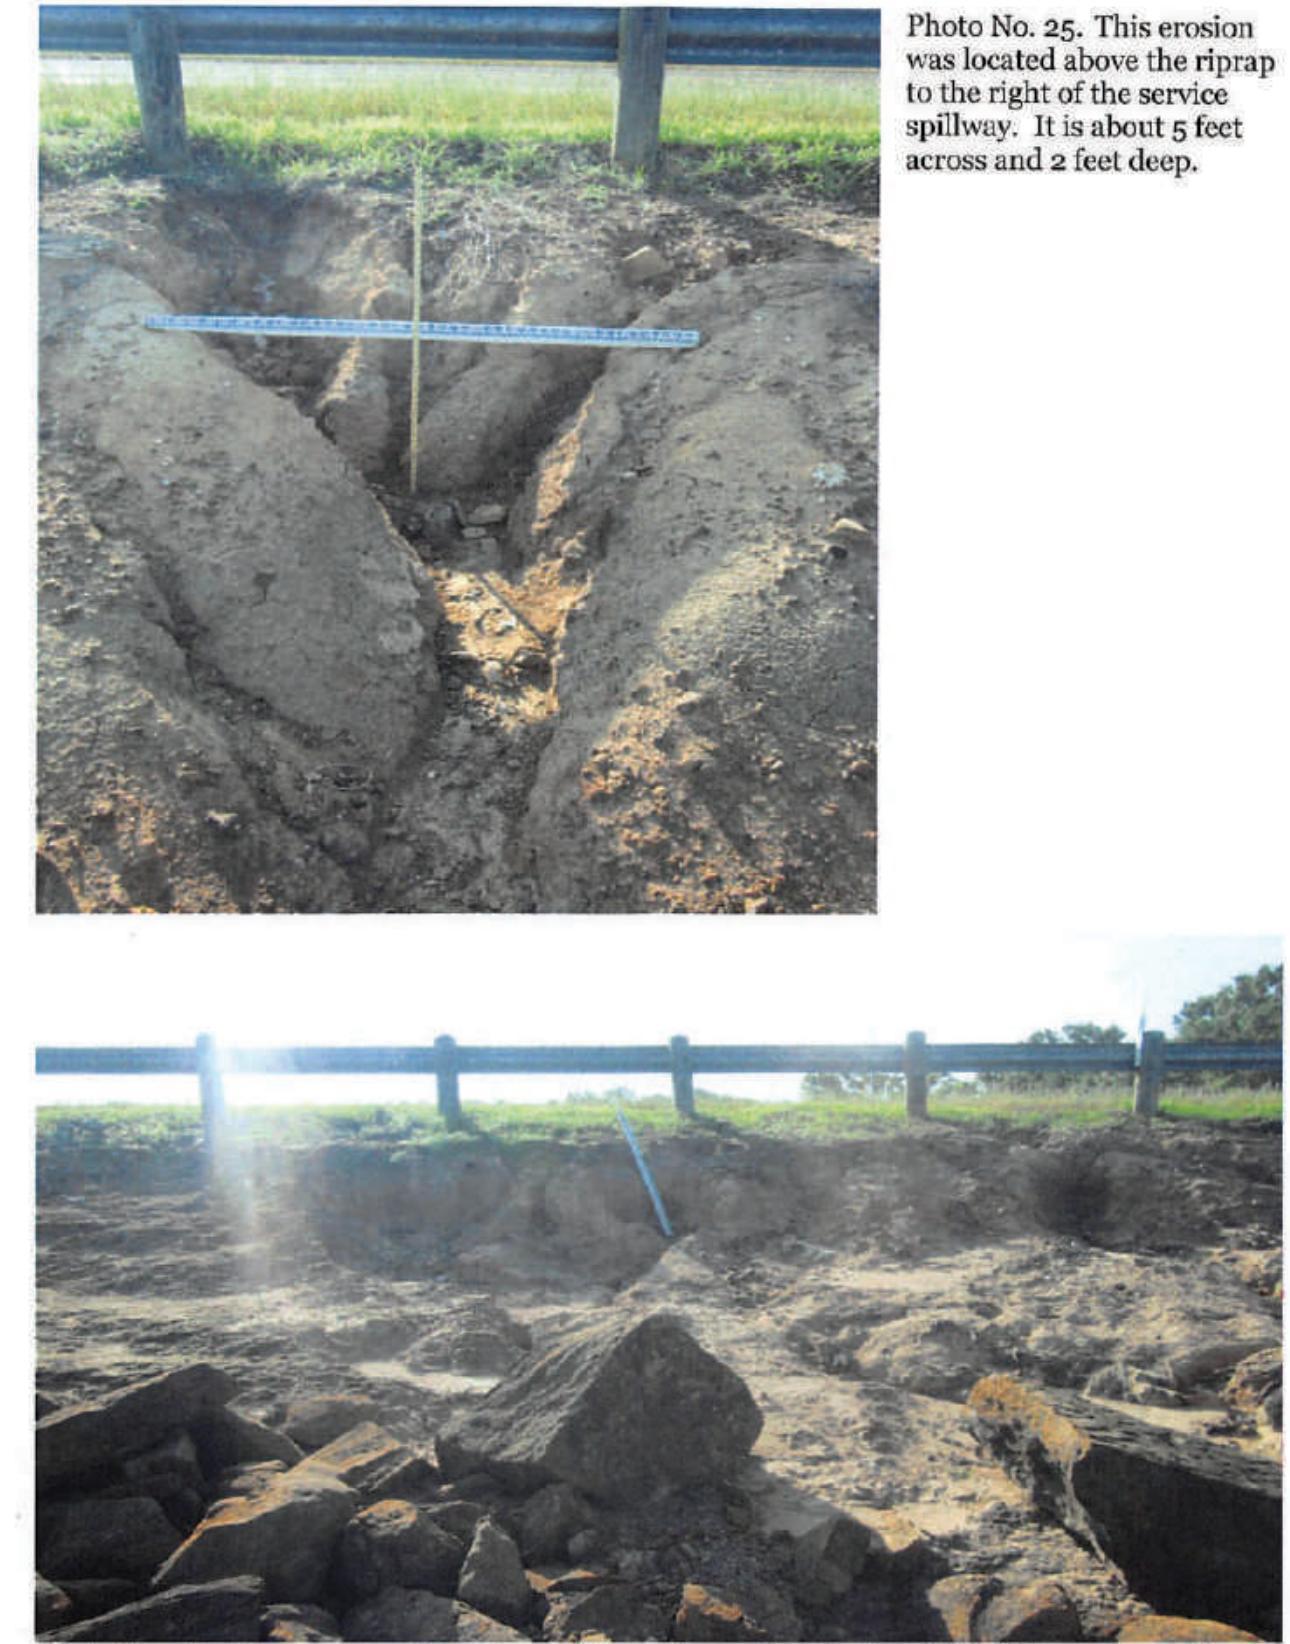
Photo No. 26. A larger area of erosion on the upstream slope to the right of the service spillway.

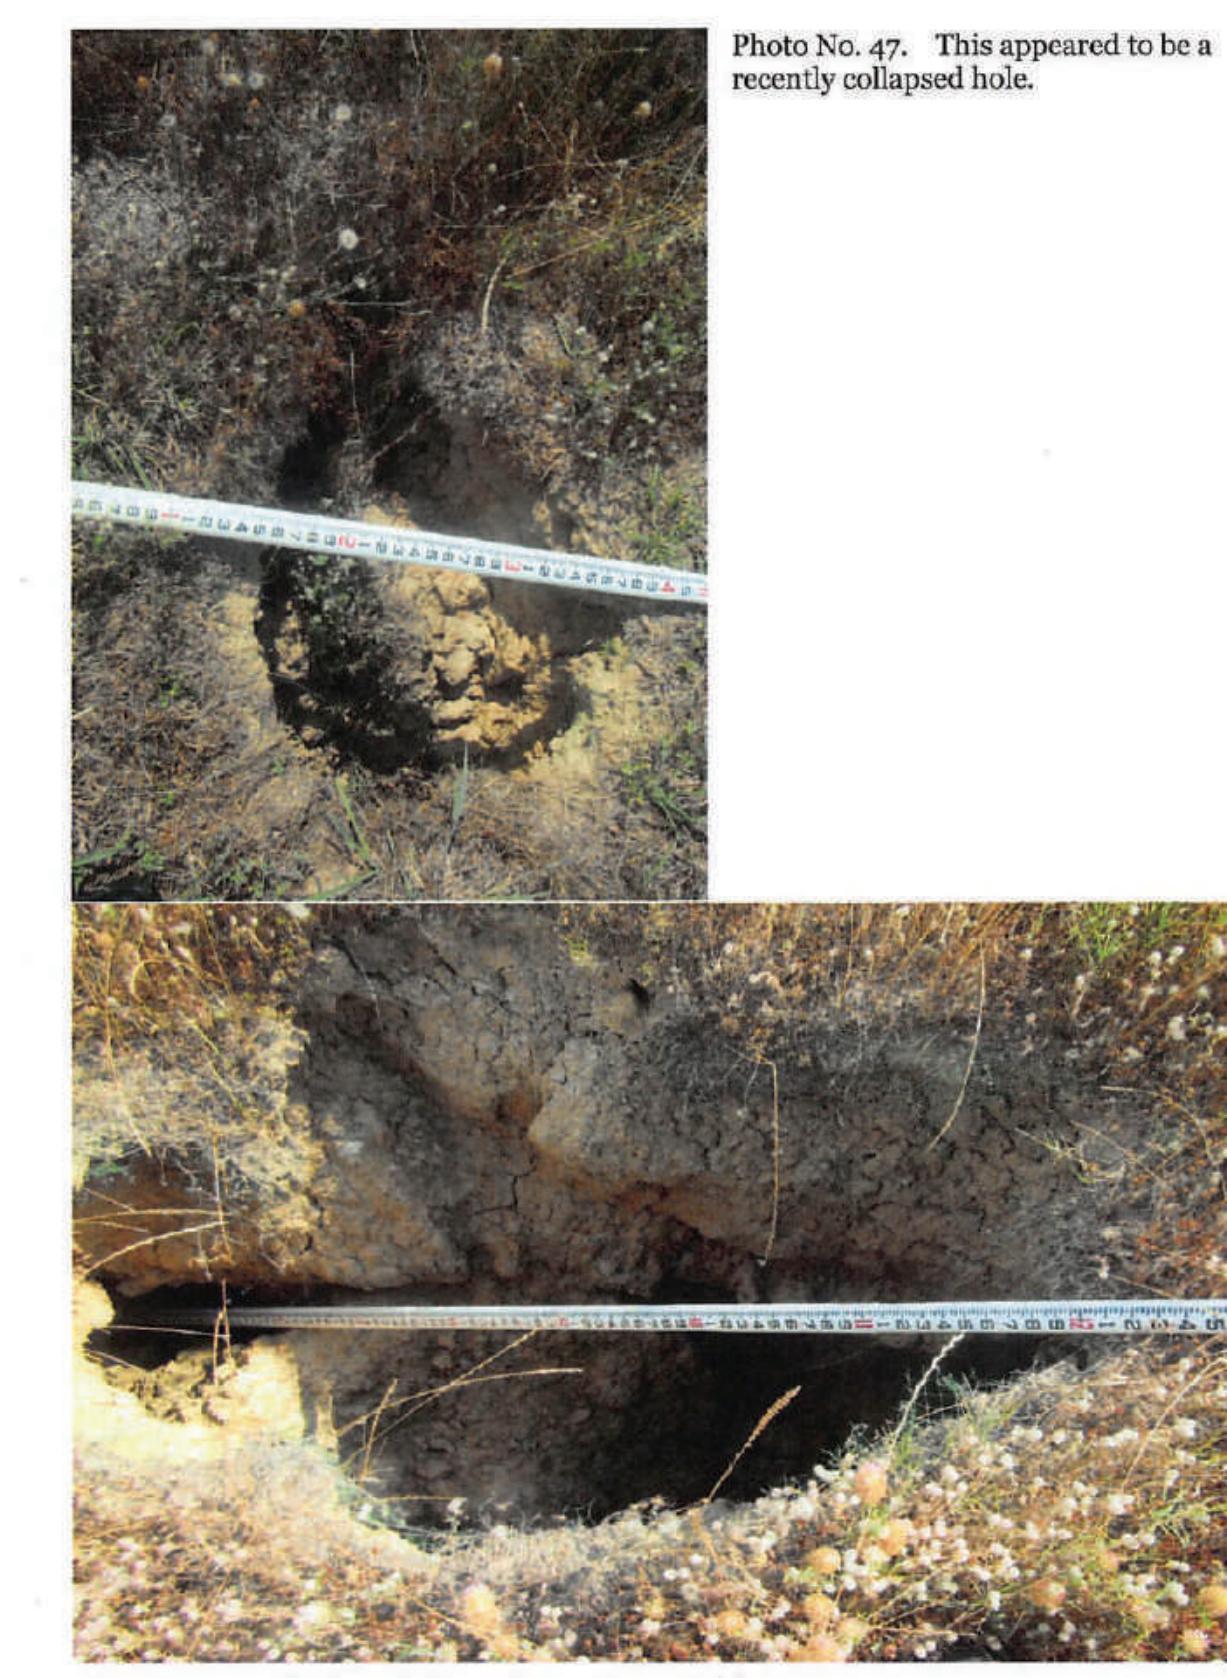
Photo No. 48. This large hole was located near Station 16+00.

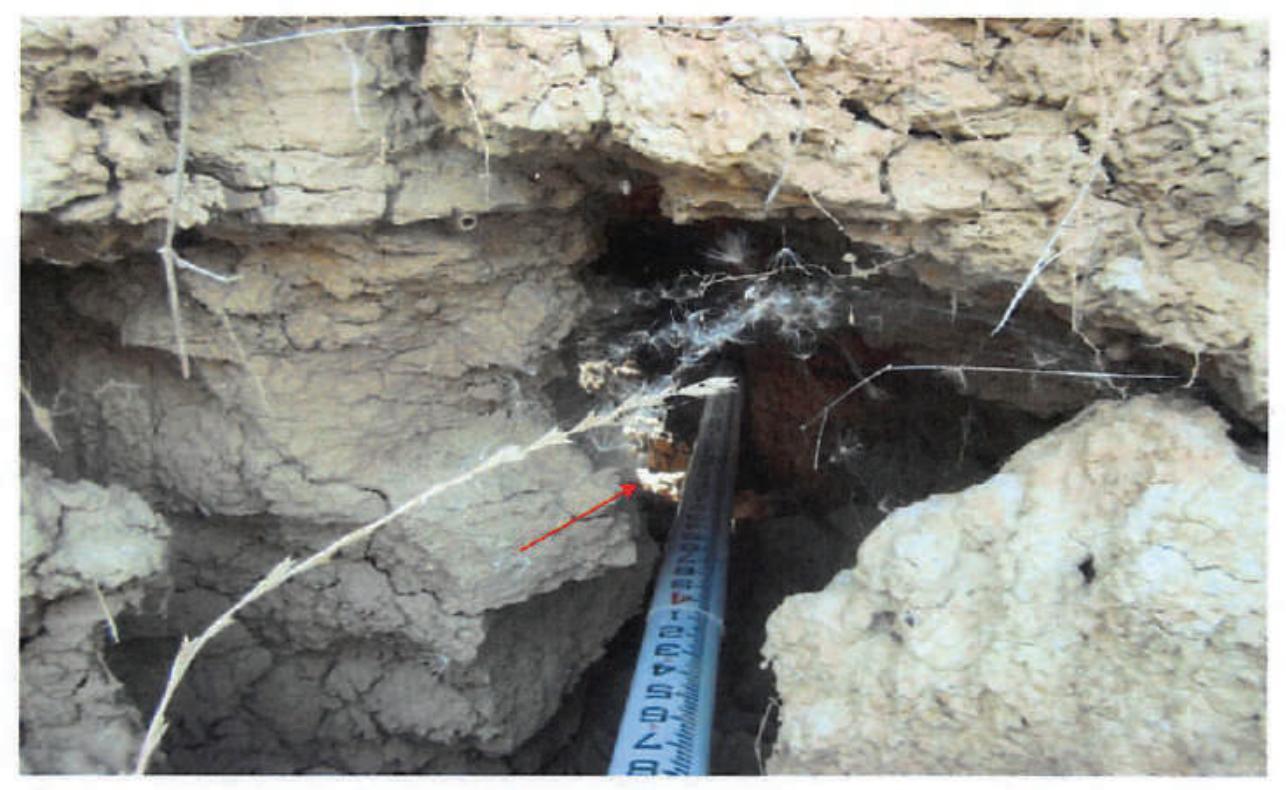
Photo No. 55. Light was observed in this tunnel (arrow). Note that the integrity of the soil has been compromised.

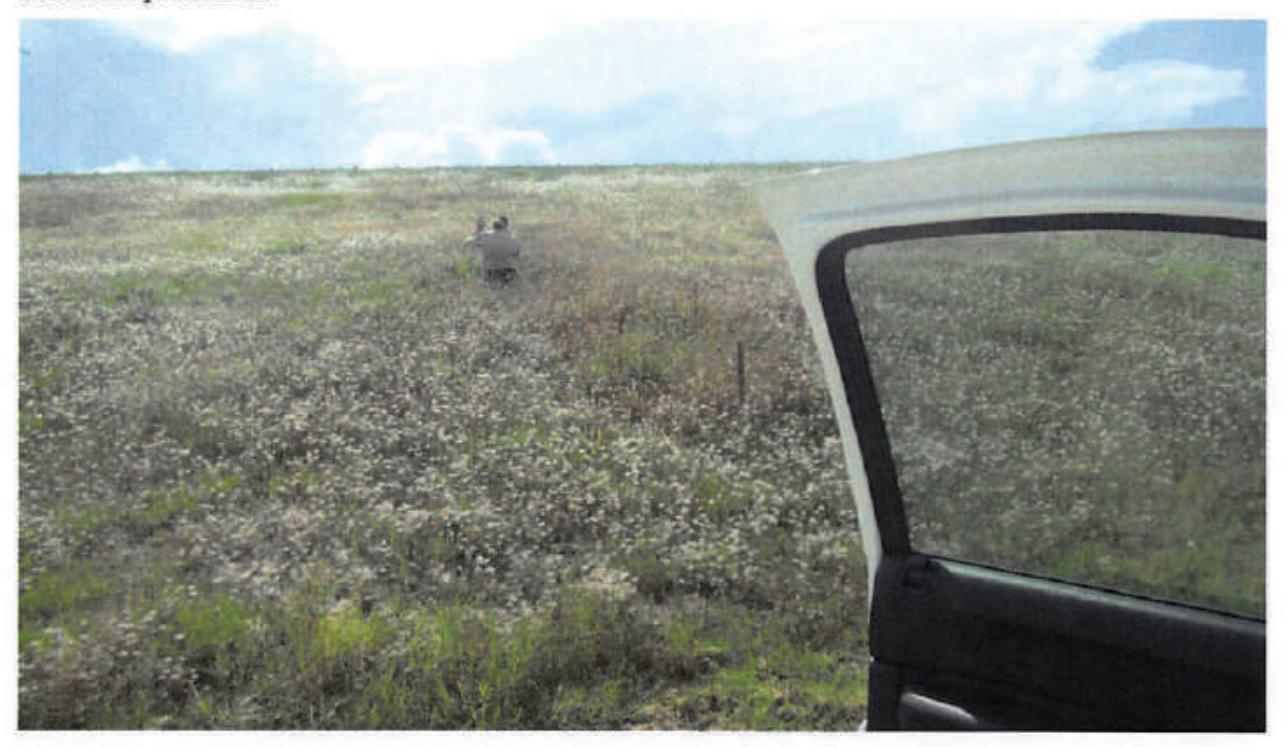
Photo No. 56. The inspector is standing in the hole for Photo No. 55. The inspector is over 6 feet tall. Note the line of wooden stakes. This is around Station 11+00.

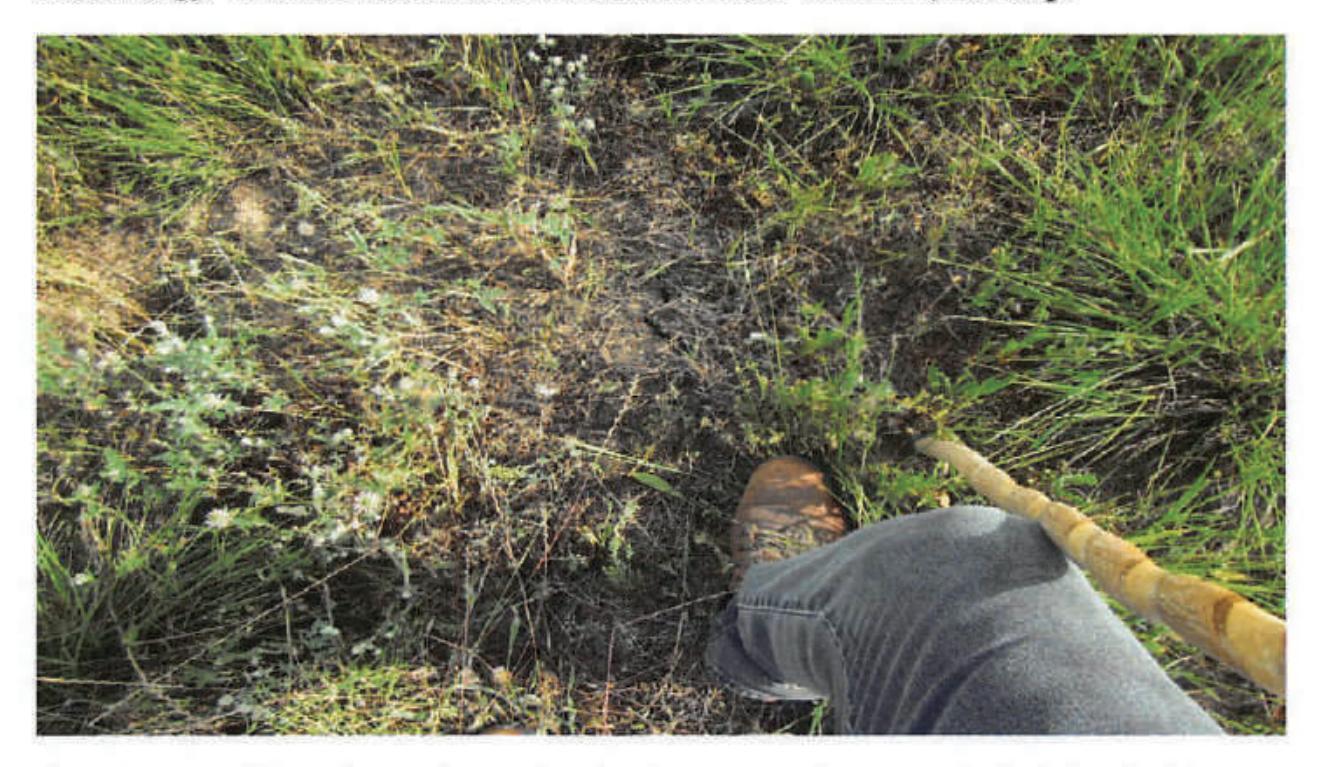
Photo No. 60. This crack was observed on the downstream slope towards the left end of the dam.

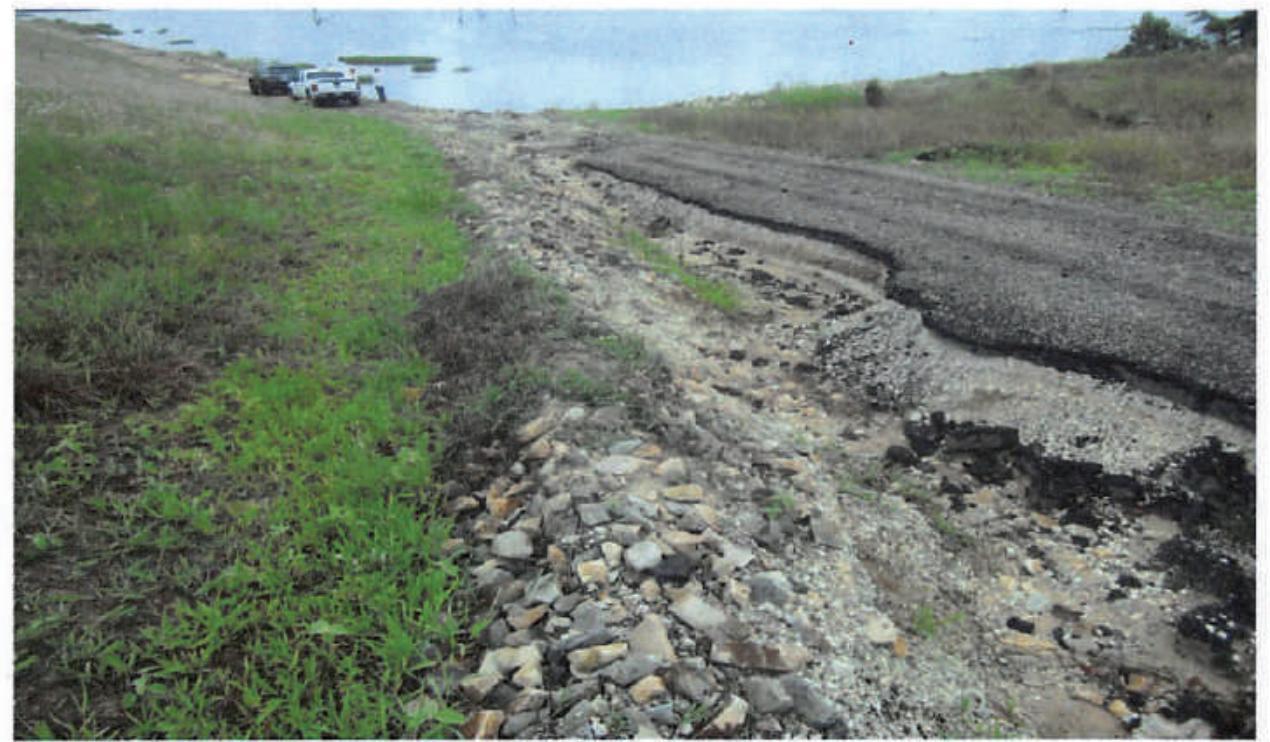
Photo No. 61. This erosion was located on the right groin.

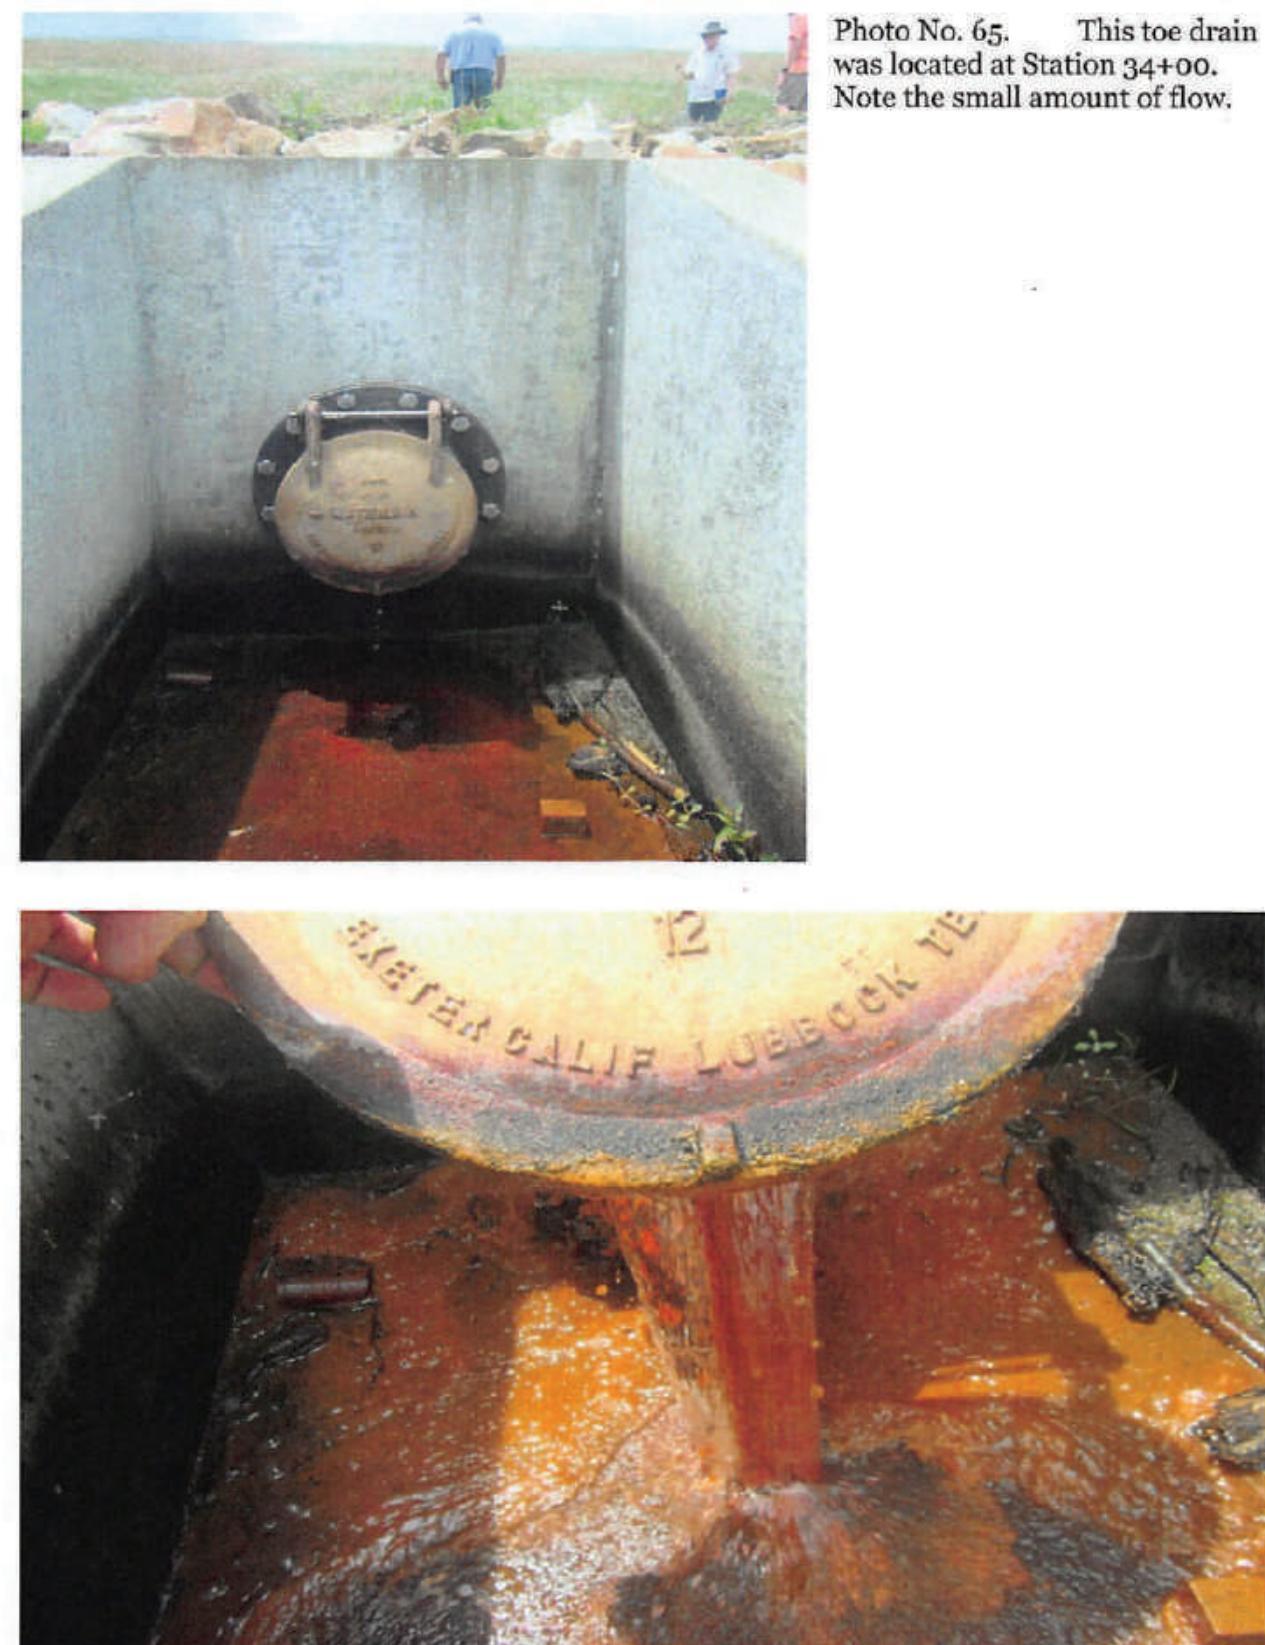
Photo No. 66. This is the flow when the flap was raised for the drain in Photo No 65. There was a build-up of water in the drain.

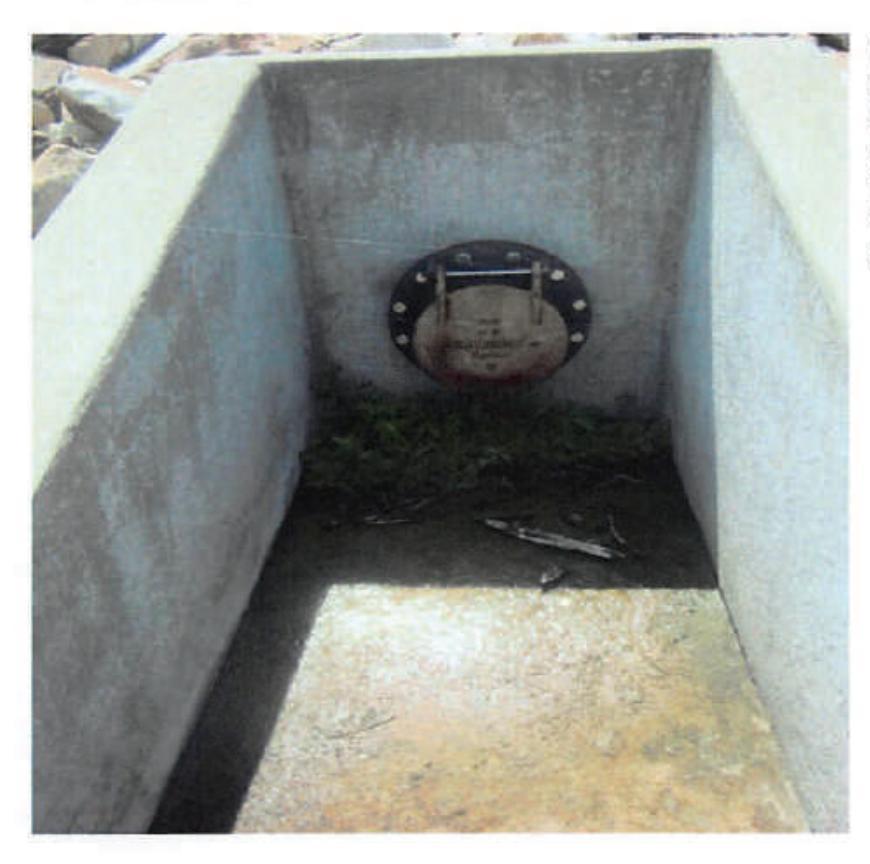
Photo No. 68. This drain at Station 16+00 before it was opened. Note the wet condition and the vegetation. There was flow when the flap was raised, but not as much as at Station 18+00.

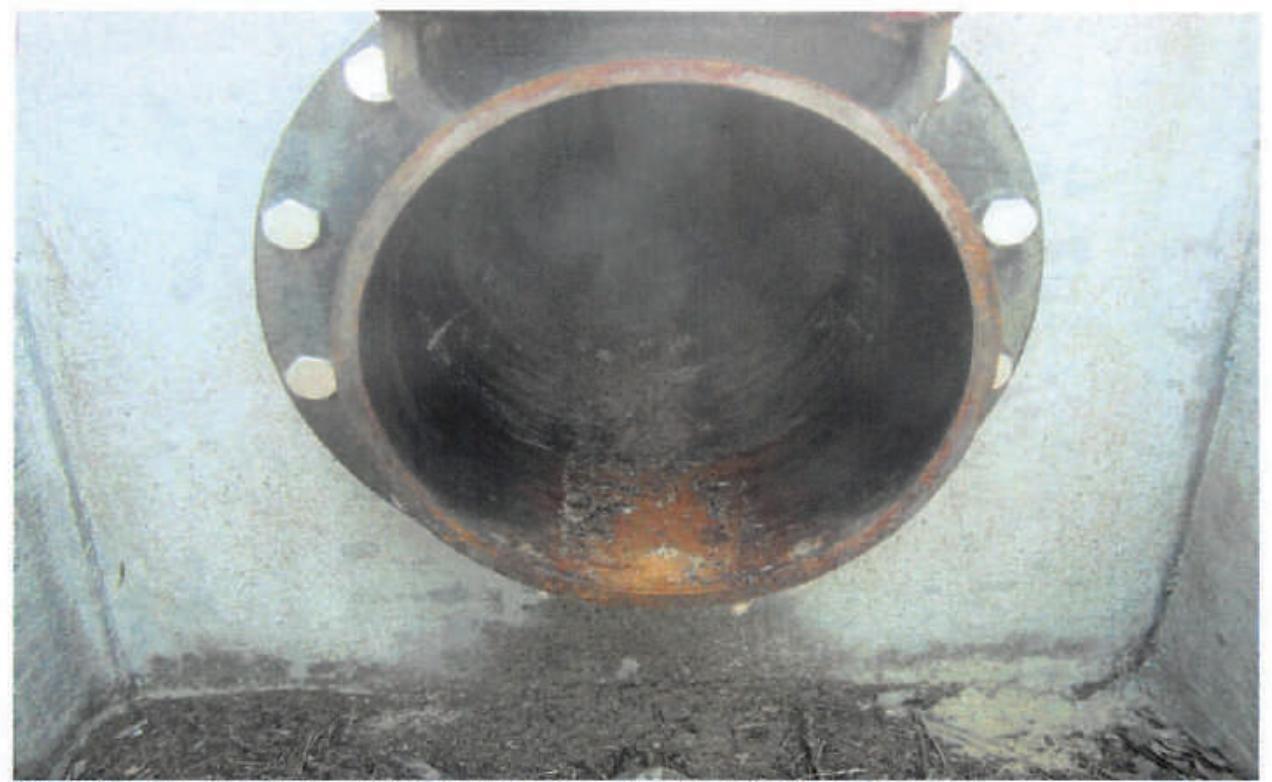
Photo No. 69. The drain at Station 14+00 was dry when the flap was raised.

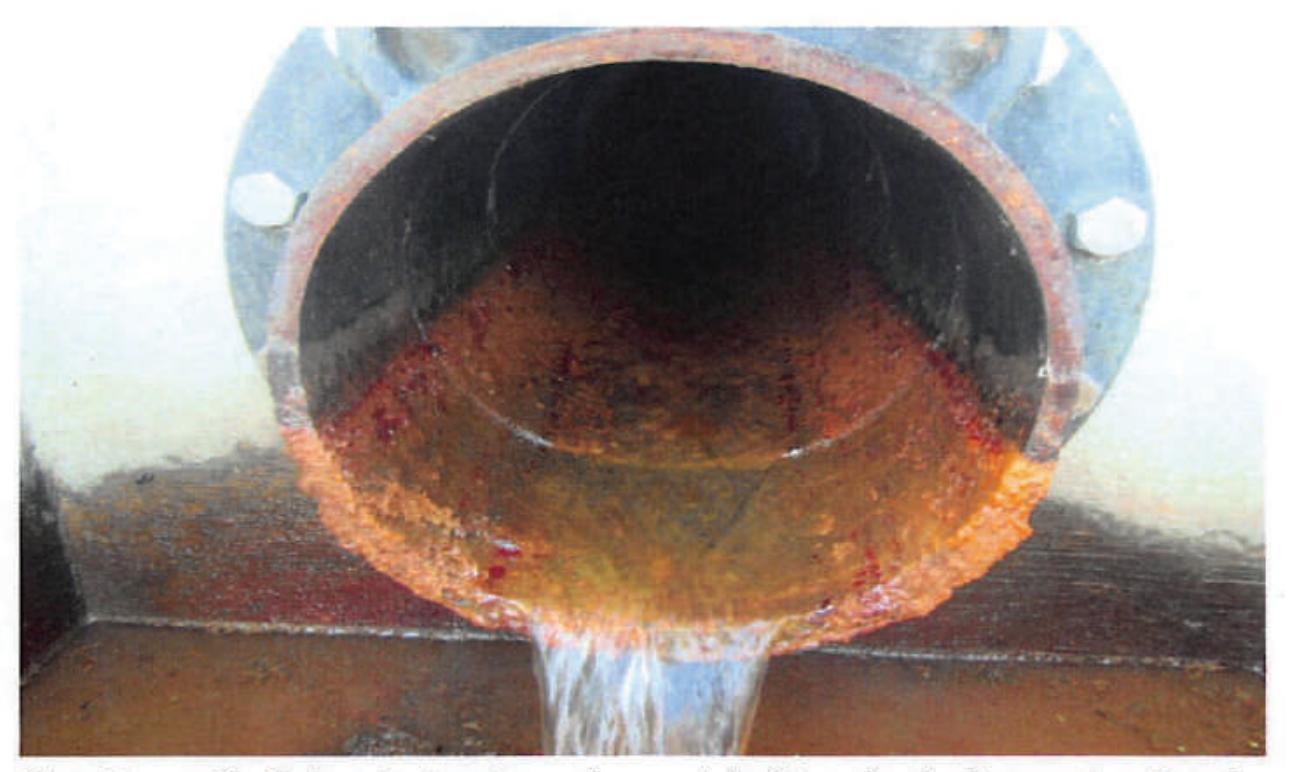
Photo No. 70. The drain at Station 18+00 after a period of time after the first opening. Note the stain in the pipe from standing water.

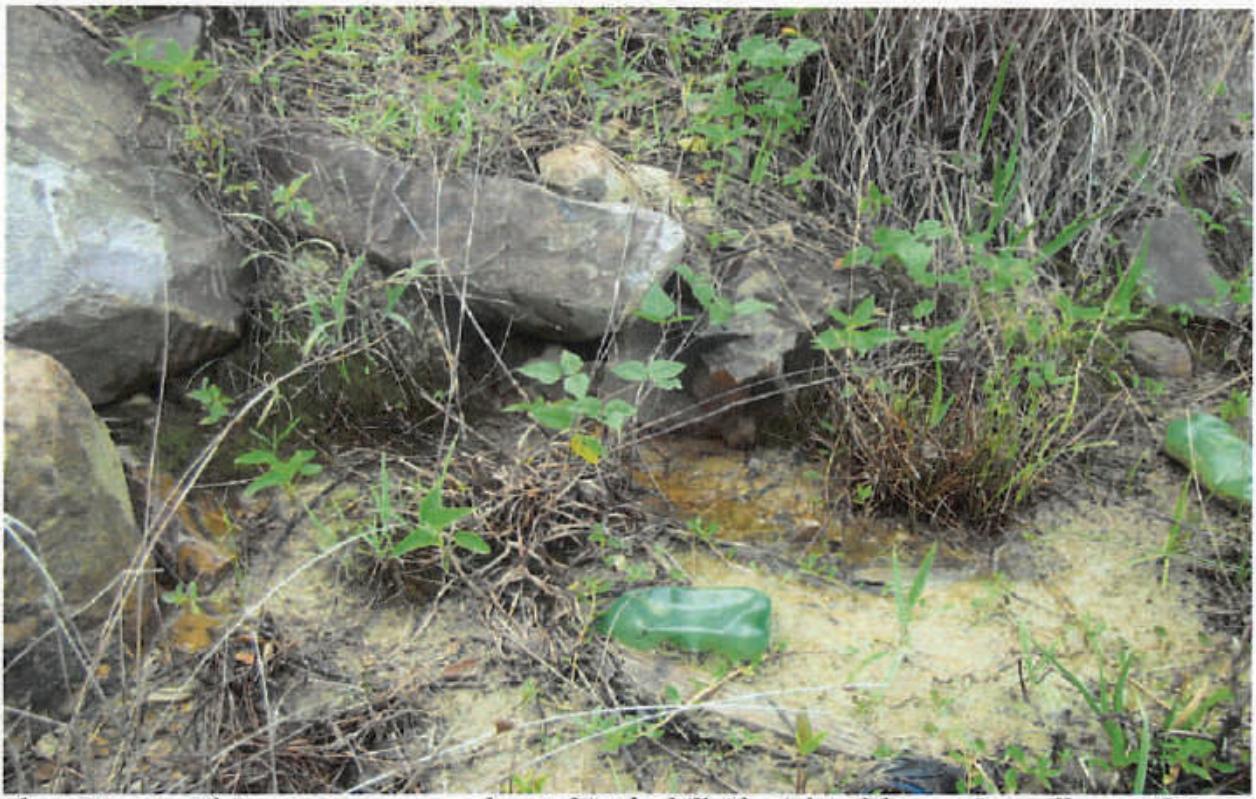
Photo No. 71. This seepage area was located in the hillside right of the service spillway. This area has been noted in the past.

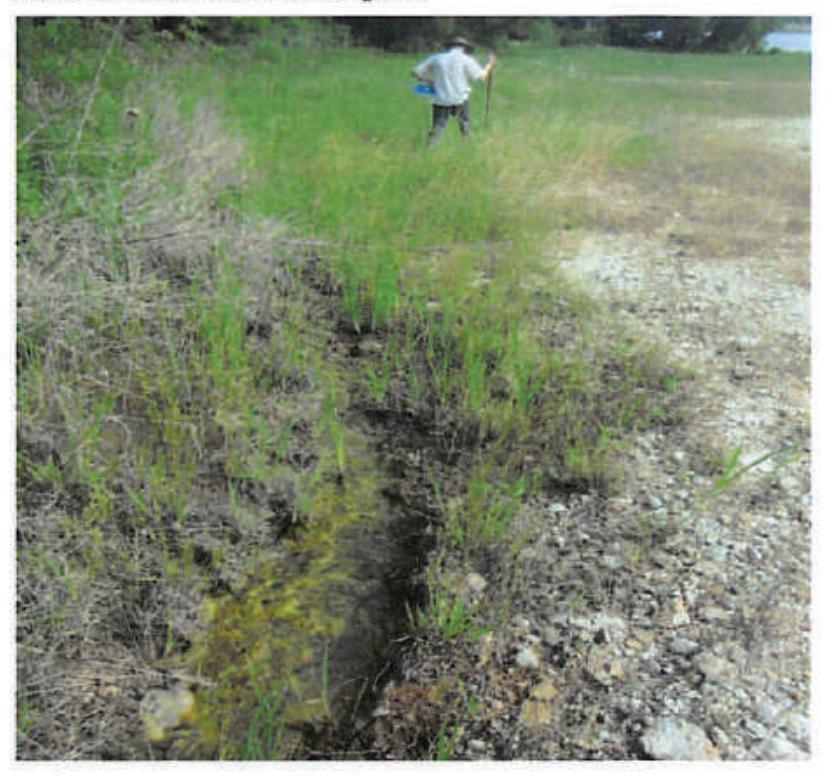
Photo No. 72. This seepage was located along the left downstream toe.
