# Franklin County Dam Preliminary Engineering Report: Development of Alternatives to Restore Downstream Slope

FRANKLIN COUNTY WATER DISTRICT

TUESDAY, FEBRUARY 18, 2020

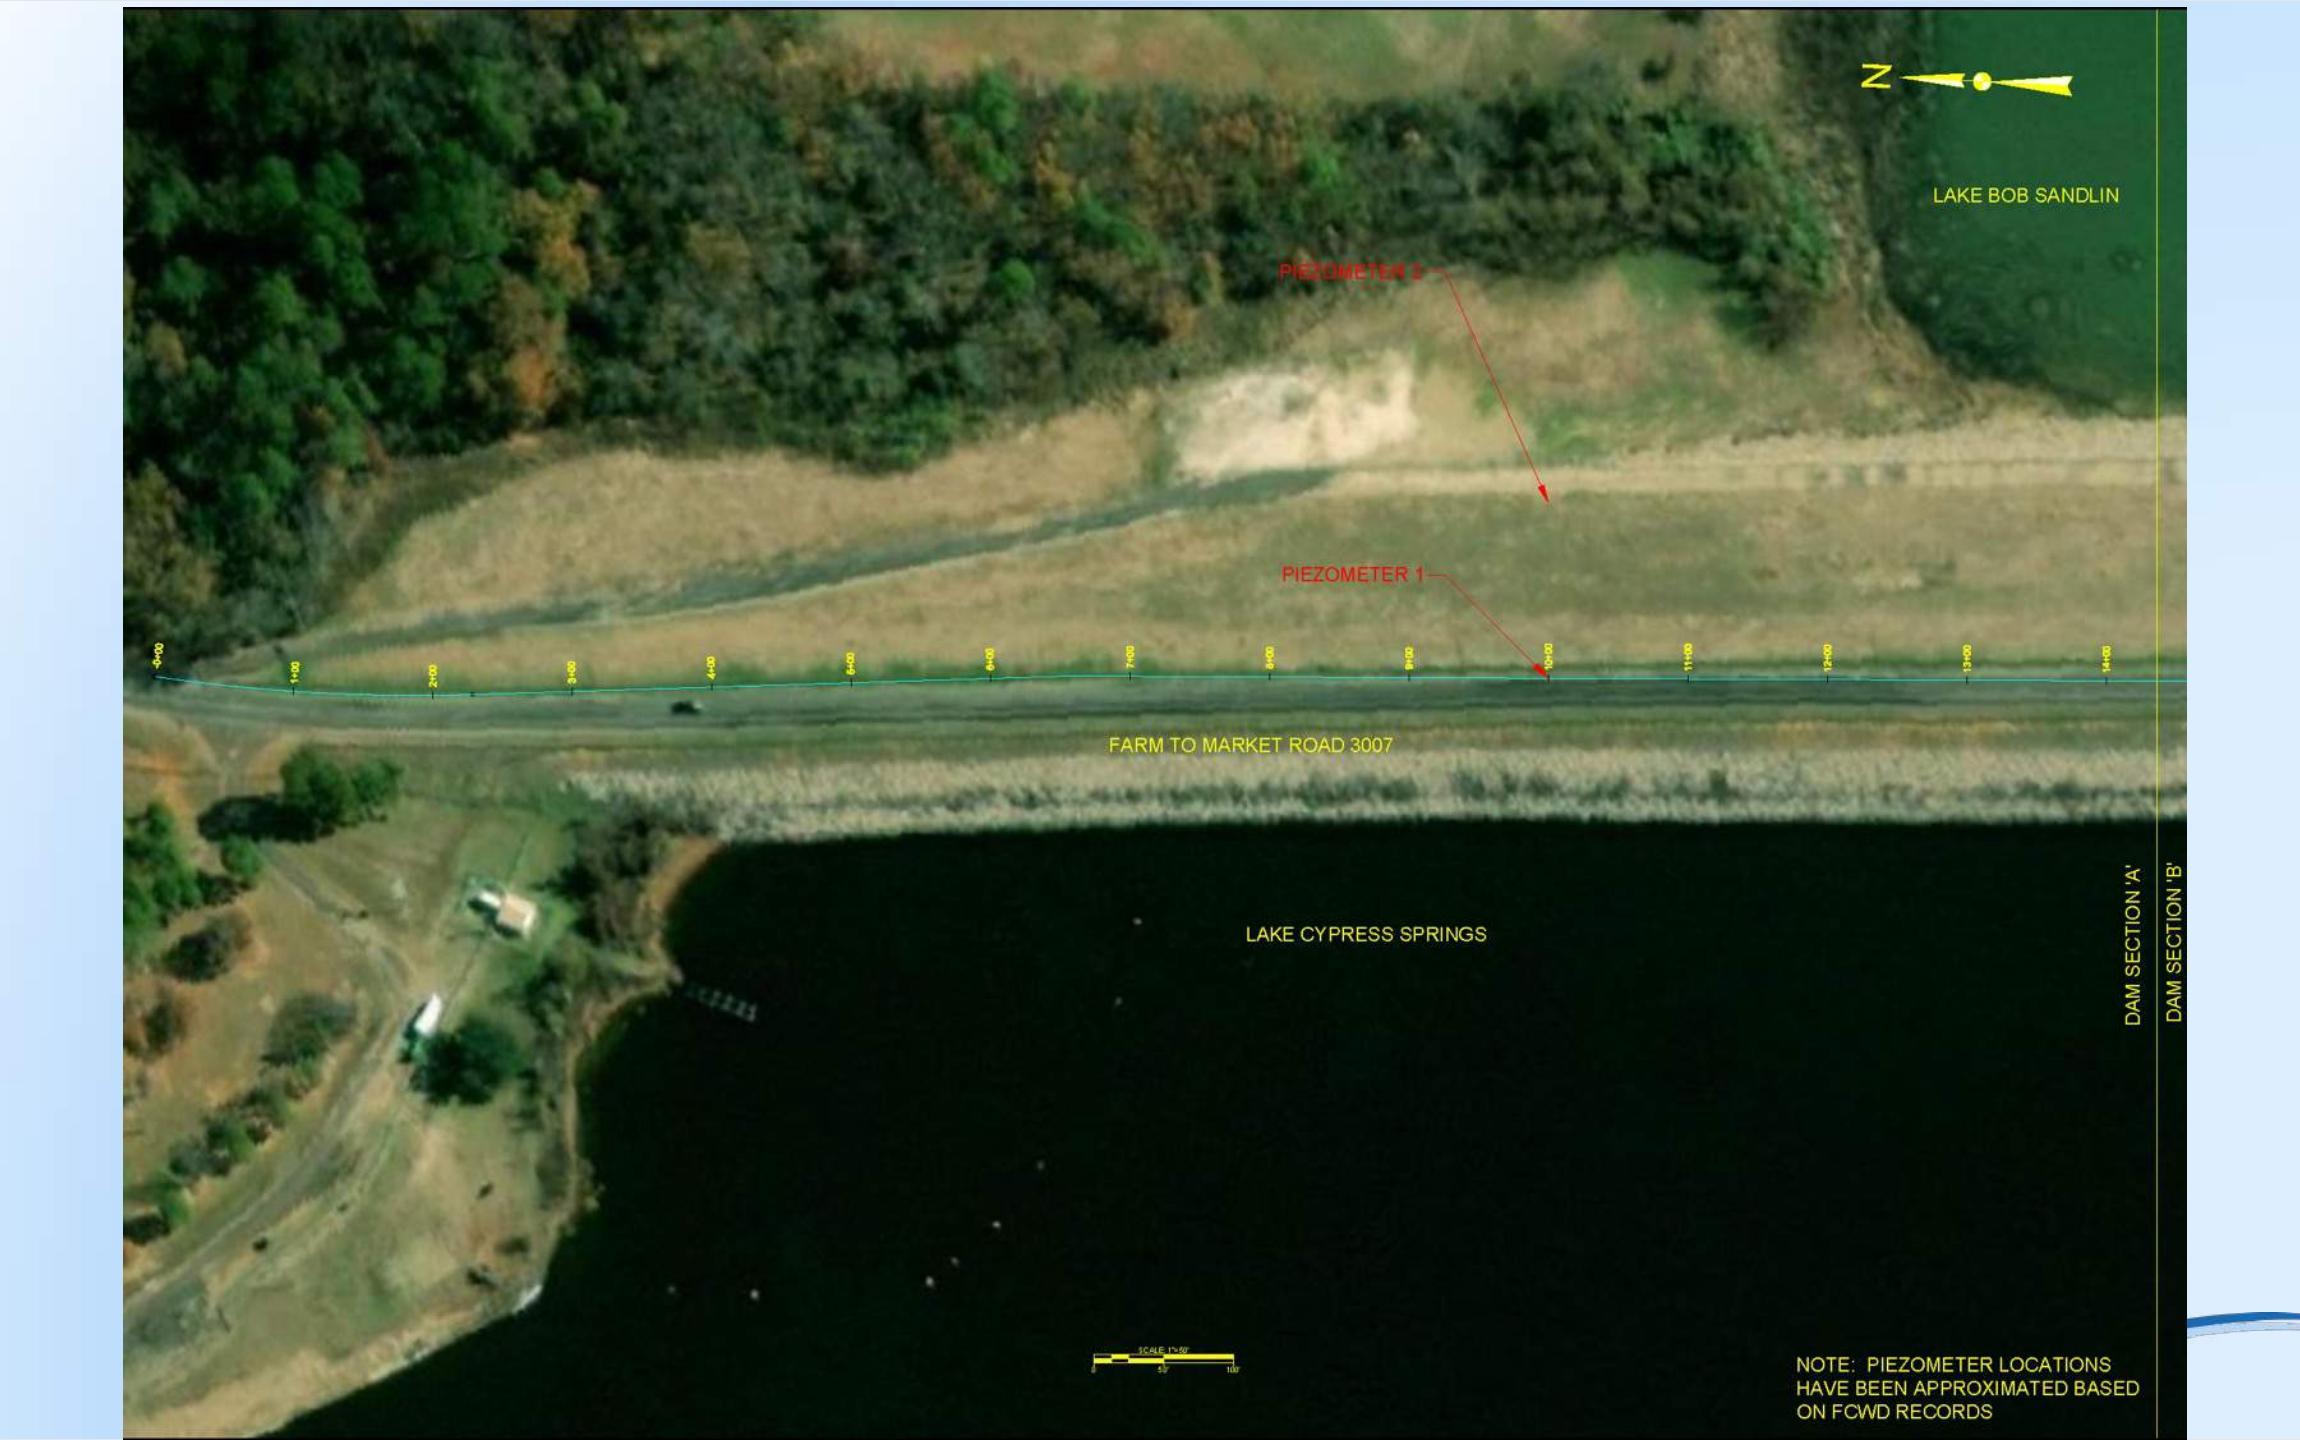
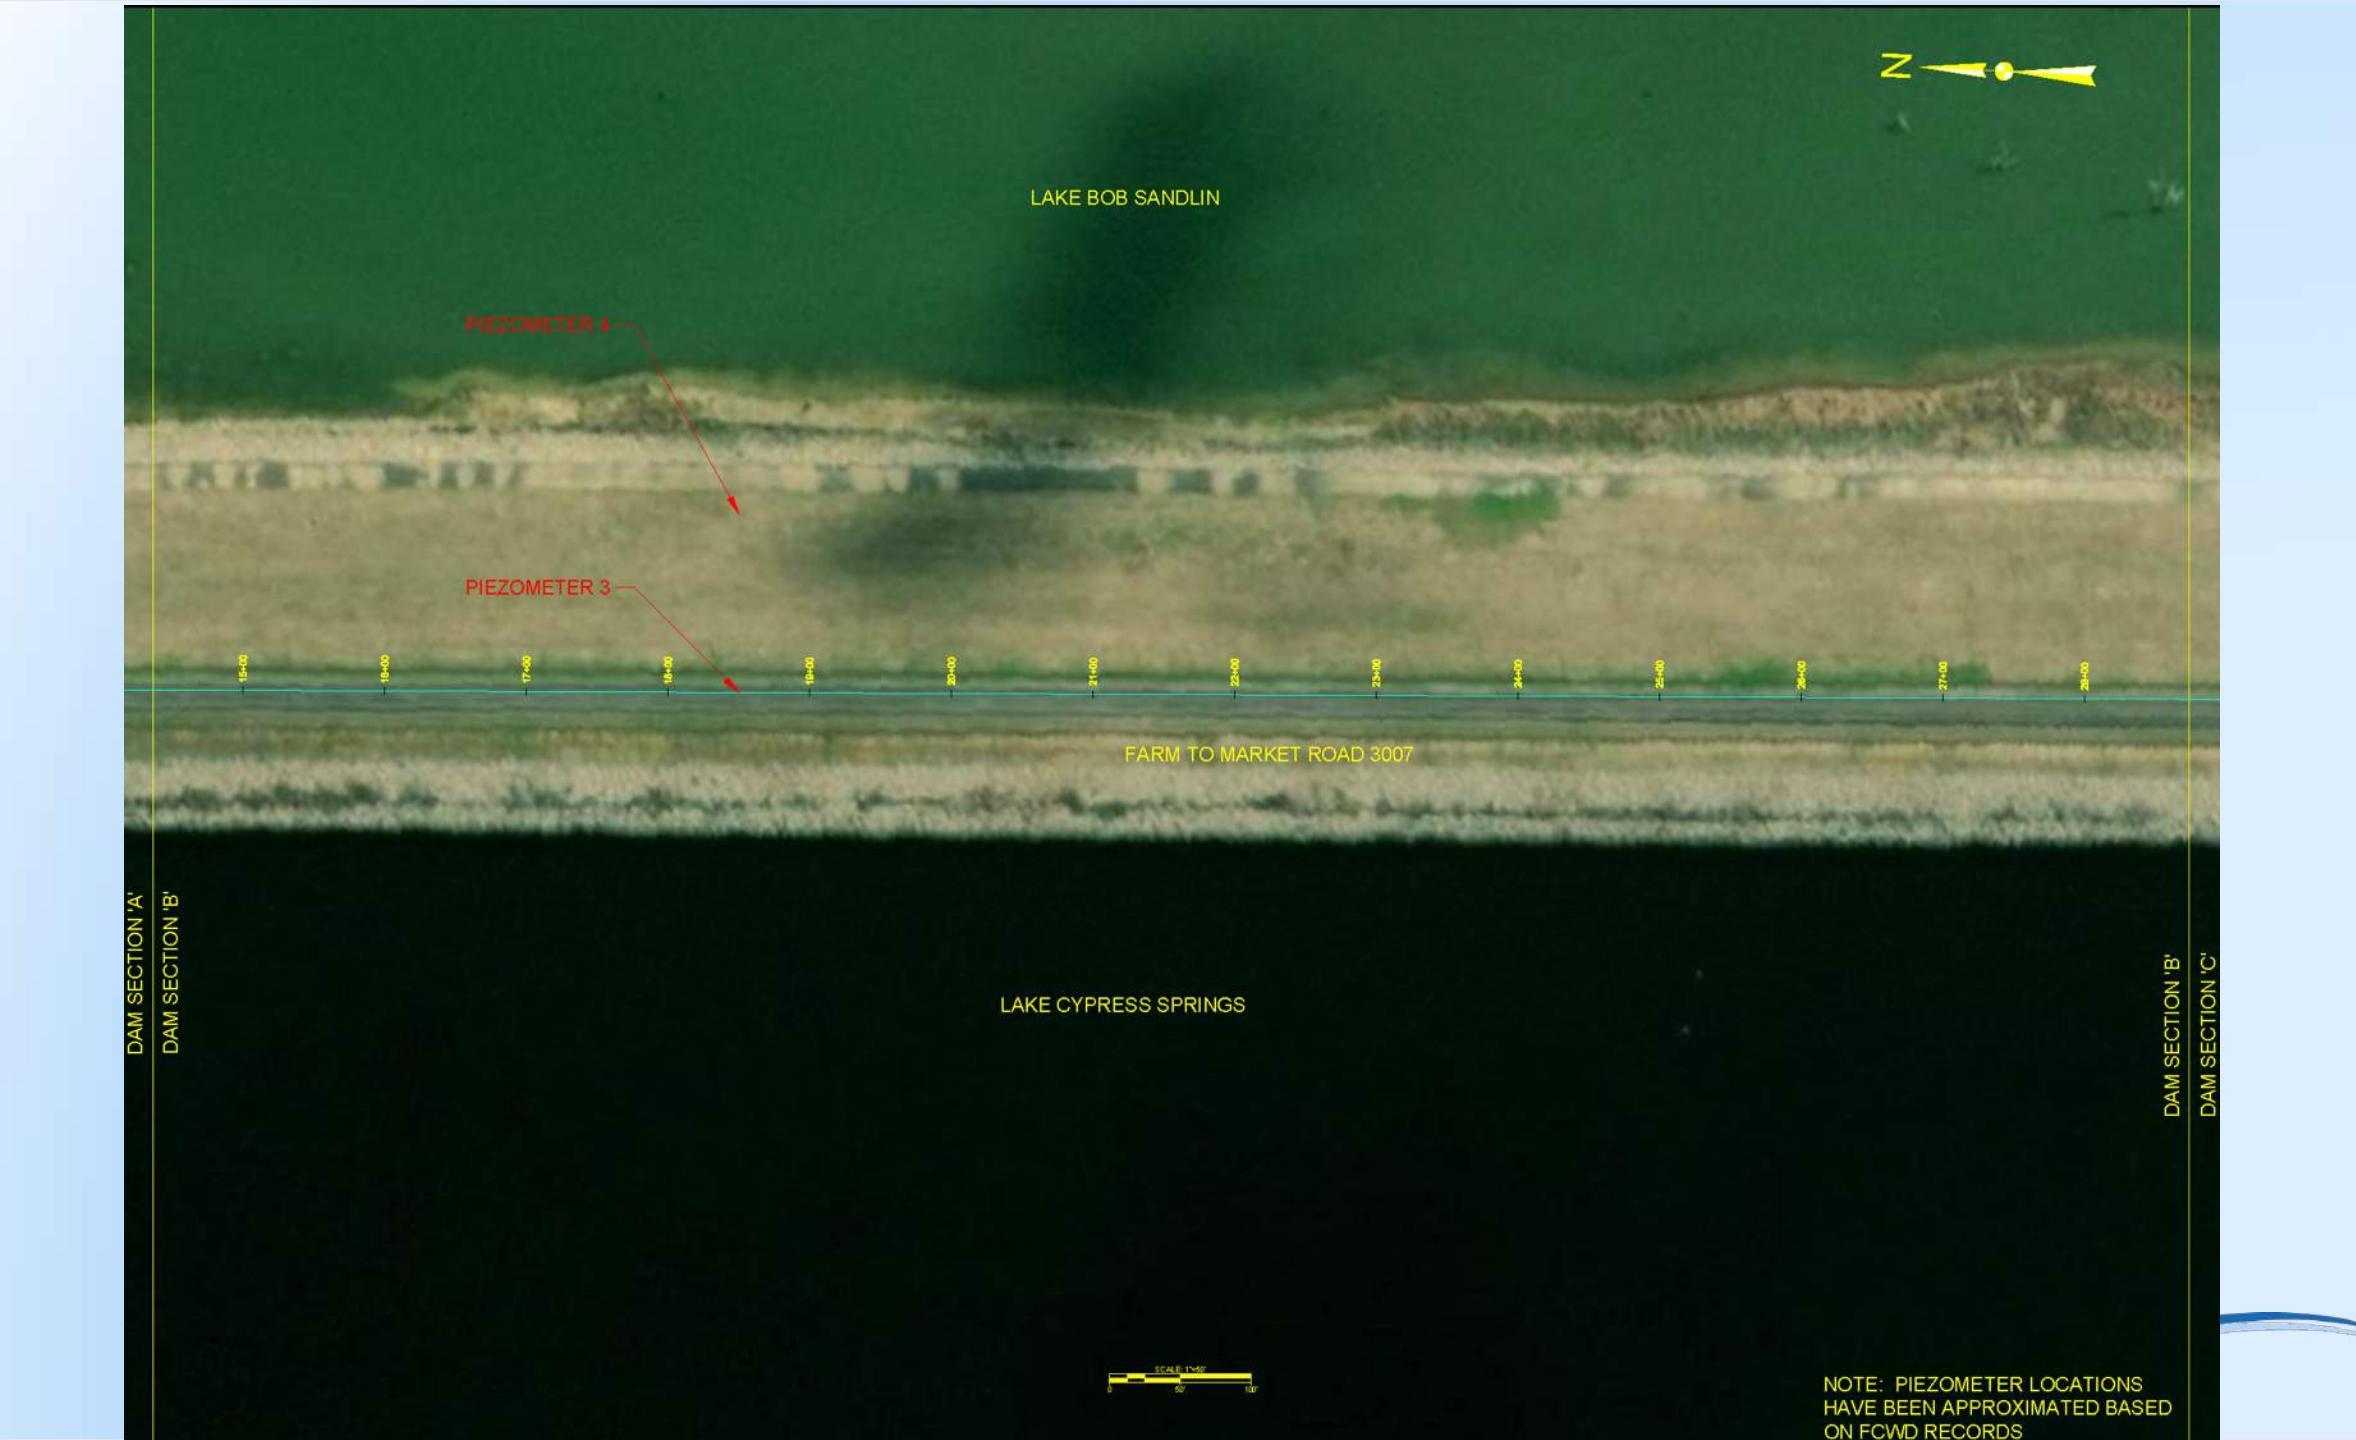
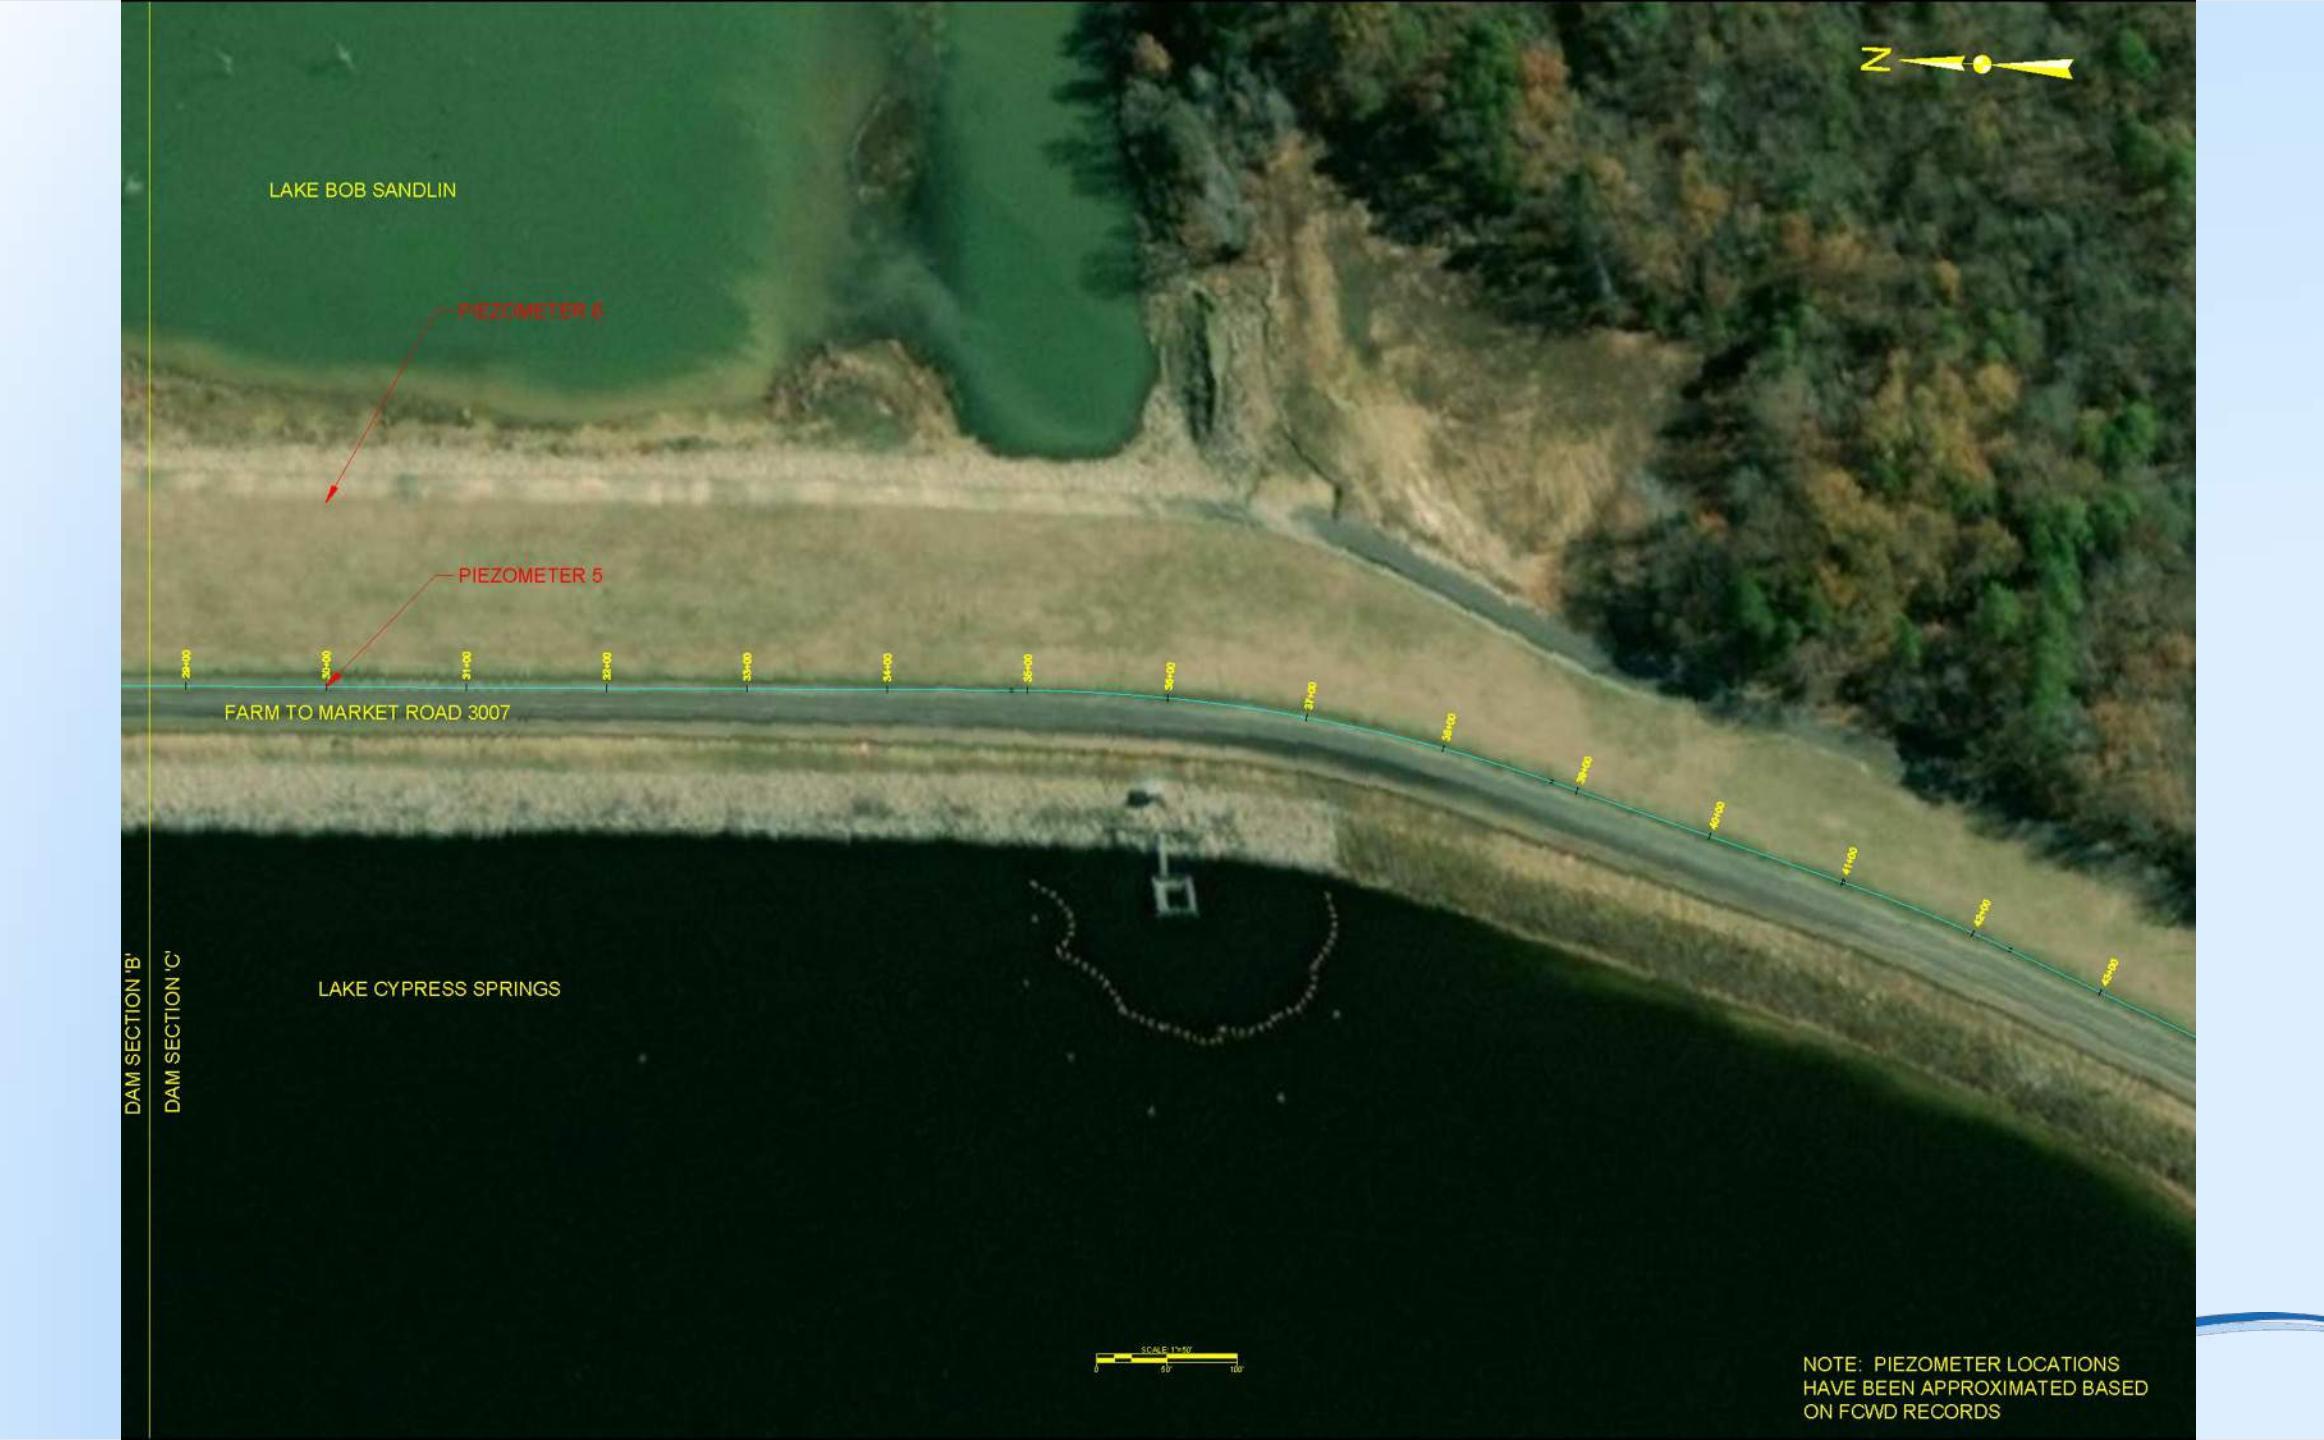
- History of dam includes an incomplete account of the installation and abandonment/removal of piezometers
- Current piezometer data limited to six piezometers
  - Three (3) located along the downstream edge of the dam crest
  - Three (3) located along the upstream side of the access road/berm on the downstream slope

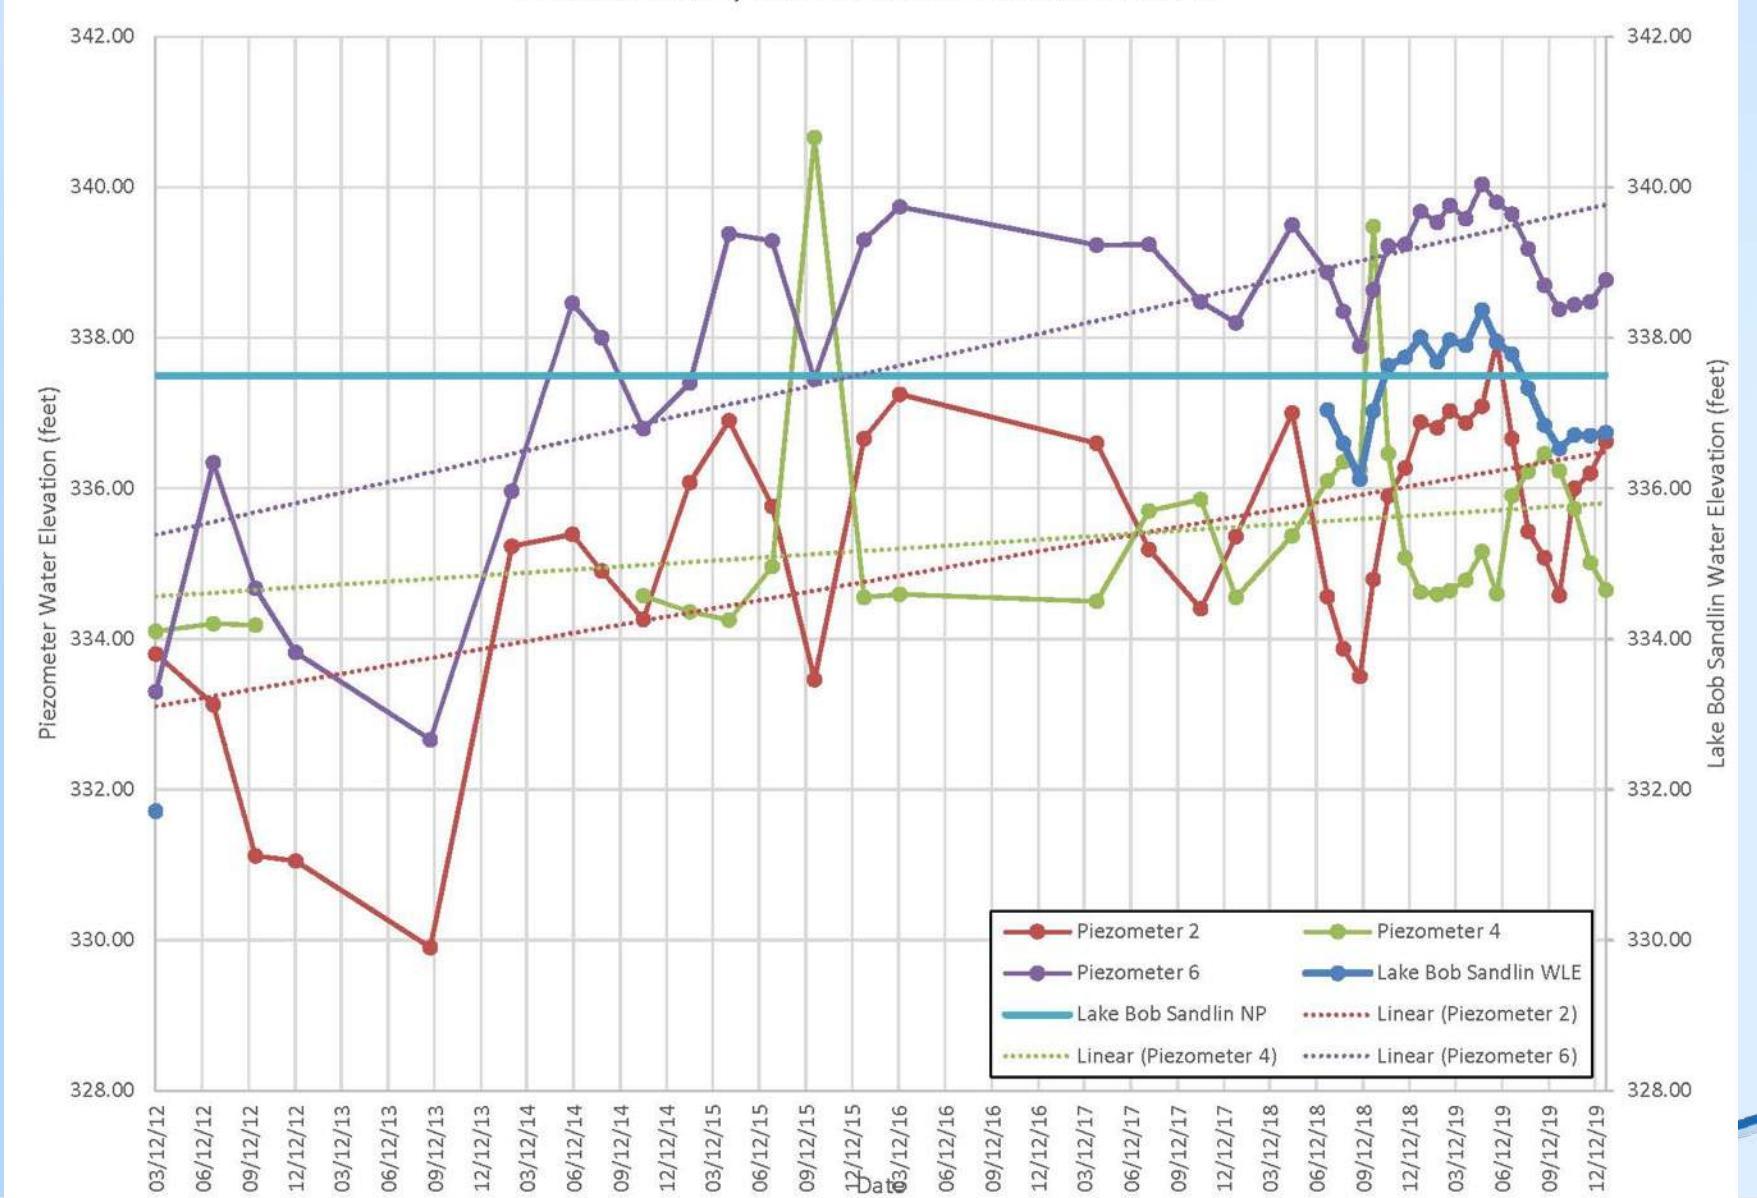
Franklin County Dam Piezometer Measurements

### **Review of Piezometer Data**

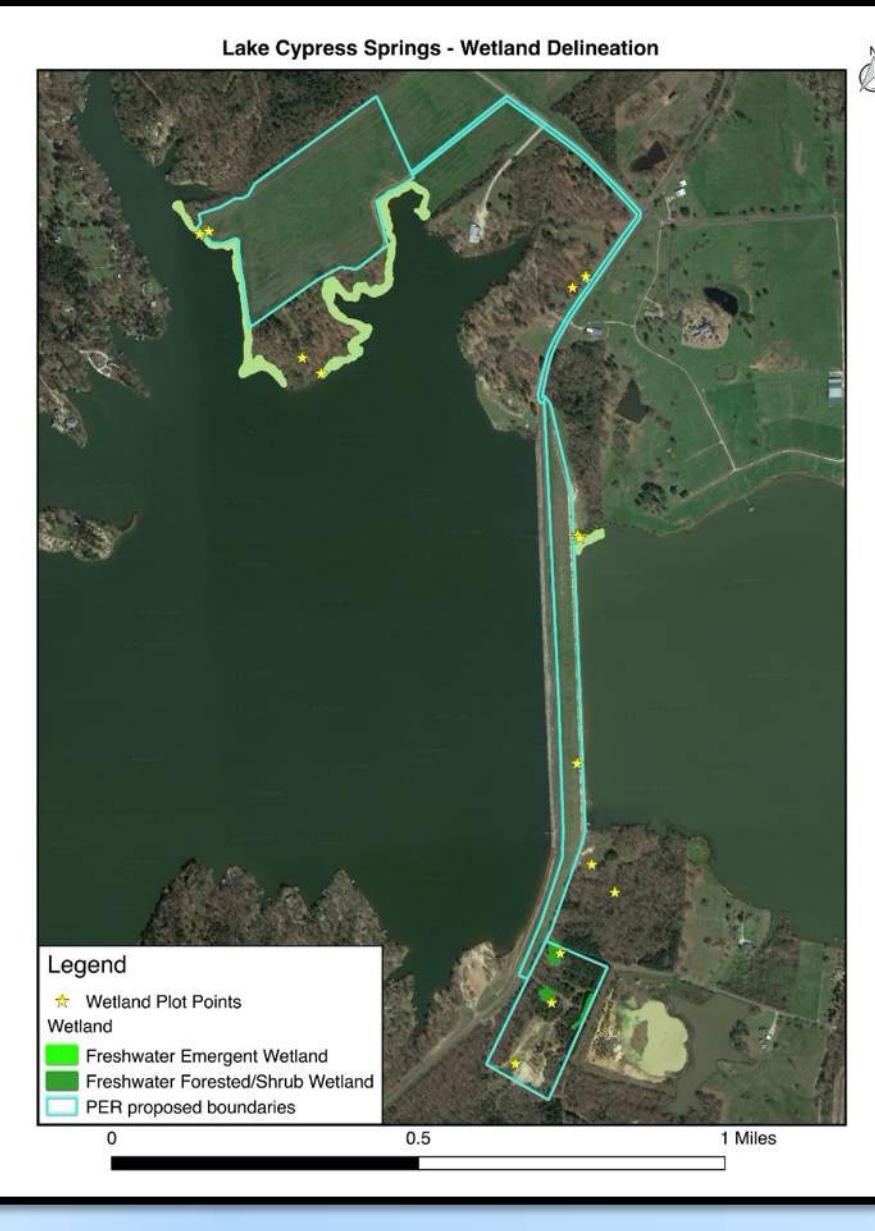
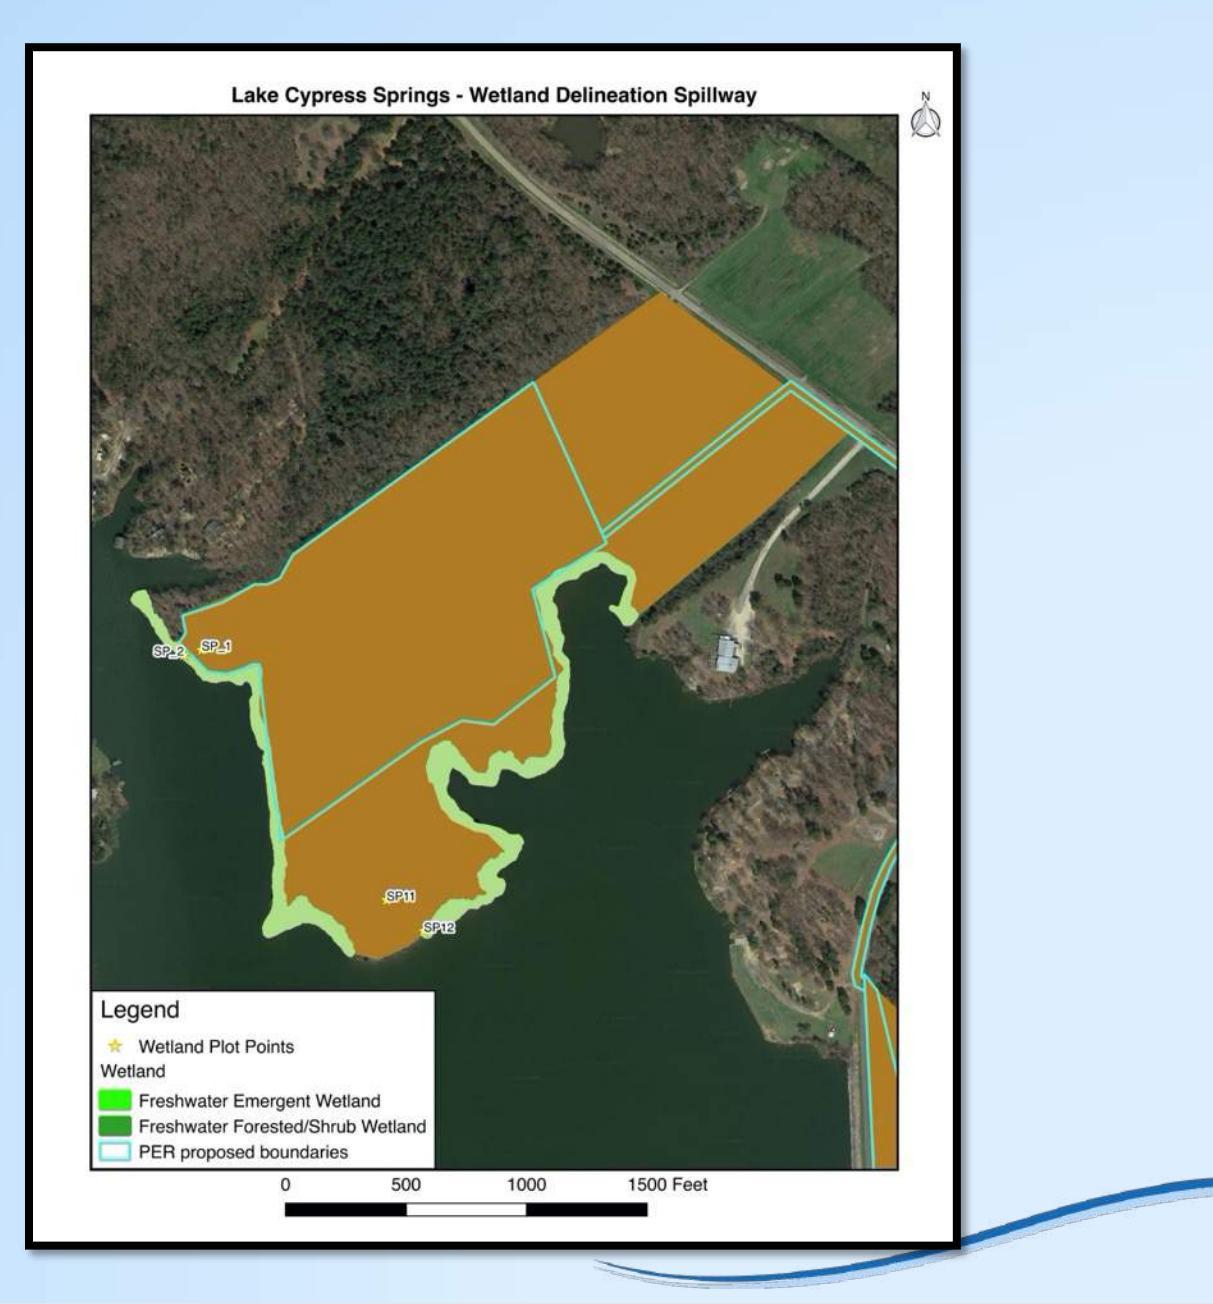
### **Identified Wetlands**

- Section 404 Permit required regardless of the dam restoration alternative selected
- Identified approximately 5.5 acres of wetlands in proximity of the project boundaries
- Additional efforts to be fully defined include:
  - Possible additional wetland determination and delineation
  - Critical habitat survey for threatened and endangered species
  - Coordination with THC to address any archeological concerns
