Franklin County Water District Development of Alternatives to Restore Downstream Slope, Franklin County Dam

PRELIMINARY ENGINEERING REPORT

FINAL | February 2020

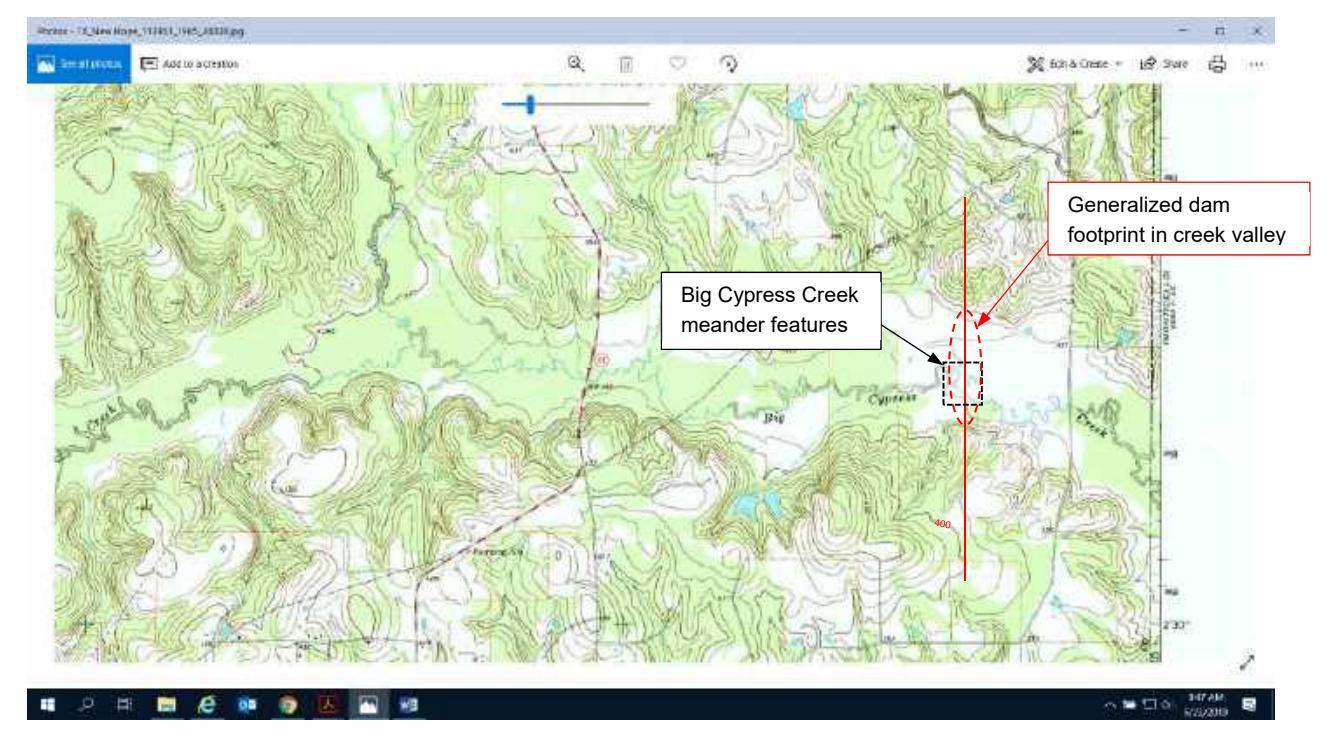
Figure 1 shows the significant channel meandering of Big Cypress Creek within the footprint of the embankment, delineating a probable zone of variable soil conditions influencing embankment differential movements. This zone is superimposed on the March 2019 aerial image (Figure 5) and indicates correlation with the persistent seepage hotspot on the downstream slope in the Big Cypress Creek valley.

Figure 5 – Relative position of Big Cypress Creek meander features existing Franklin County Dam downstream erosion hotspots (March 2019)

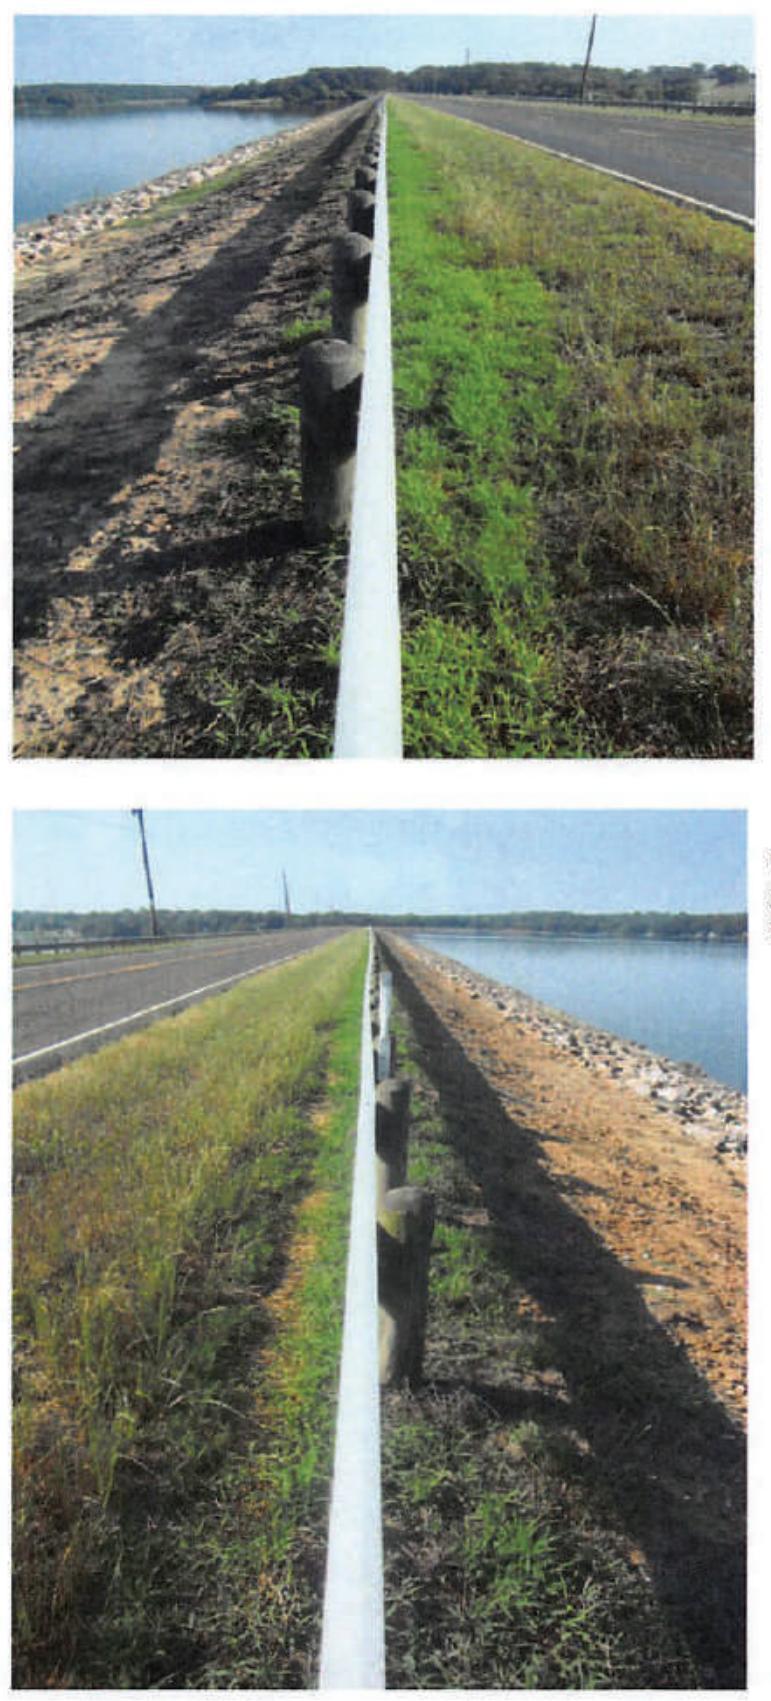
Photo No. 7. Another view of the upstream guardrail. Note the lack of cover on the upstream slope above the riprap.

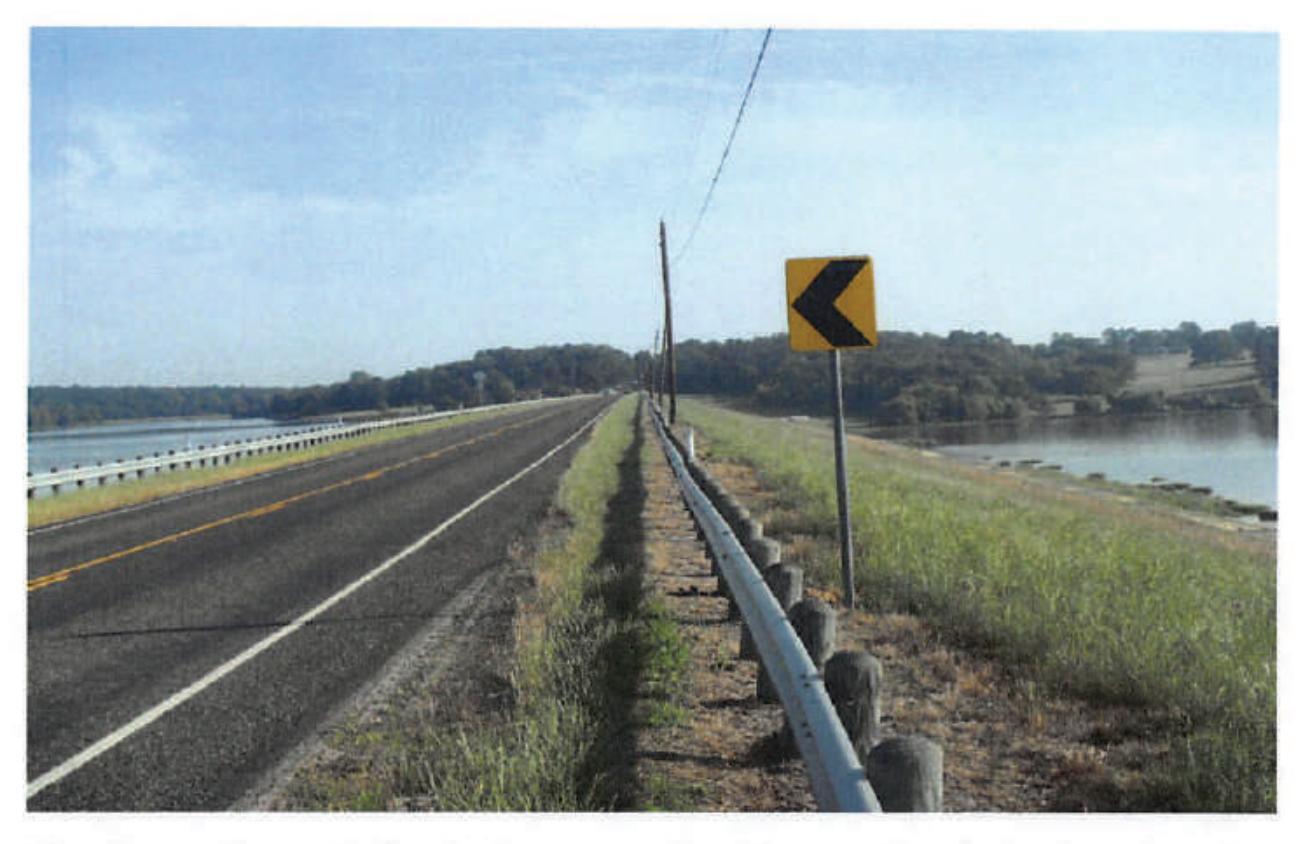
- Several of the utility poles on the downstream side of the crest were leaning downstream near the center of the dam. See Photo No. 9. This situation occurred during periods of historic sliding on the downstream slope, prior to completion of the 2010 rehabilitation. It does not appear that the condition was worse.

Photo No. 9. The guardrail on the downstream side of the crest. Note the leaning utility poles. The area around the guardrail was well maintained.

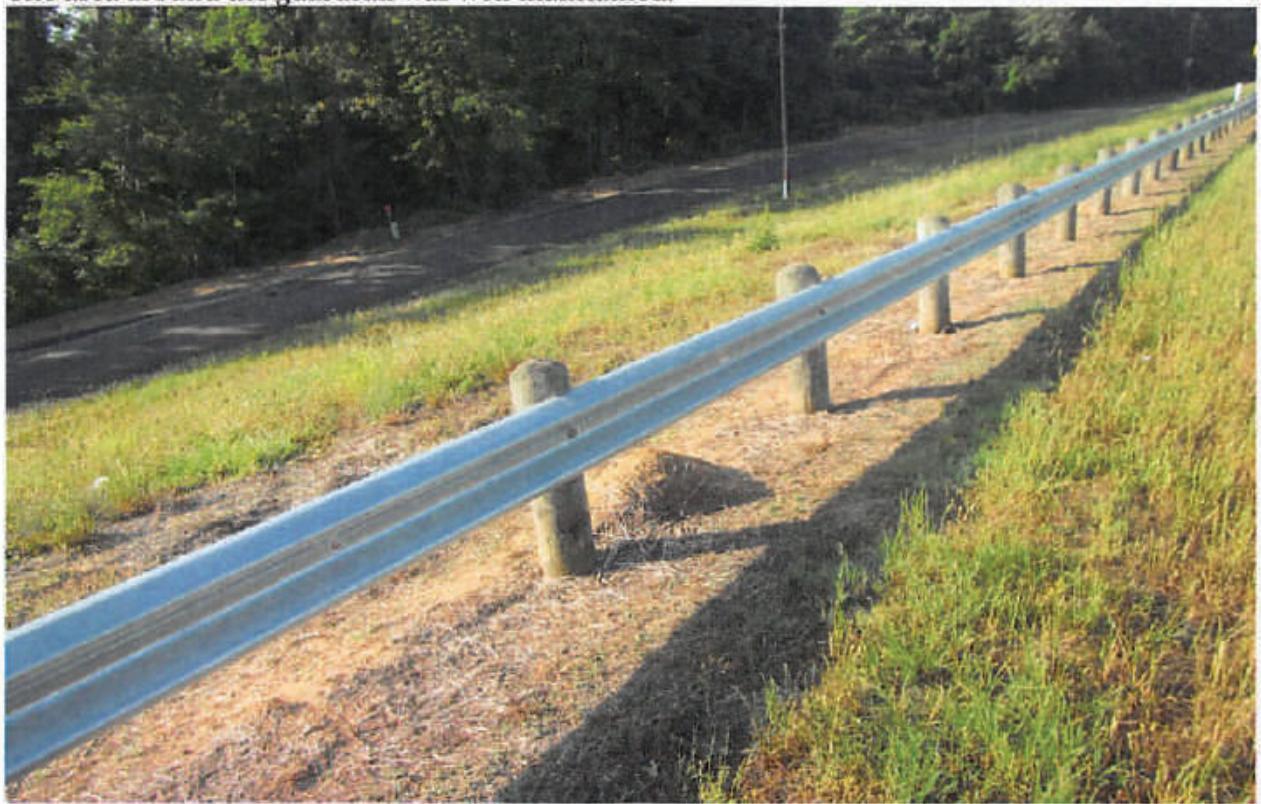
- There were numerous ant mounds along the area of the guardrails. See Photo No. 10.
- There were a number of animal holes near the guardrail posts and utility poles. See Photos 11 and 12.

Photo No. 10. This is one of a number of ant mounds near the downstream guardrail.

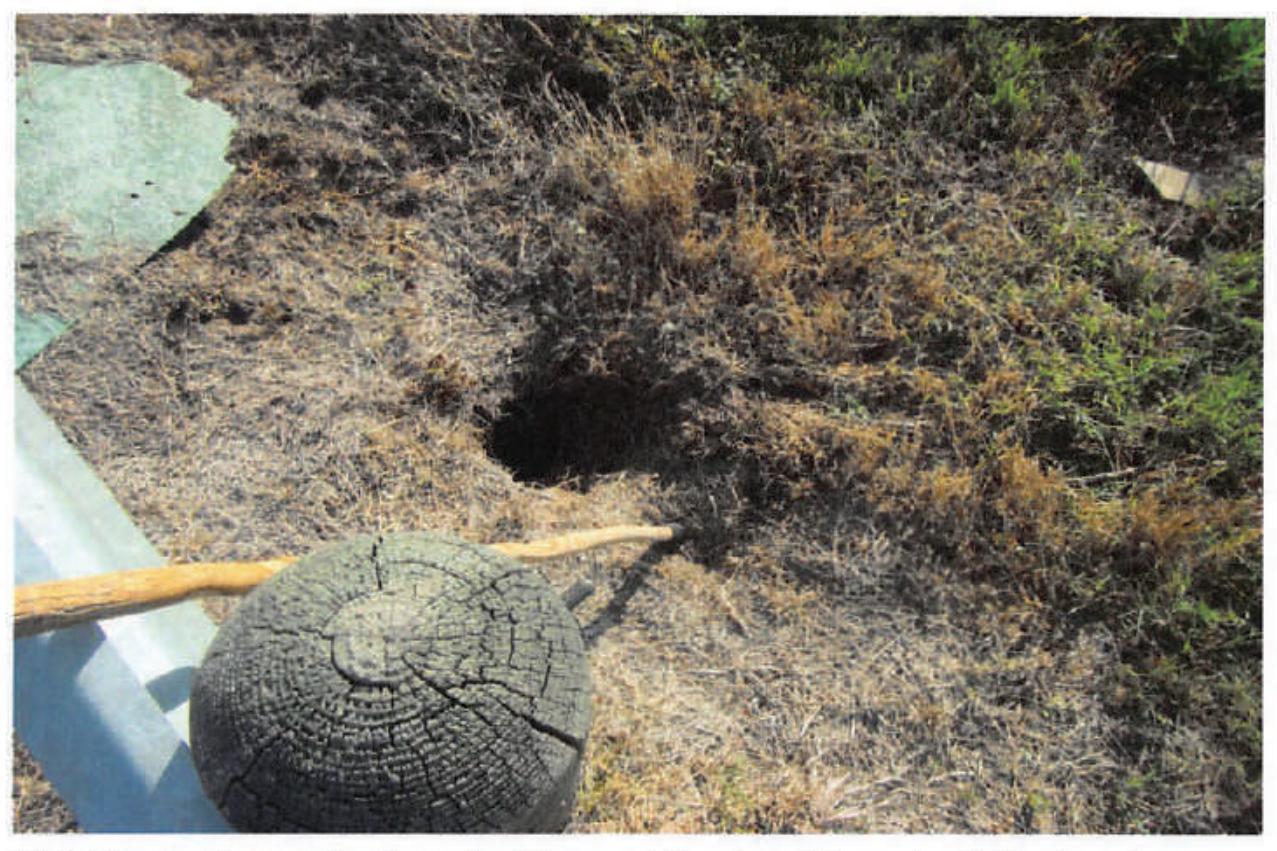
Photo No. 11. An example of an animal burrow at the edge of the crest with the downstream slope.

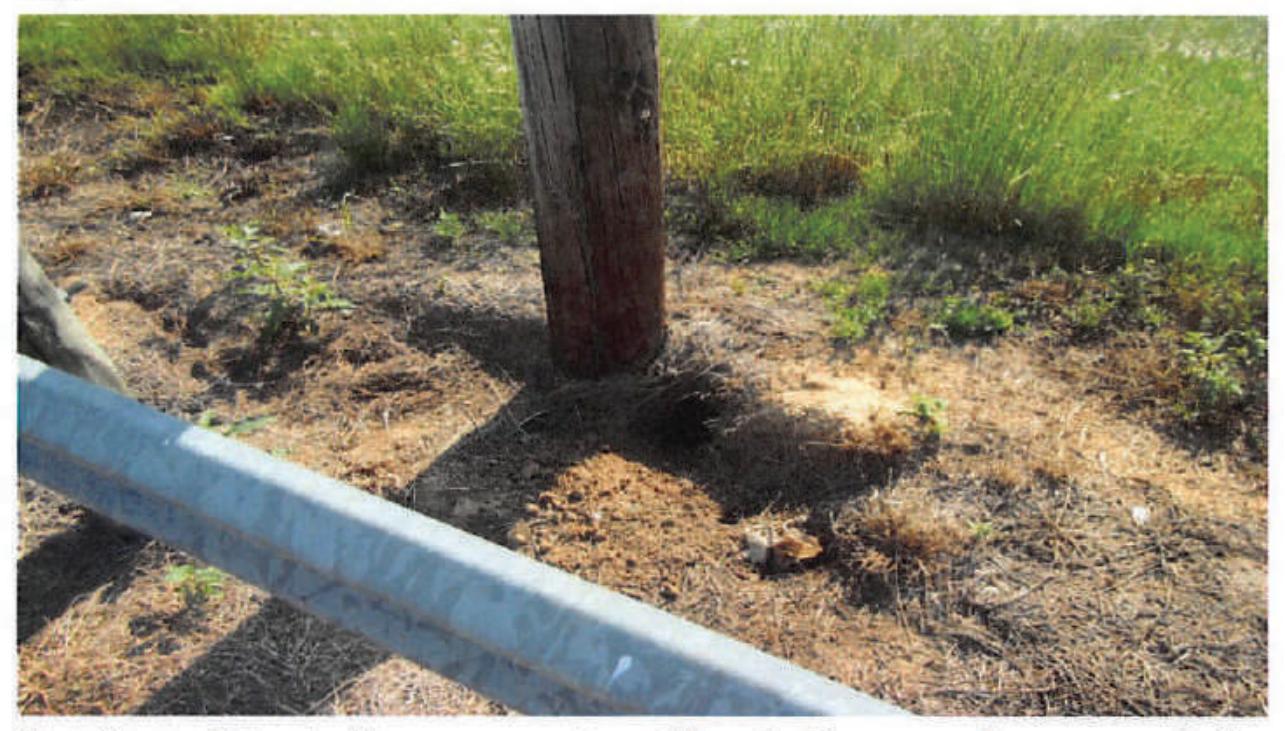
Photo No. 12. This animal burrow was next to a utility pole. There were others near guardrail posts.

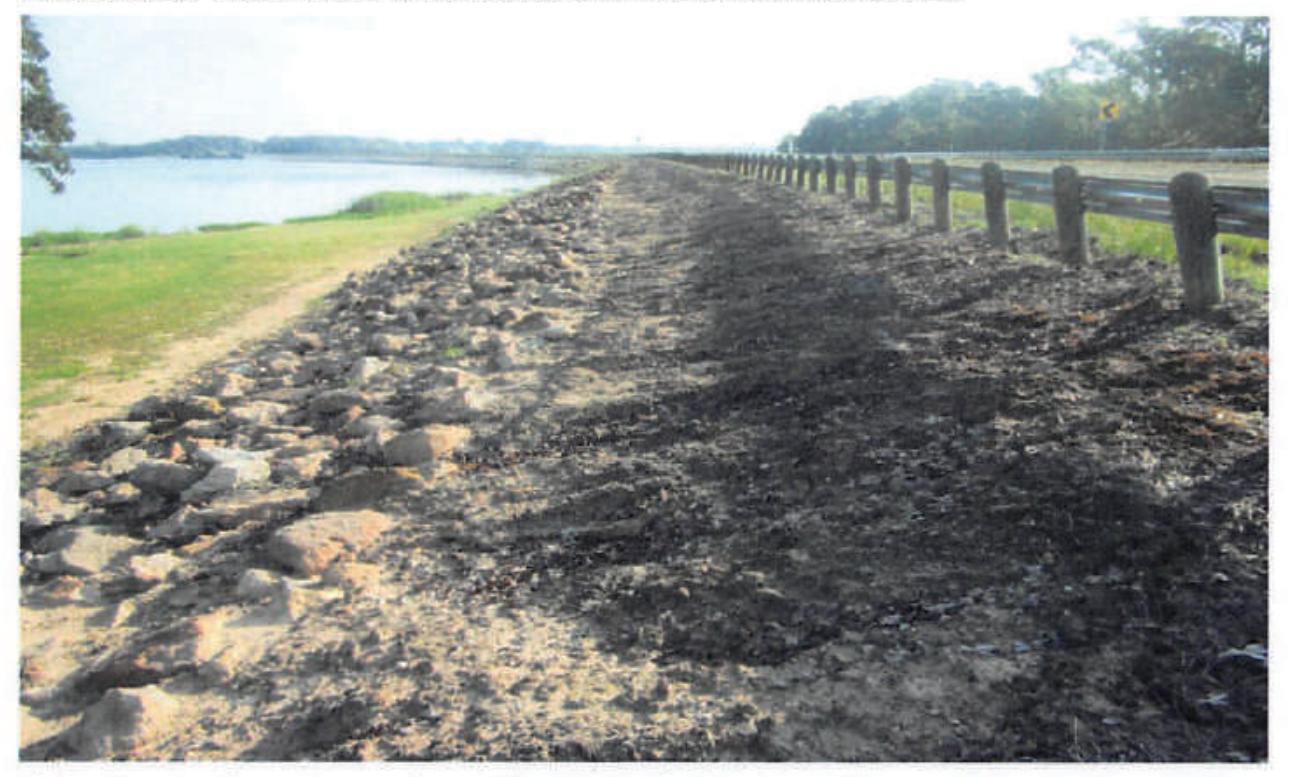
Photo No. 16. The upstream slope at the right end of the dam. The area above the riprap had no cover and was eroded in a number of places.

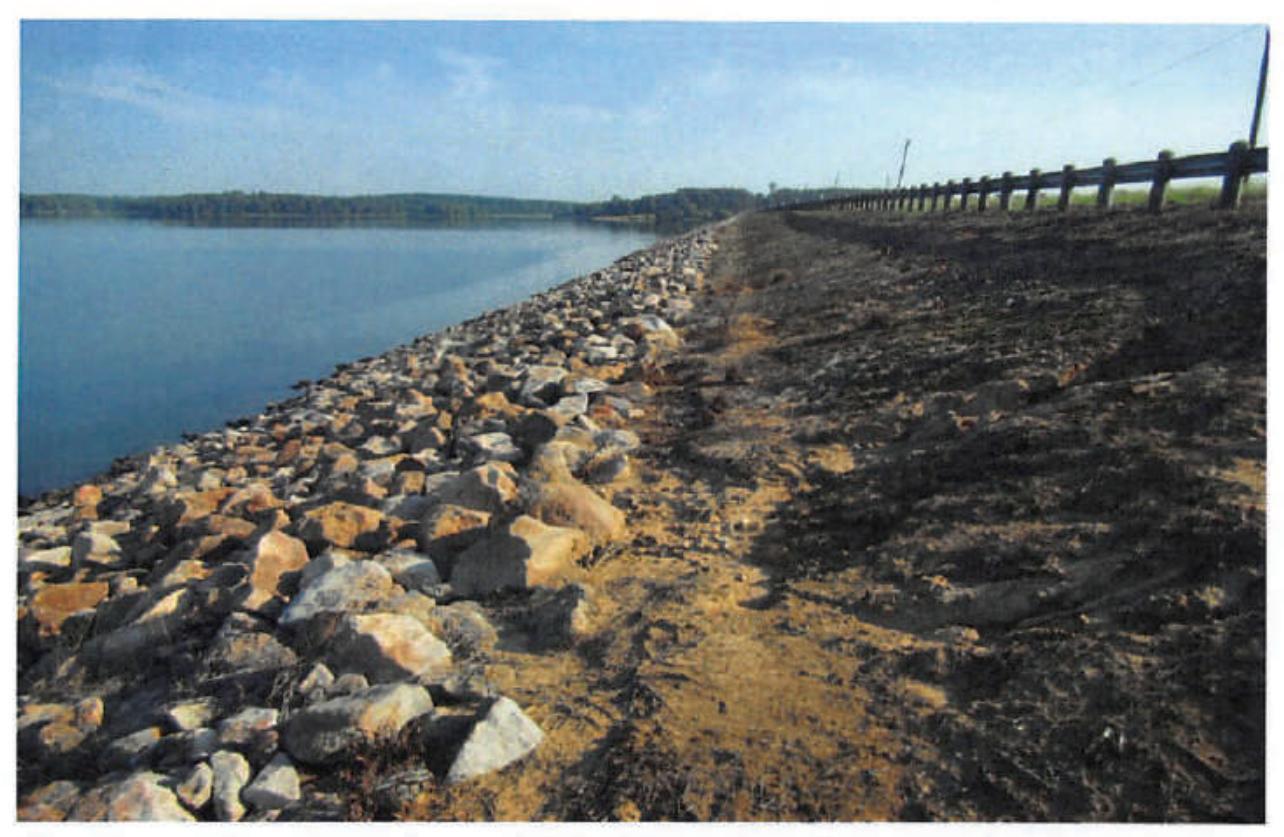
Photo No. 17. The upstream slope to the left of the service spillway. Note the mix of old and new riprap.

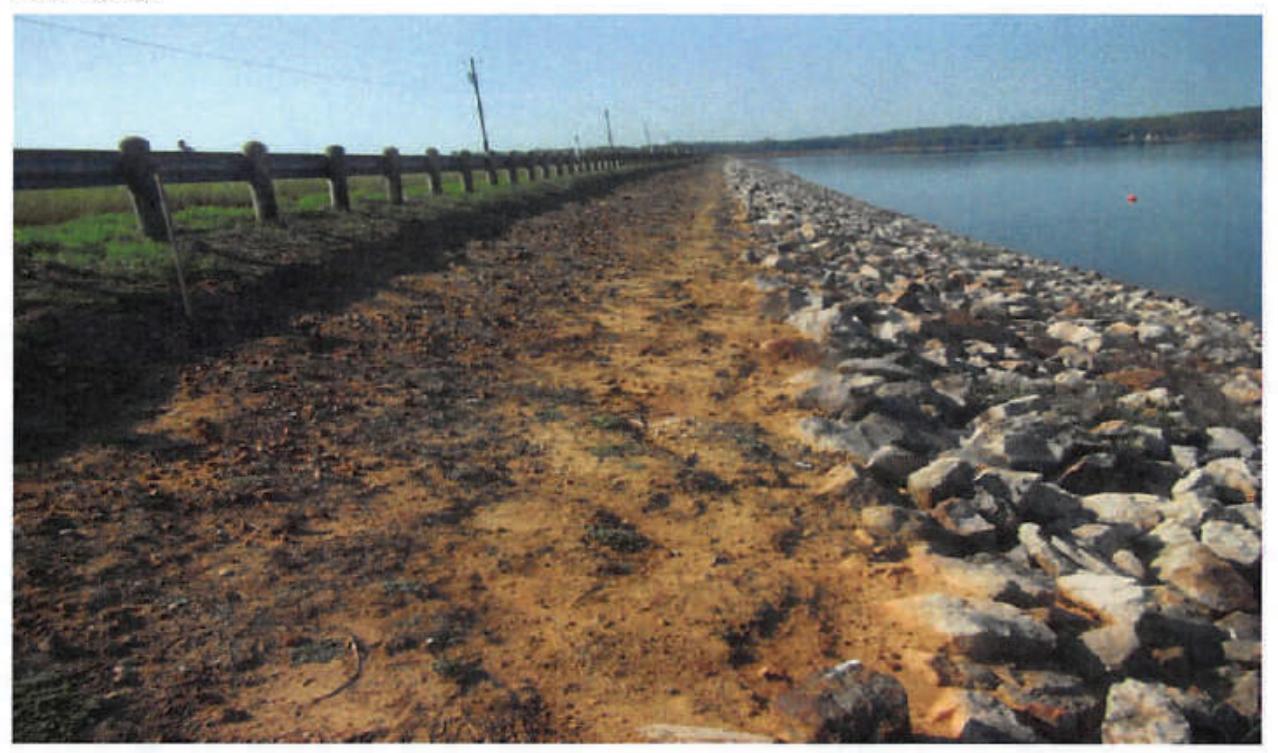
Photo No. 18. The upstream slope at the left end of the dam. Again, the slope is exposed with little to no cover.

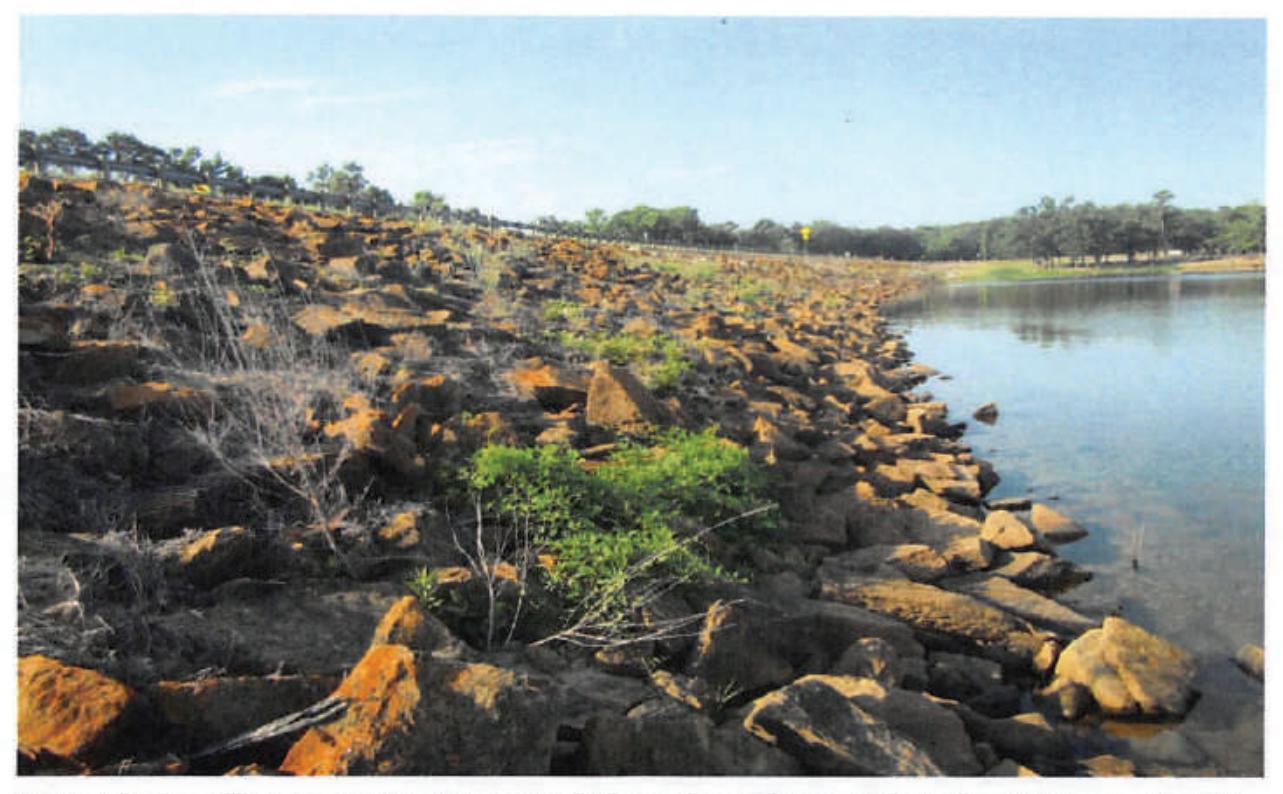
- The riprap to the right of the service spillway is older riprap. See Photo No. 19. The riprap from the service spillway to the left end of the dam is primarily newer rock; however, there is some older rock mixed with the new rock. See Photo No. 20.

- There was an area in the older rock that lacked larger rock. See Photo No. 24.
- There was minor growth of vegetation in various areas of the rock riprap. See Photos 19, 20, and 22.

Photo No. 19. This is located to the right of the service spillway. This is the old riprap. Note the vegetation in the rock.

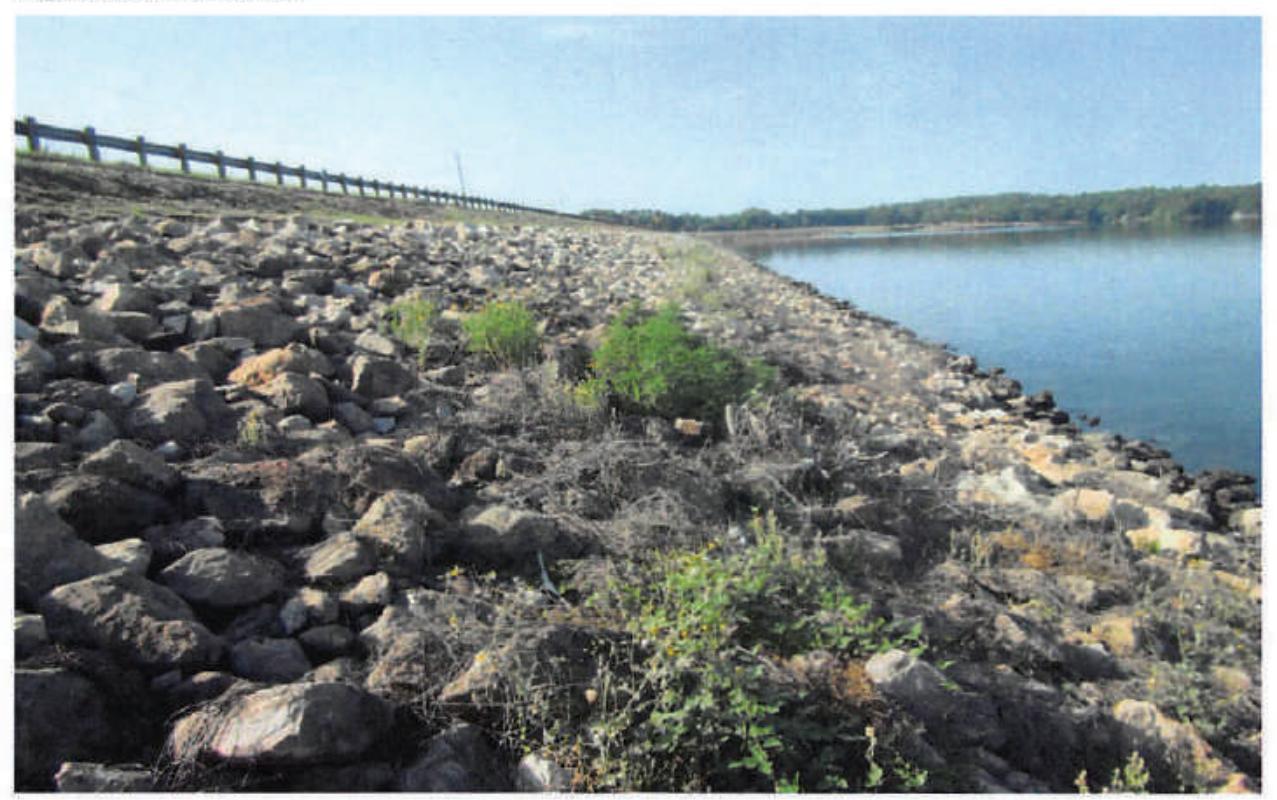
Photo No. 20. The riprap near the left end of the dam. This is primarily new riprap. Note the vegetation in the rock.

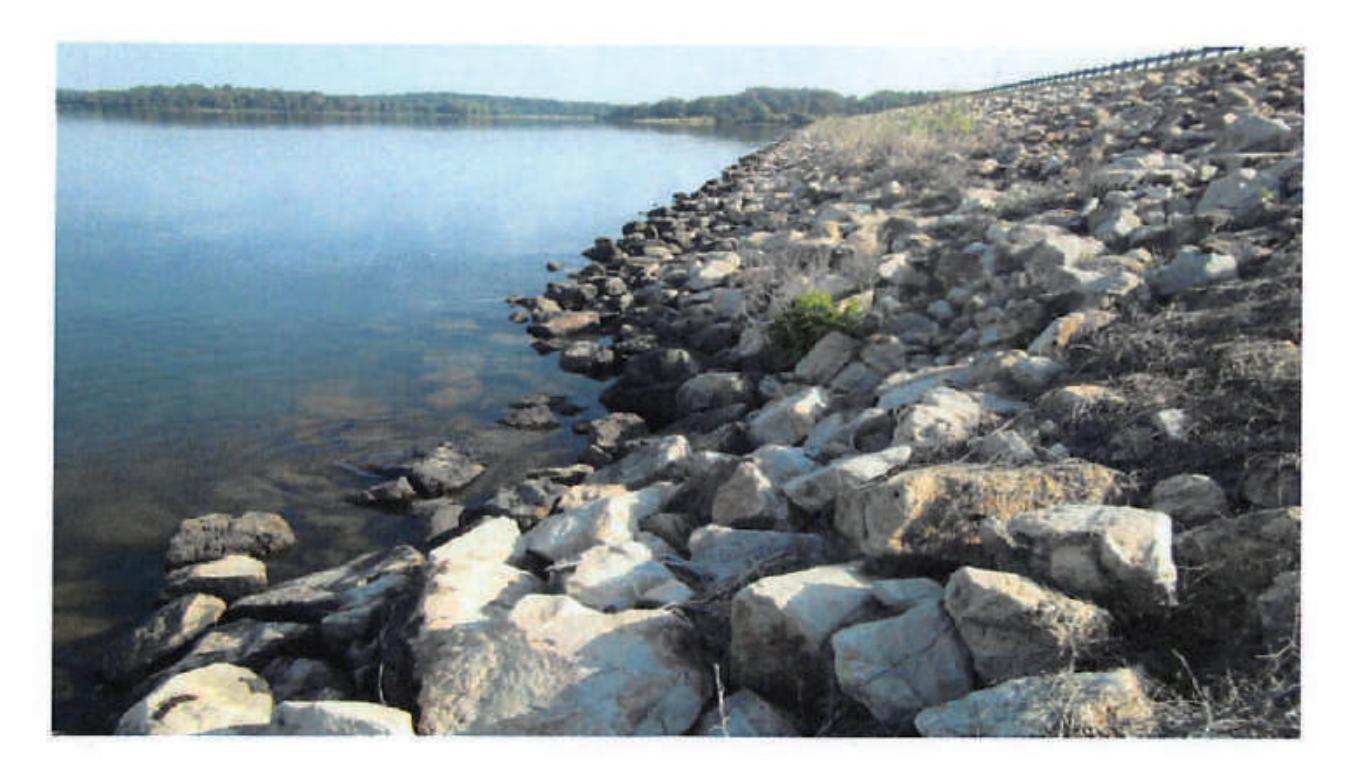
- Some of the older rock was continuing to deteriorate and crack. See Photo No. 21.
- There was an indention in the rock riprap along the water line. See Photos 22 and 23.

Photo No. 23. A close-up of the indention shown in Photo No. 22.

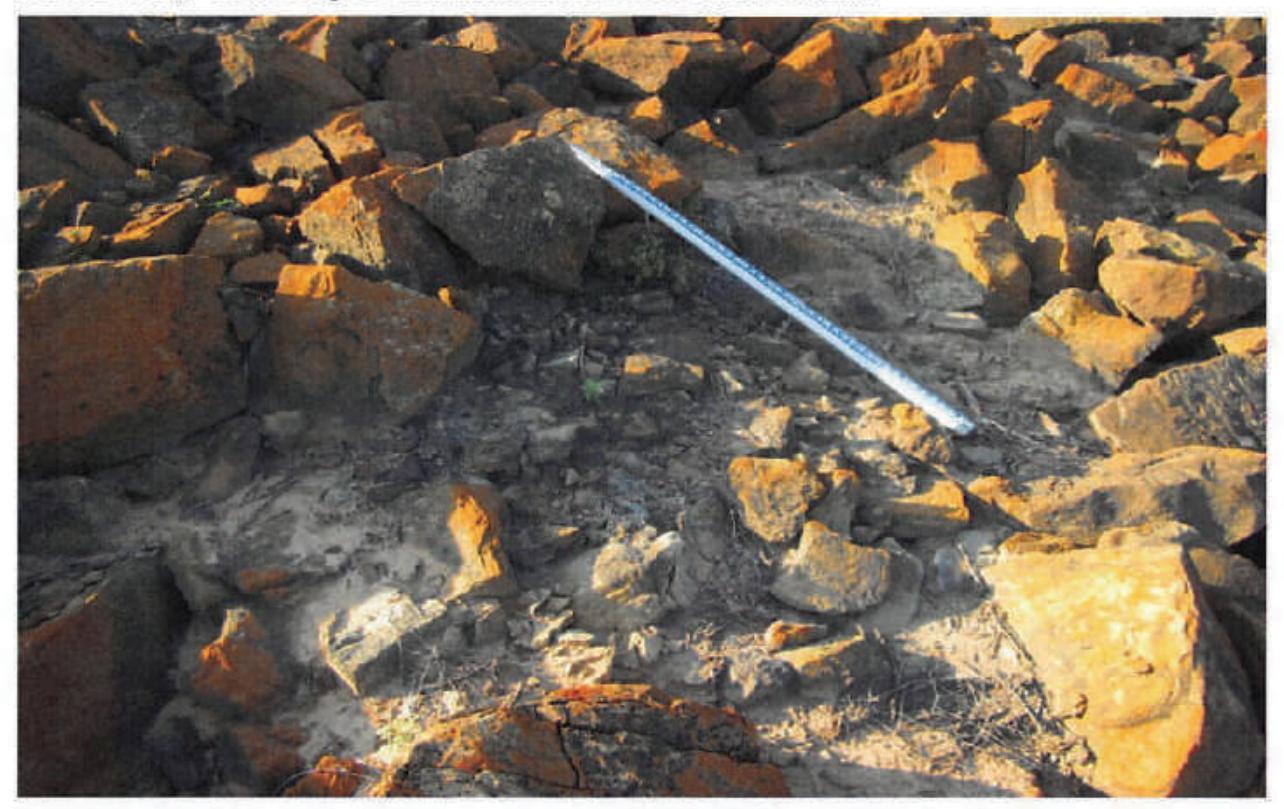
Photo No. 24. This area of old riprap near the right end of the dam lacked large rock.

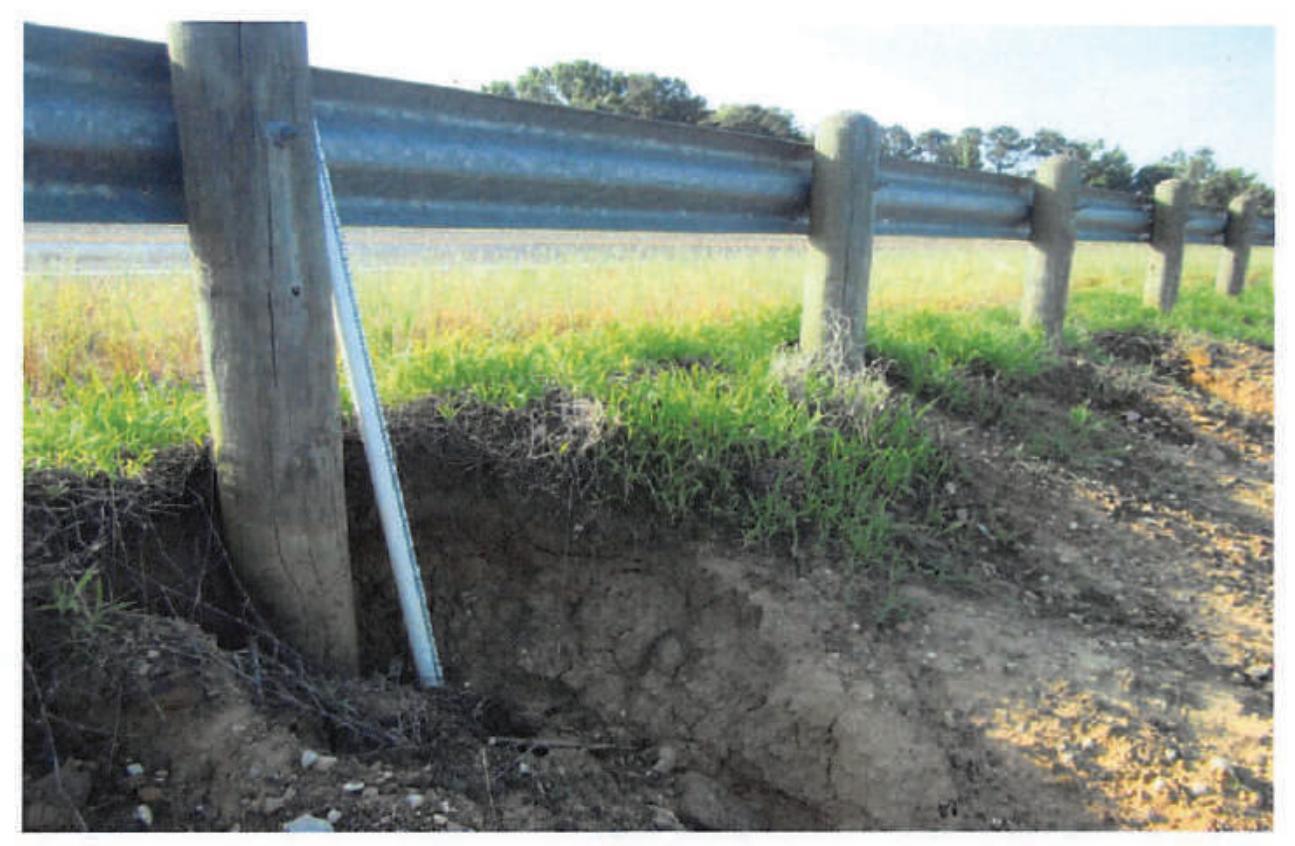
- Erosion was occurring next to guardrail posts in several places. See Photos 27 and 28.

Photo No. 27. This erosion is affecting a guardrail post.

It is recommended that the erosion on the upstream slope be repaired before the damage becomes worse. The erosion is affecting the guardrail posts in several places. A grass cover needs to be established once the repairs are completed.

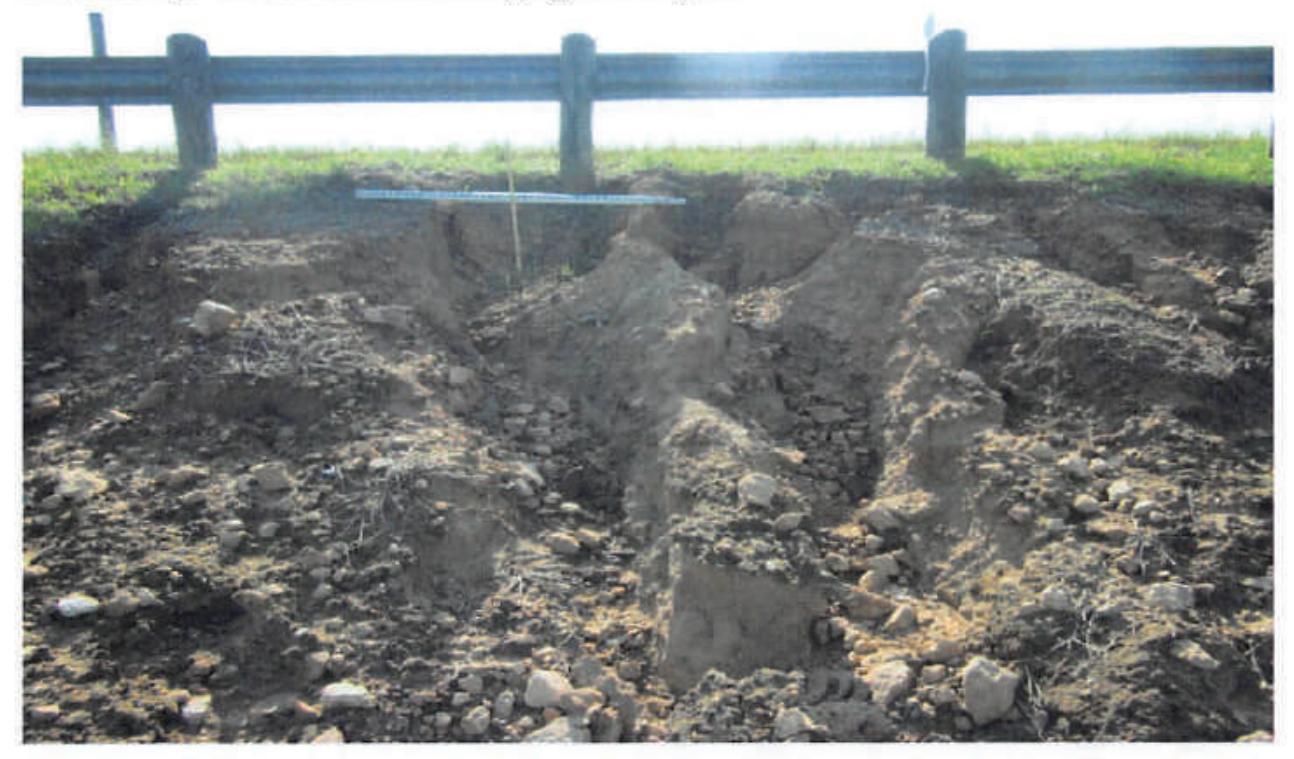
Photo No. 28. This erosion was located near the left end of the dam. The indicated area is 3 feet across and about 1.5 feet deep.

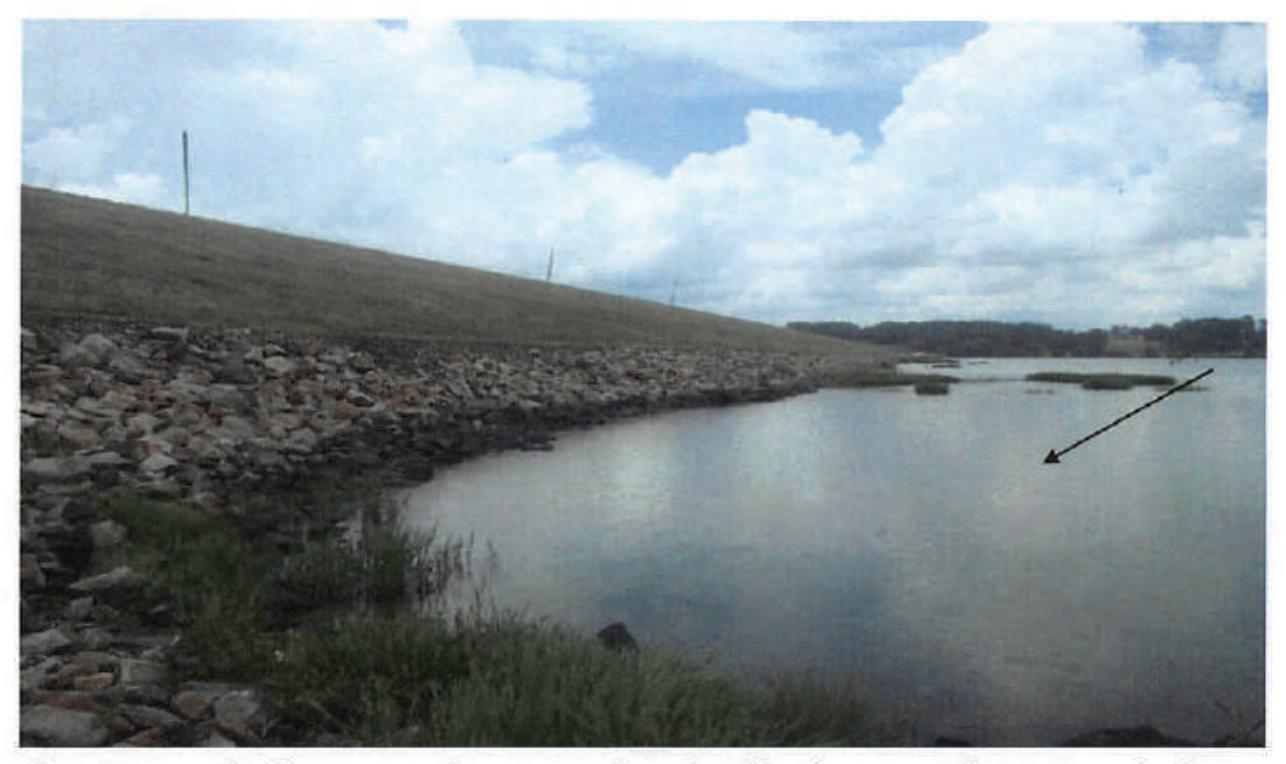
Photo No. 29. The downstream slope as seen from the right abutment. The arrow marks the approximate location of the service spillway outlet, which is submerged by Lake Bob Sandlin.

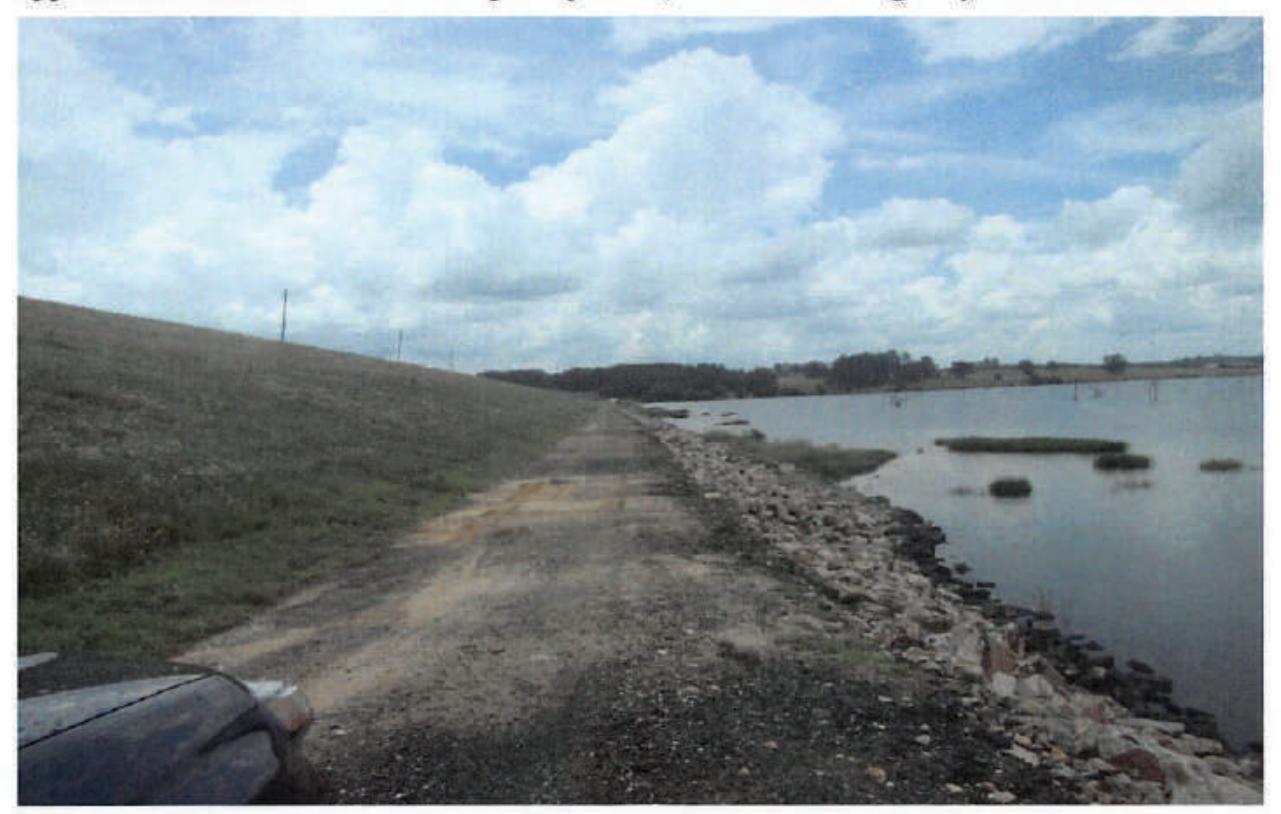
Photo No. 30. A view of the road along the downstream toe of the dam. Note the deposited soil that is from the eroded holes on the slope.

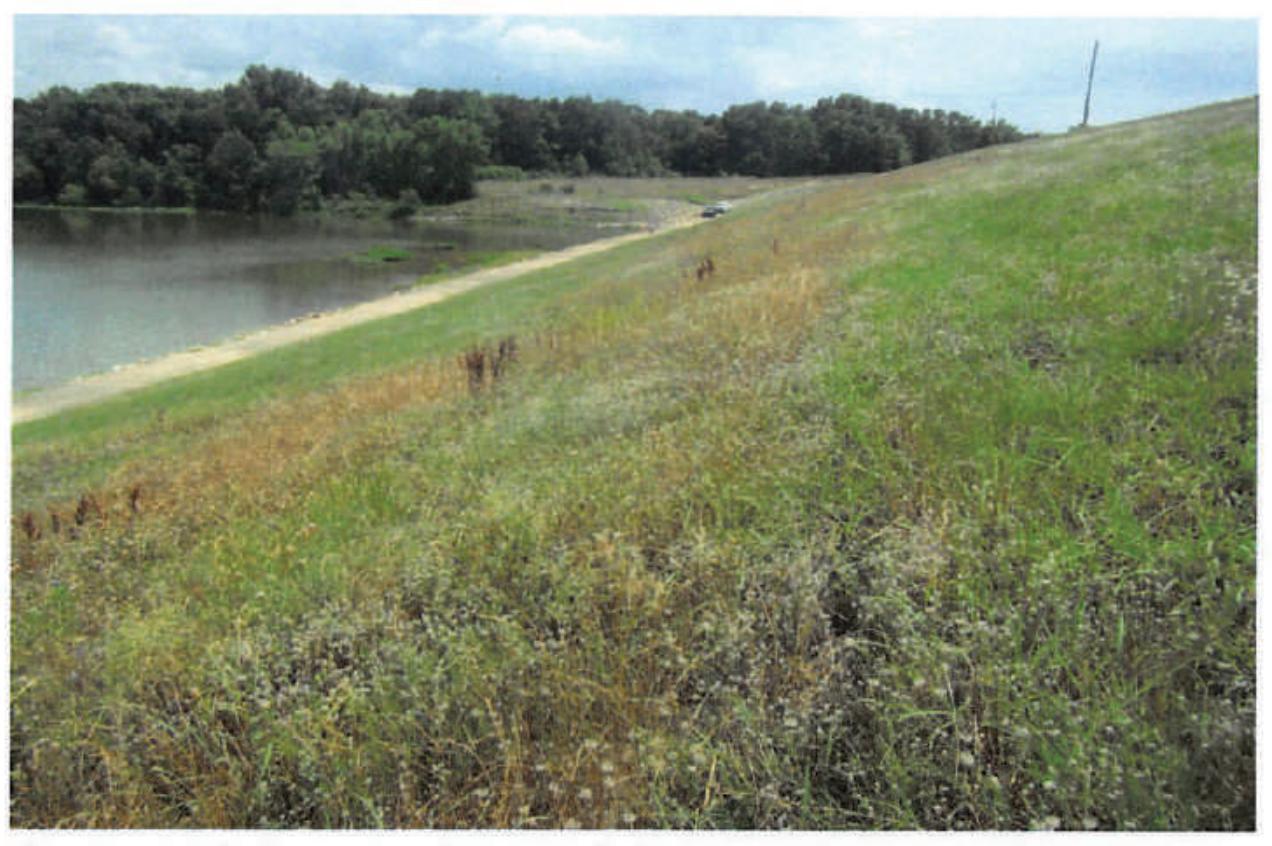
Photo No. 31. The downstream slope as seen looking toward the right end of the dam. The taller weeds are in areas with holes.

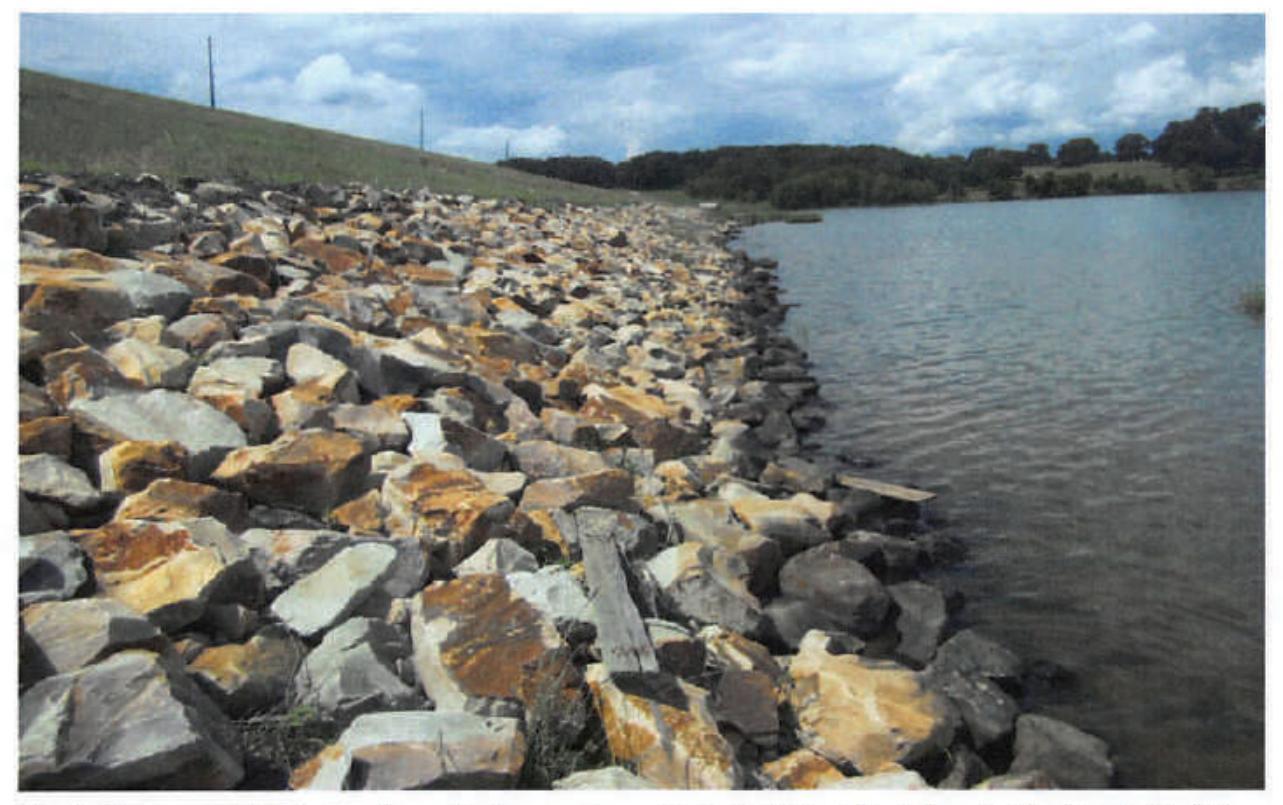
Photo No. 33. Rock riprap along the lower slope. Lake Bob Sandlin is located to the right of the photo.

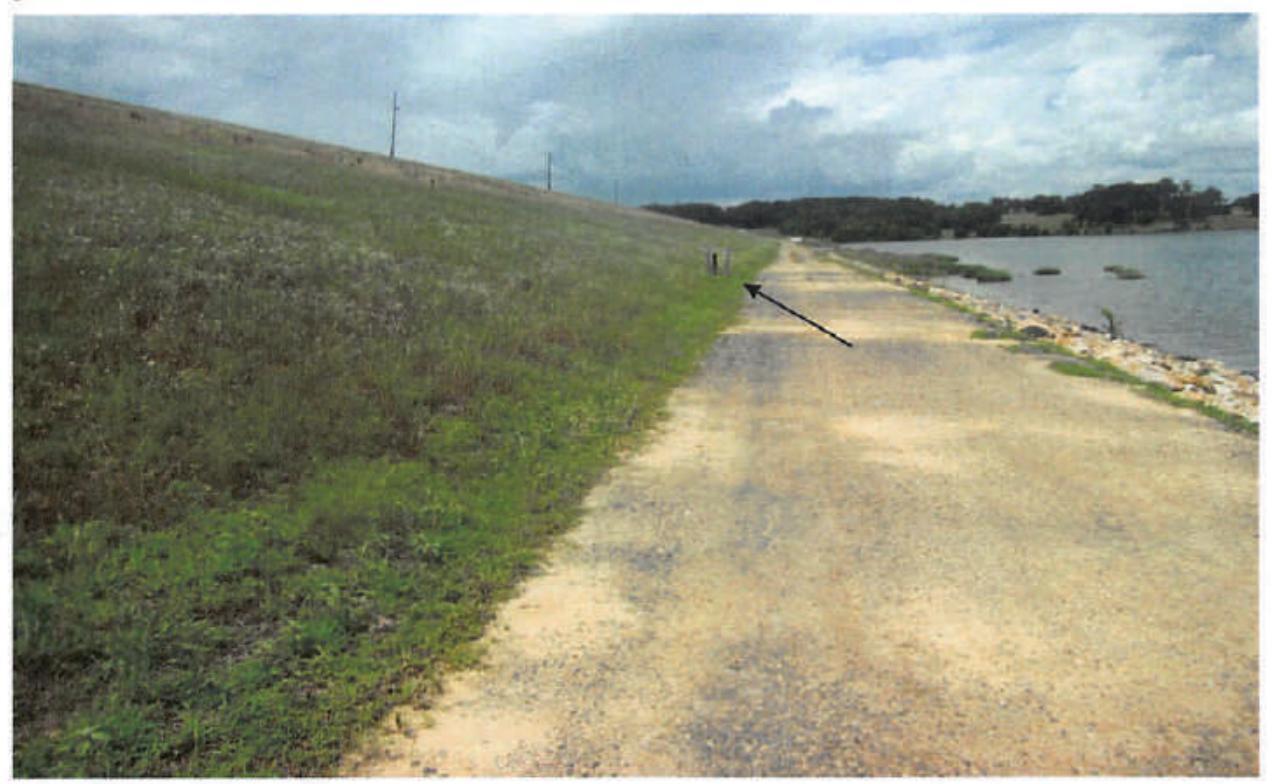
Photo No. 34. The road on the downstream slope. Note the soil on the road coming from the holes on the slope. The arrow indicates Piezometer P-6.
