Franklin County Water District Development of Alternatives to Restore Downstream Slope, Franklin County Dam

PRELIMINARY ENGINEERING REPORT

FINAL | February 2020

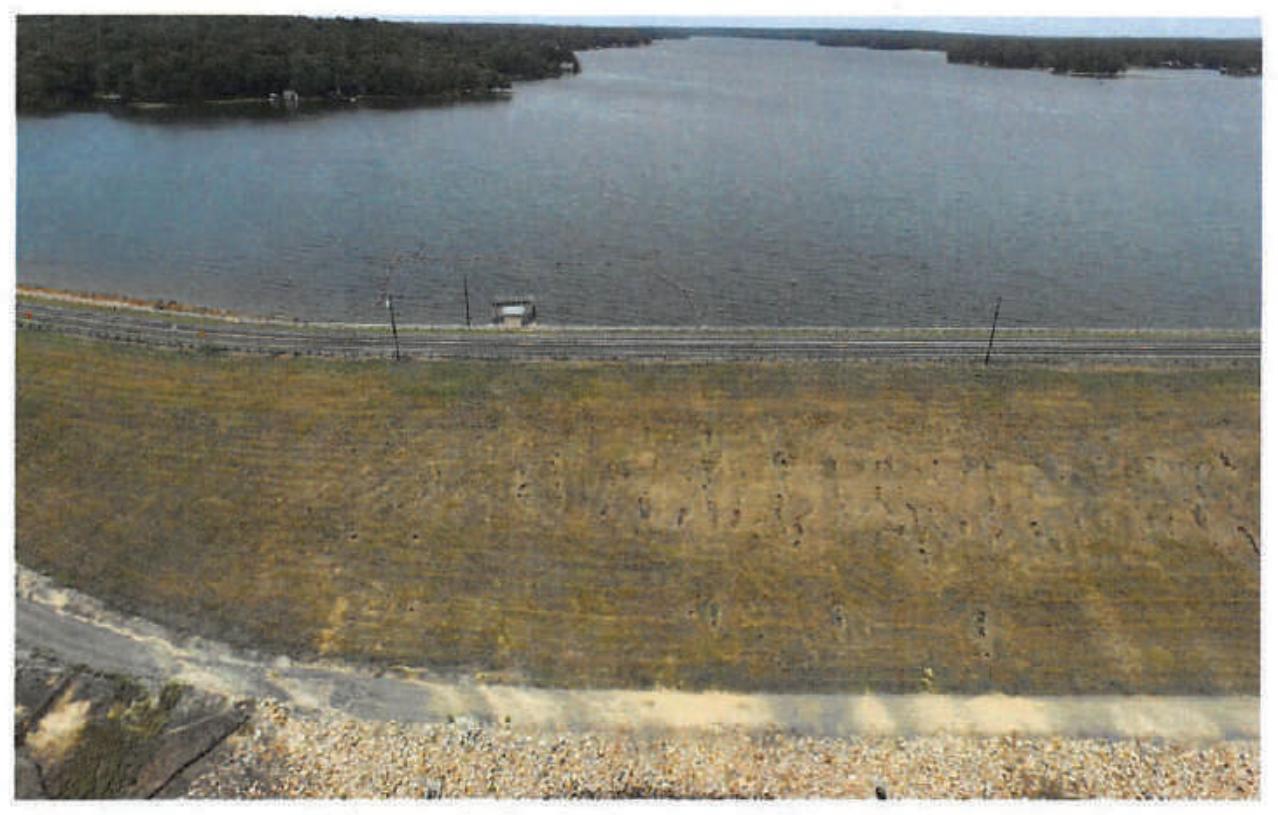
Photo No. 35. An aerial photograph (dated July 27, 2017) of the right downstream slope. Note the numerous holes and collapsed tunnels on the slope.

It is recommended that the District take immediate steps to retain an engineer, possibly someone not involved in the litigation, to develop a permanent repair plan for the entire downstream slope. The plan needs to take into consideration: the length of time that the slope has been exposed with no repairs or surface treatment undertaken; the increasing size and depth of the holes and tunnels; the formation of new holes; the observation of cracks on the slope, which could lead to new holes; the presence of dispersive soils, as evidenced by tests taken by various engineers and the appearance of the slope; and the loss of soil integrity evident on the sides of the hole. LiDAR data has been developed by the District, which should be incorporated into the development of the plan. The plans and specifications and geotechnical report should then be submitted to this agency for review at various percentages of completion and eventually approval.

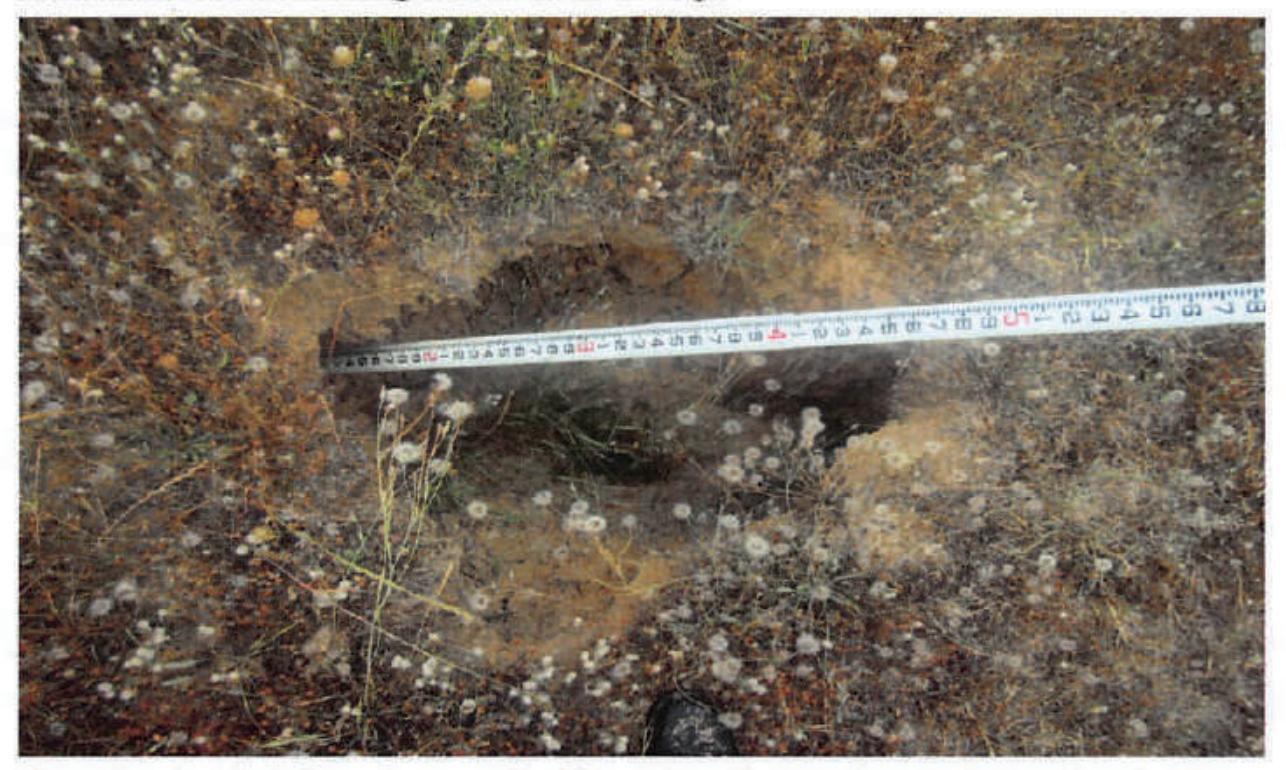
Photo No. 36. A hole formed as a result of dispersive soil. Note the tunnels at each end of the hole. This was located to the right of the service spillway on the downstream slope.

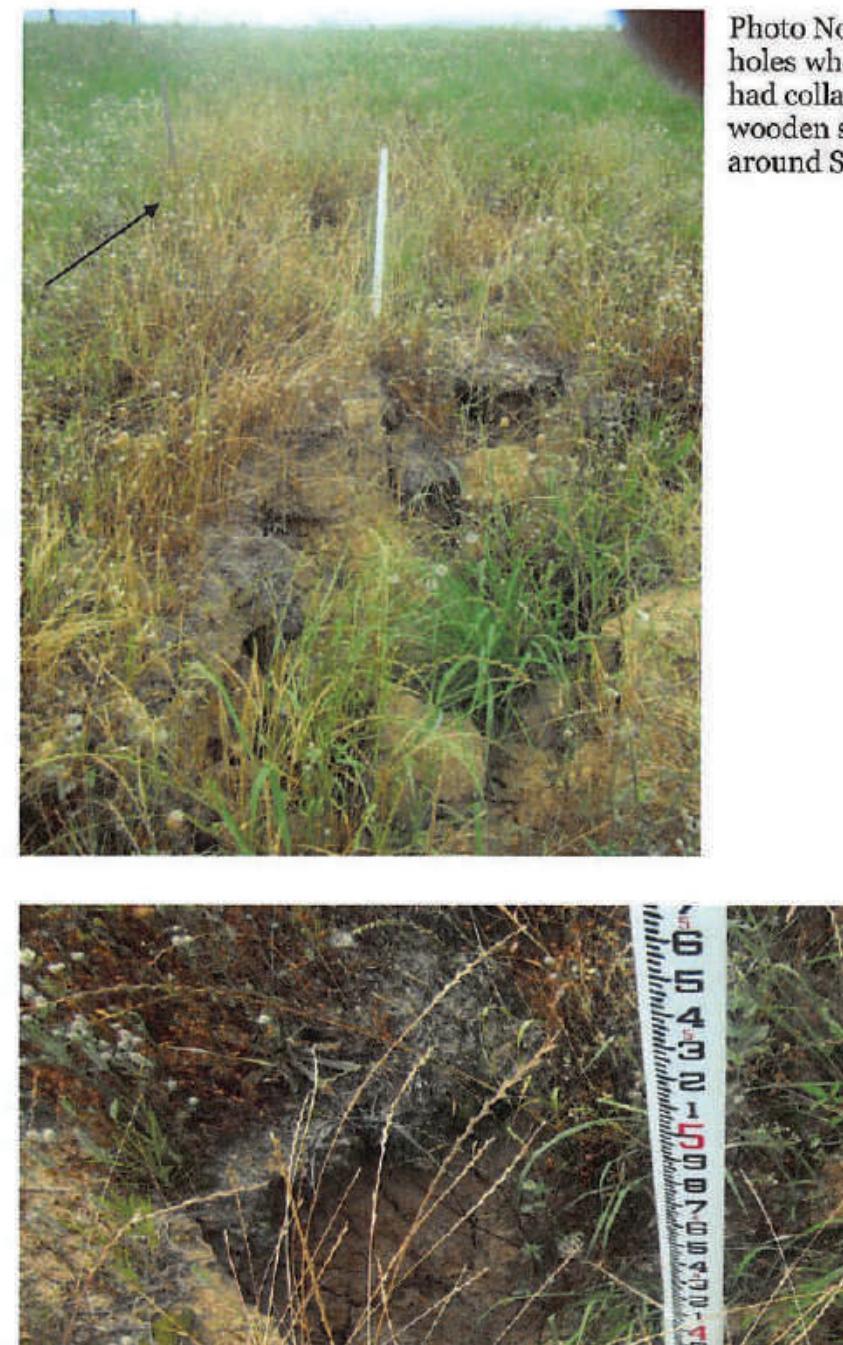
Photo No. 37. This is a series of holes where the tunnel between holes had collapsed. The arrow marks a wooden stake used to mark holes. This is around Station 35+00.

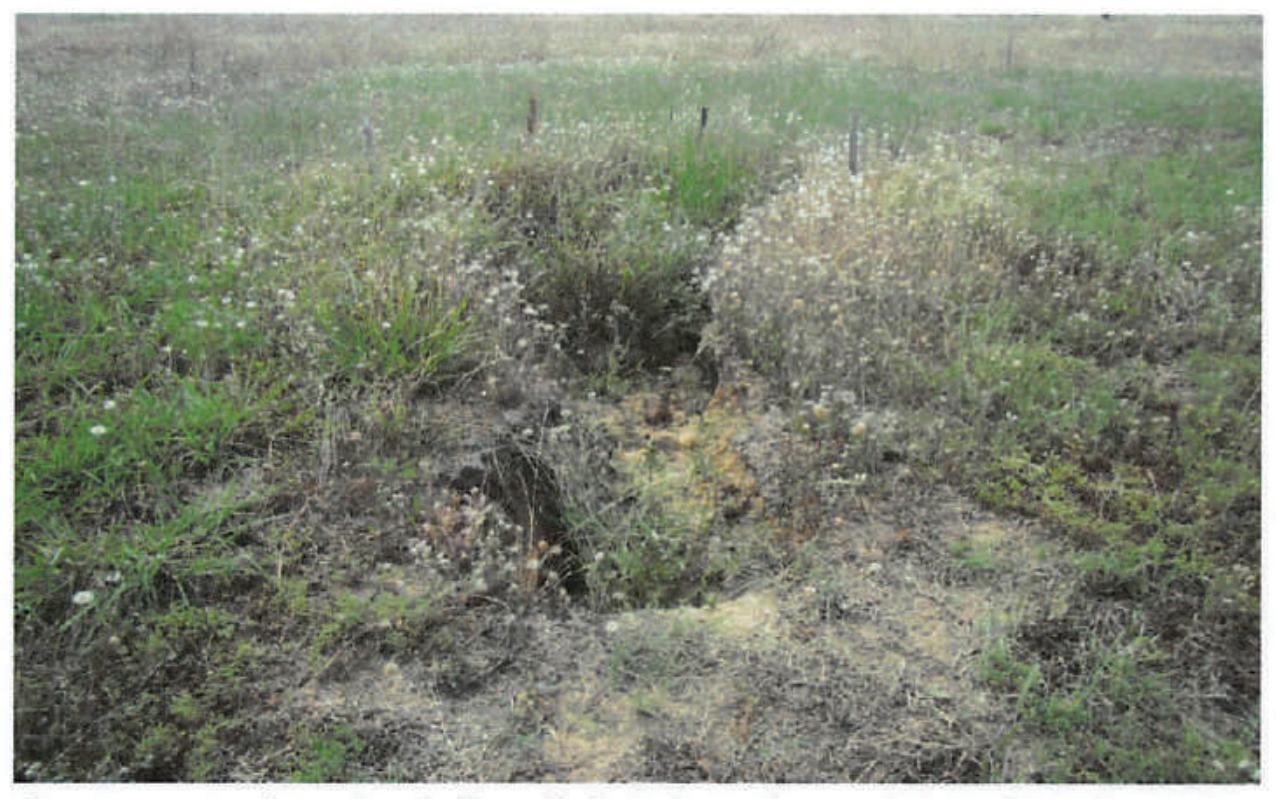
Photo No. 39. Another series of collapsed holes and tunnels. Note the several wooden stakes indicating additional holes.

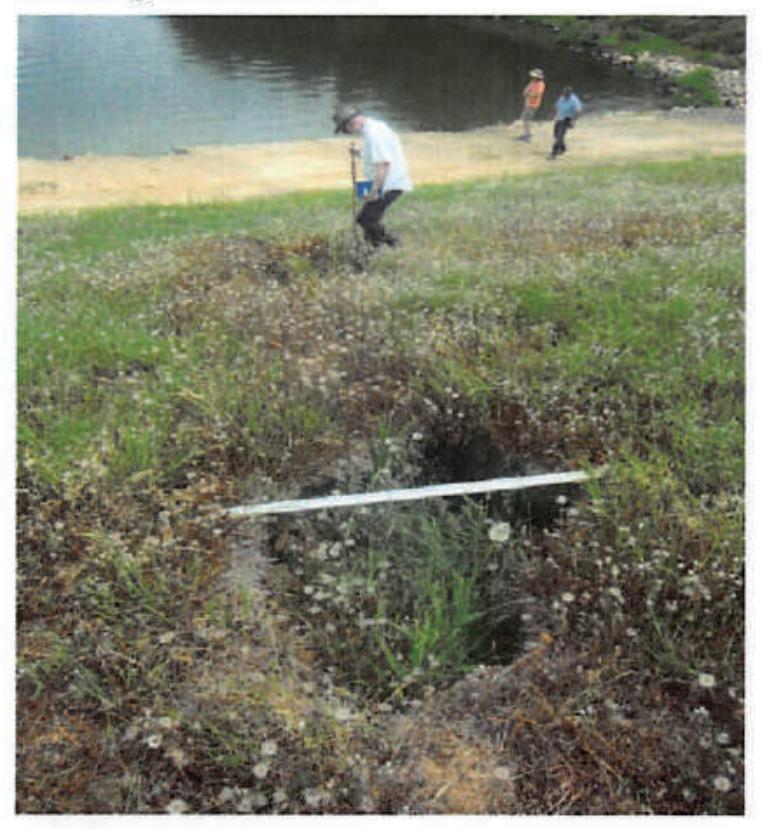
Photo No. 40. The hole in the foreground connects with the hole beside the inspector down the slope. Note the amount of soil on the road. This is around Station 34+00.

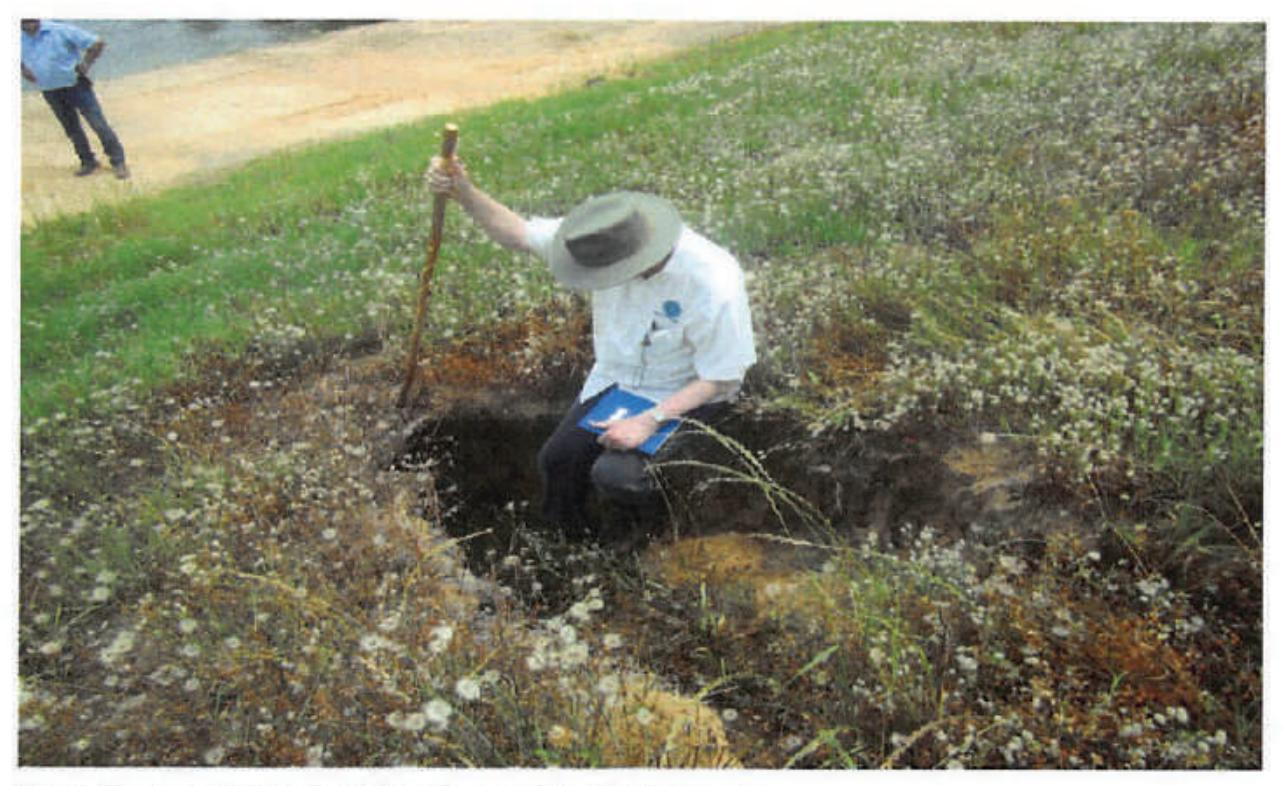
Photo No. 41. This is the hole referenced in Photo No. 40.

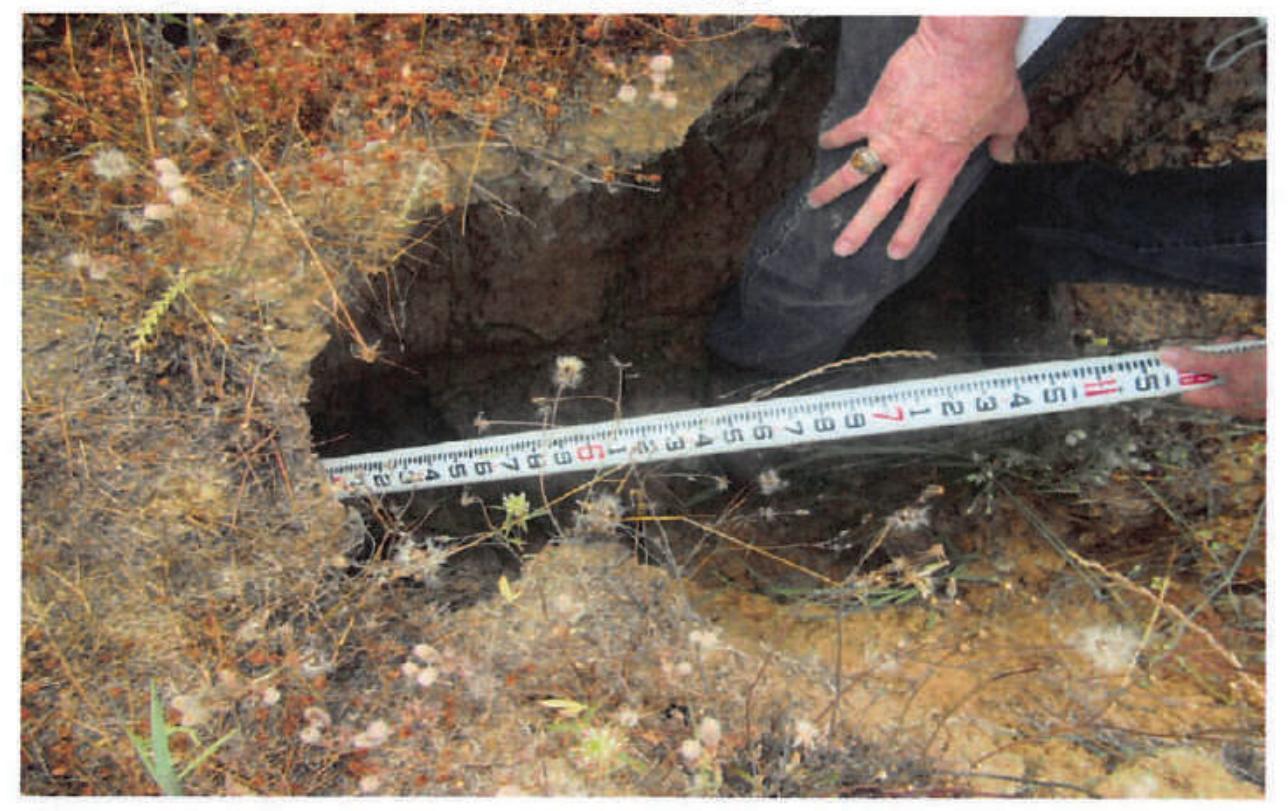
Photo No. 42. The tunnel is measured to be 5 feet deep downstream. This is the same location as Photos 40 and 41, around Station 34+00.

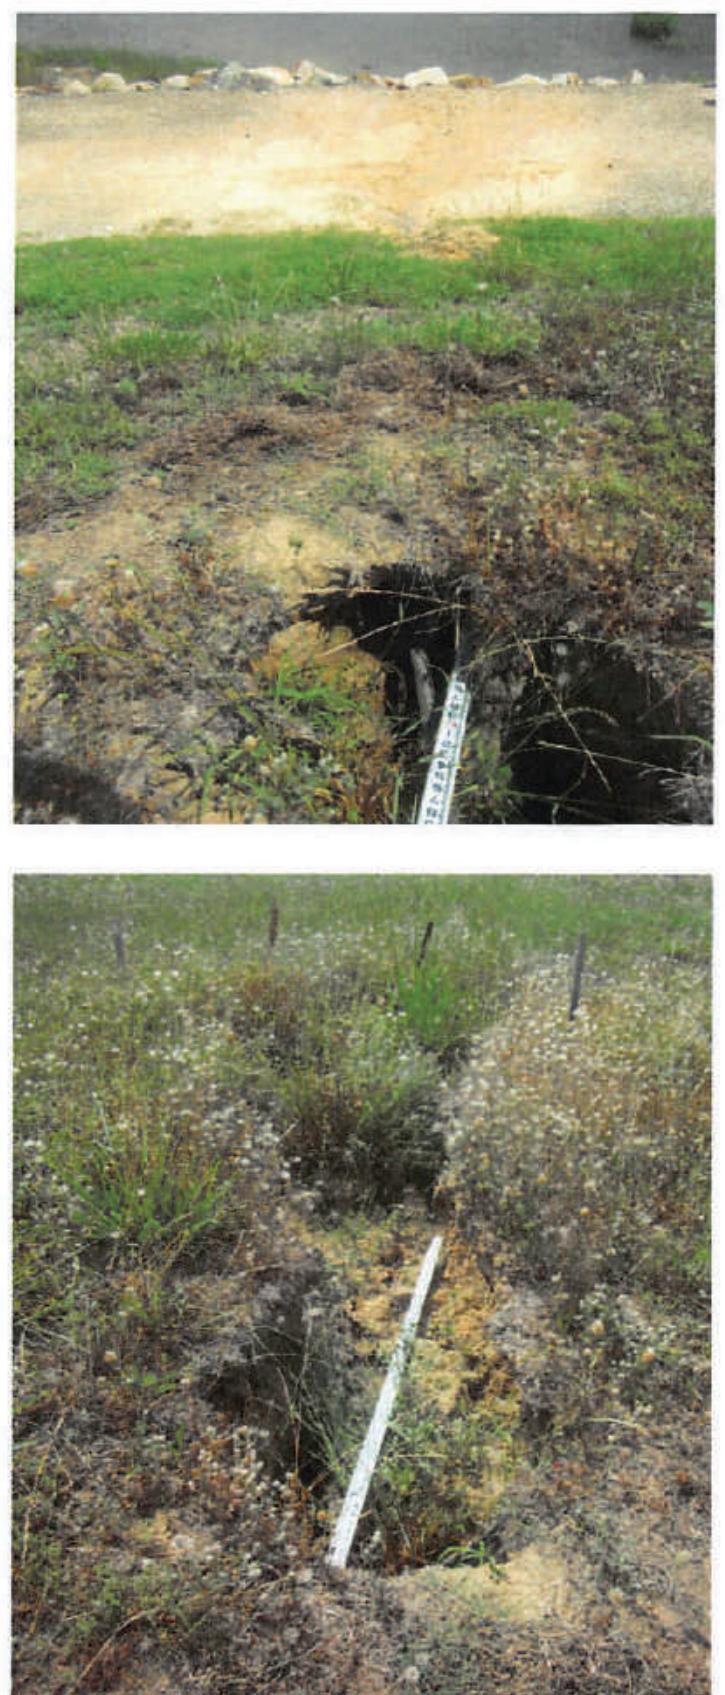
Photo No. 43. This hole extends at least 5.5 feet down slope. Note the soil on the slope at the road and the soil on the road.

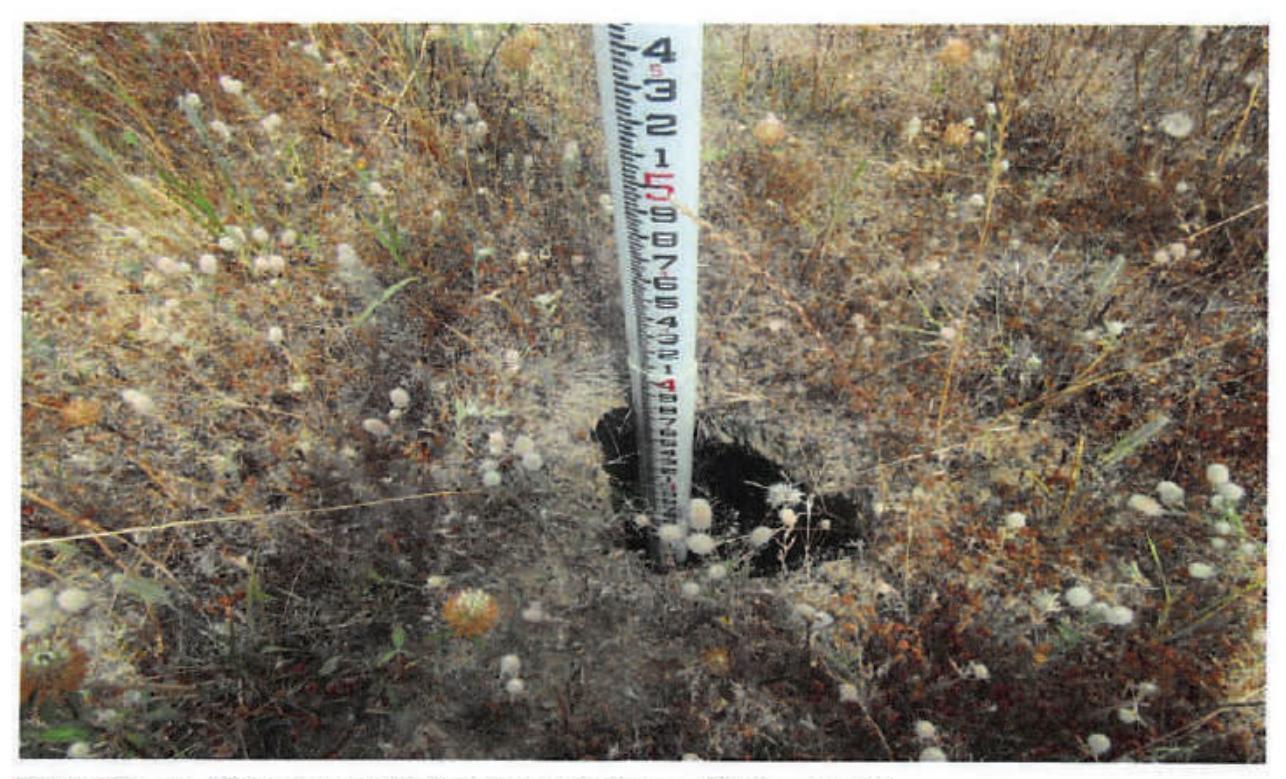
Photo No. 45. This appeared to be a newer hole near Station 30+00.

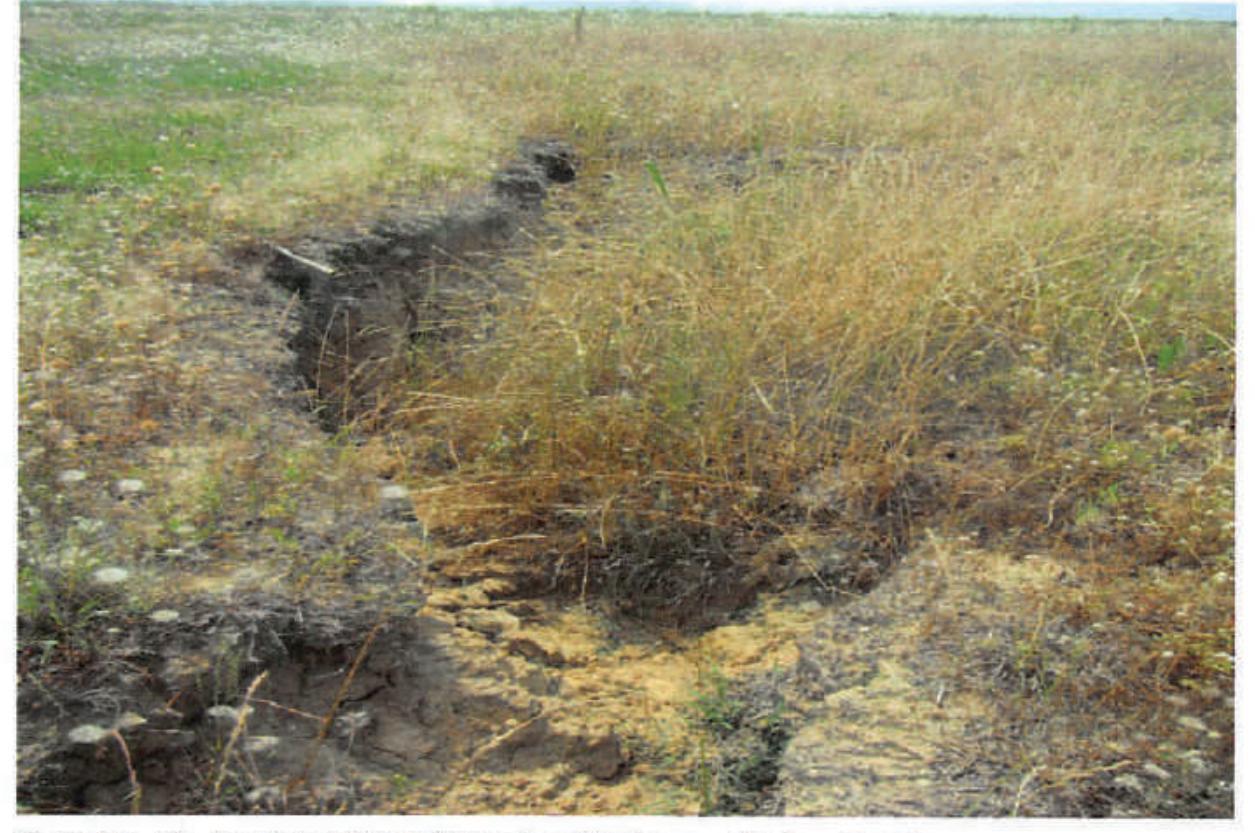
Photo No. 46. Another collapsed tunnel and holes near Station 30+00.

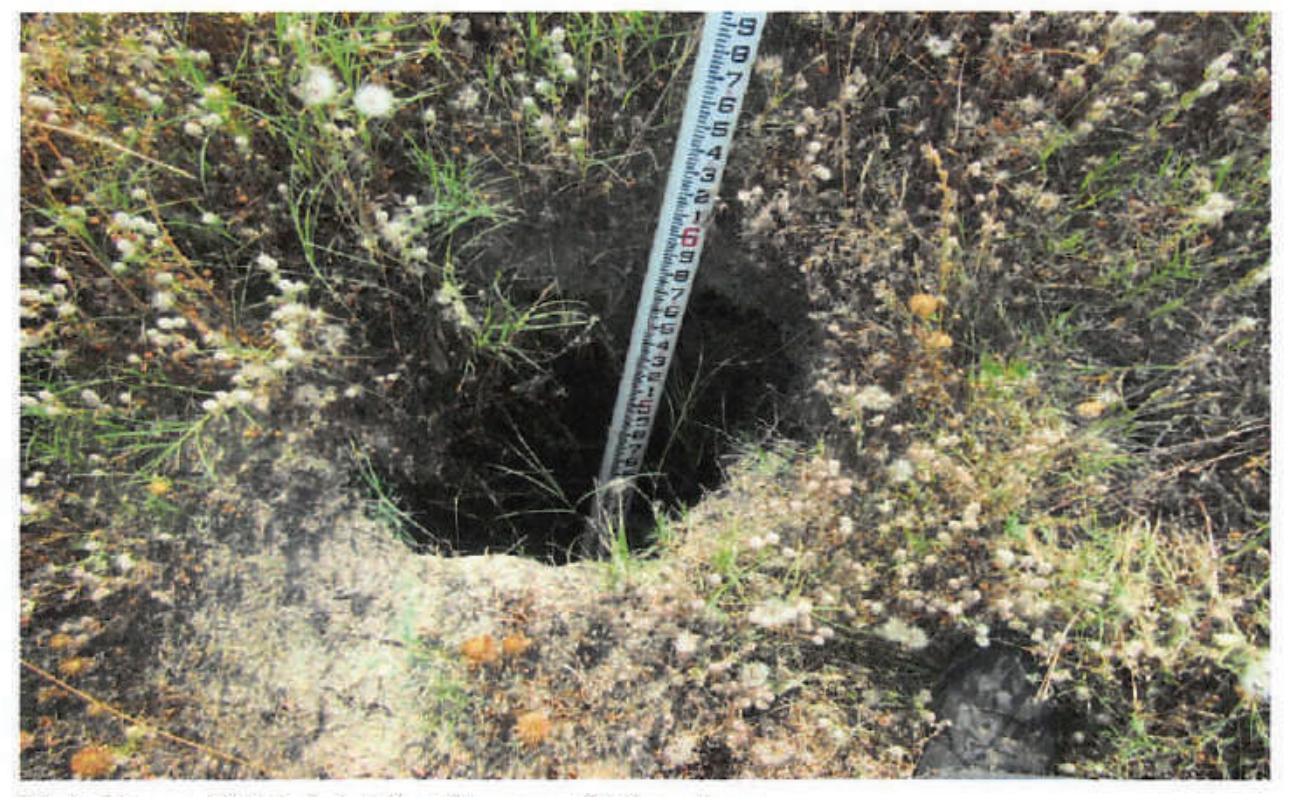
Photo No. 49. This hole is 6 feet deep near Station 16+00.

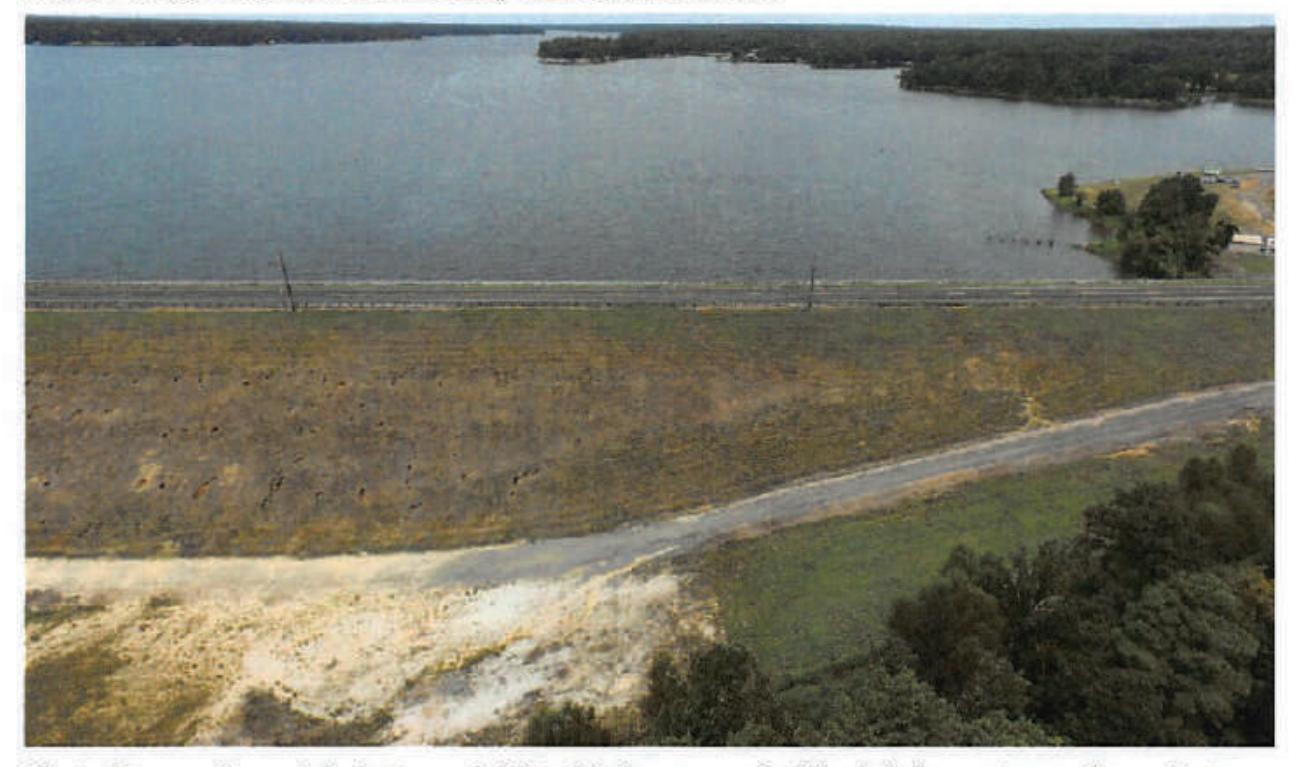
Photo No. 50. An aerial photograph (dated July 27, 2017) of the left downstream slope. Note the numerous holes on the slope.

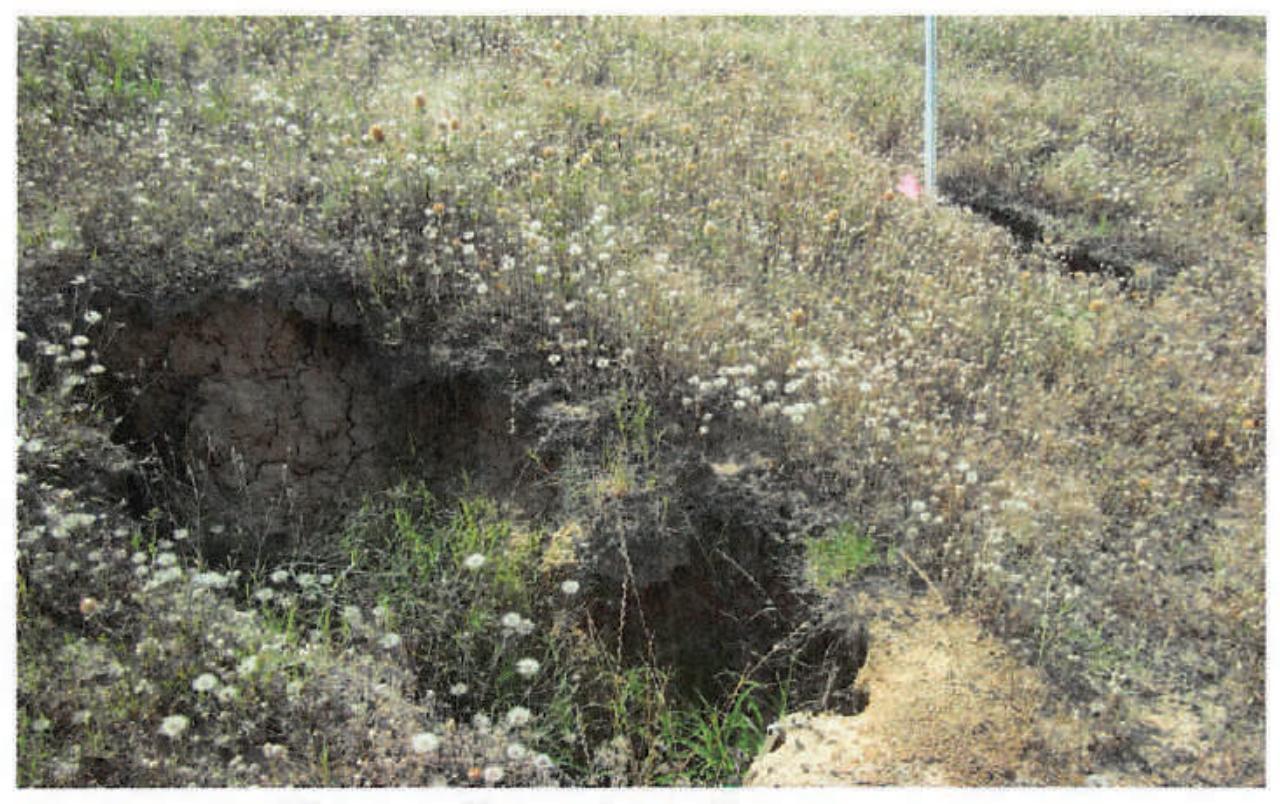
Photo No. 51. Two different sets of holes to the left of Station 16+00.

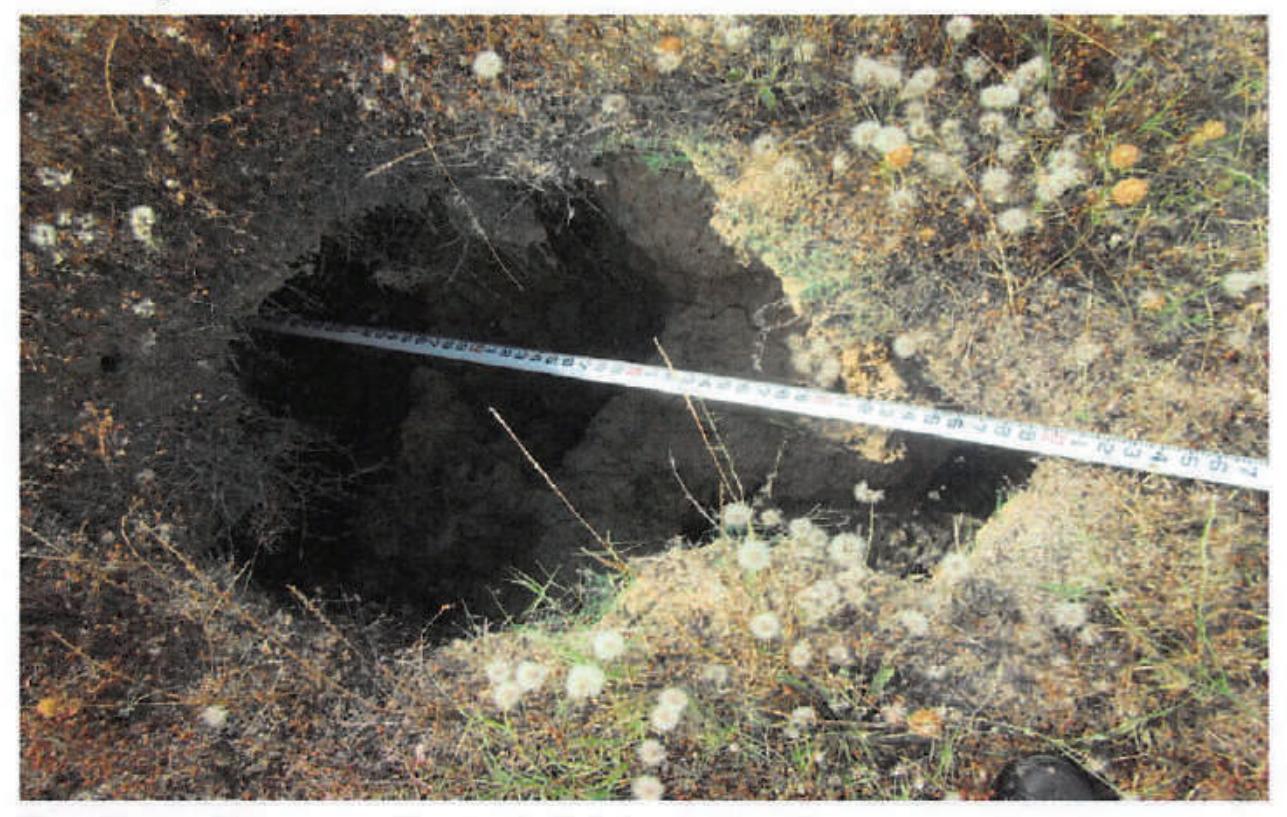
Photo No. 52. The survey rod is extended 8 feet into a tunnel.

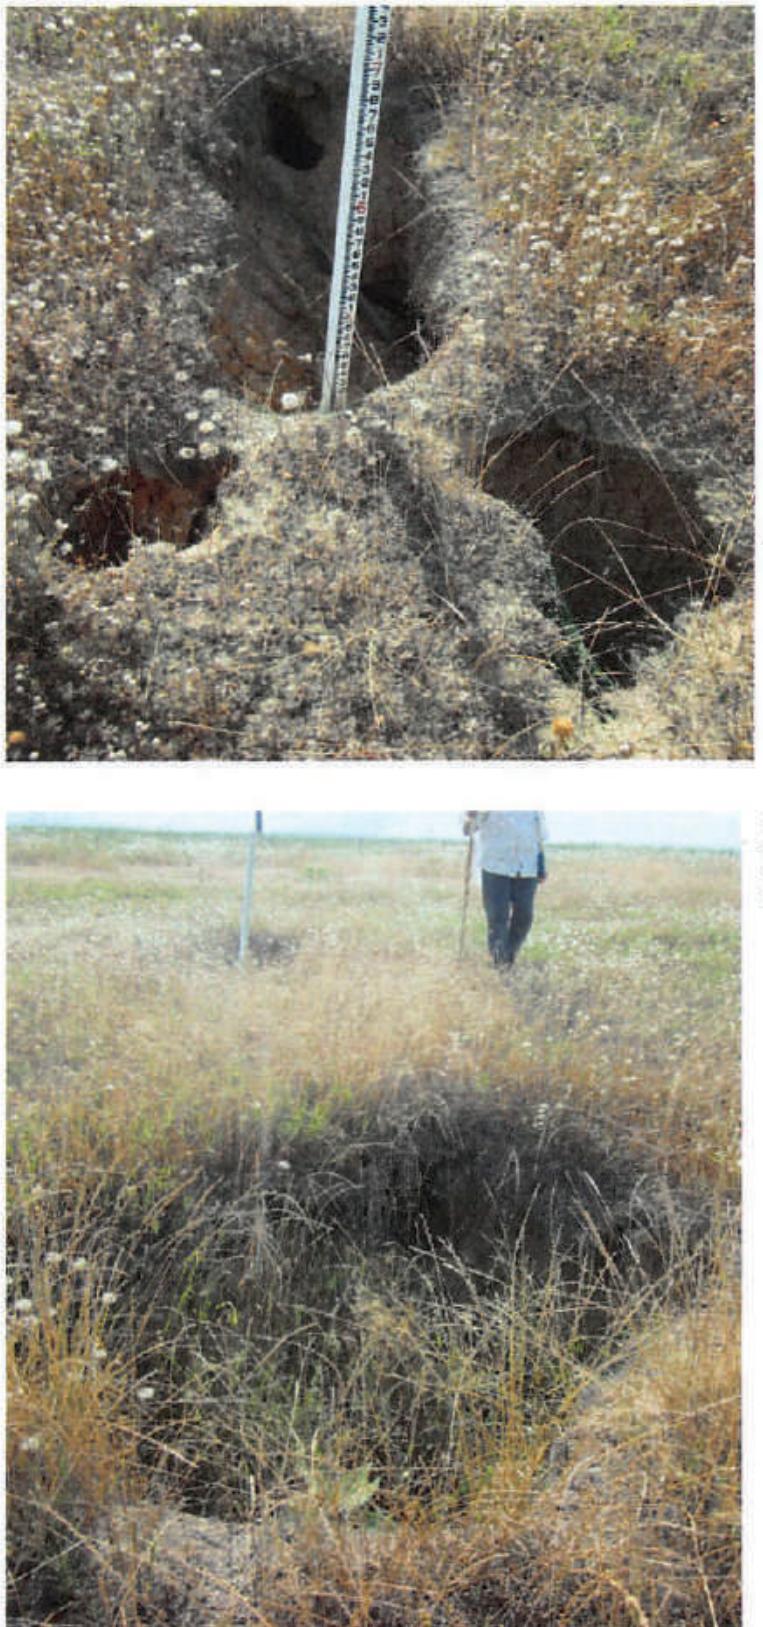
Photo No. 53. Multiple holes between Stations 12+00 and 14+00. The hole is 4 feet deep.

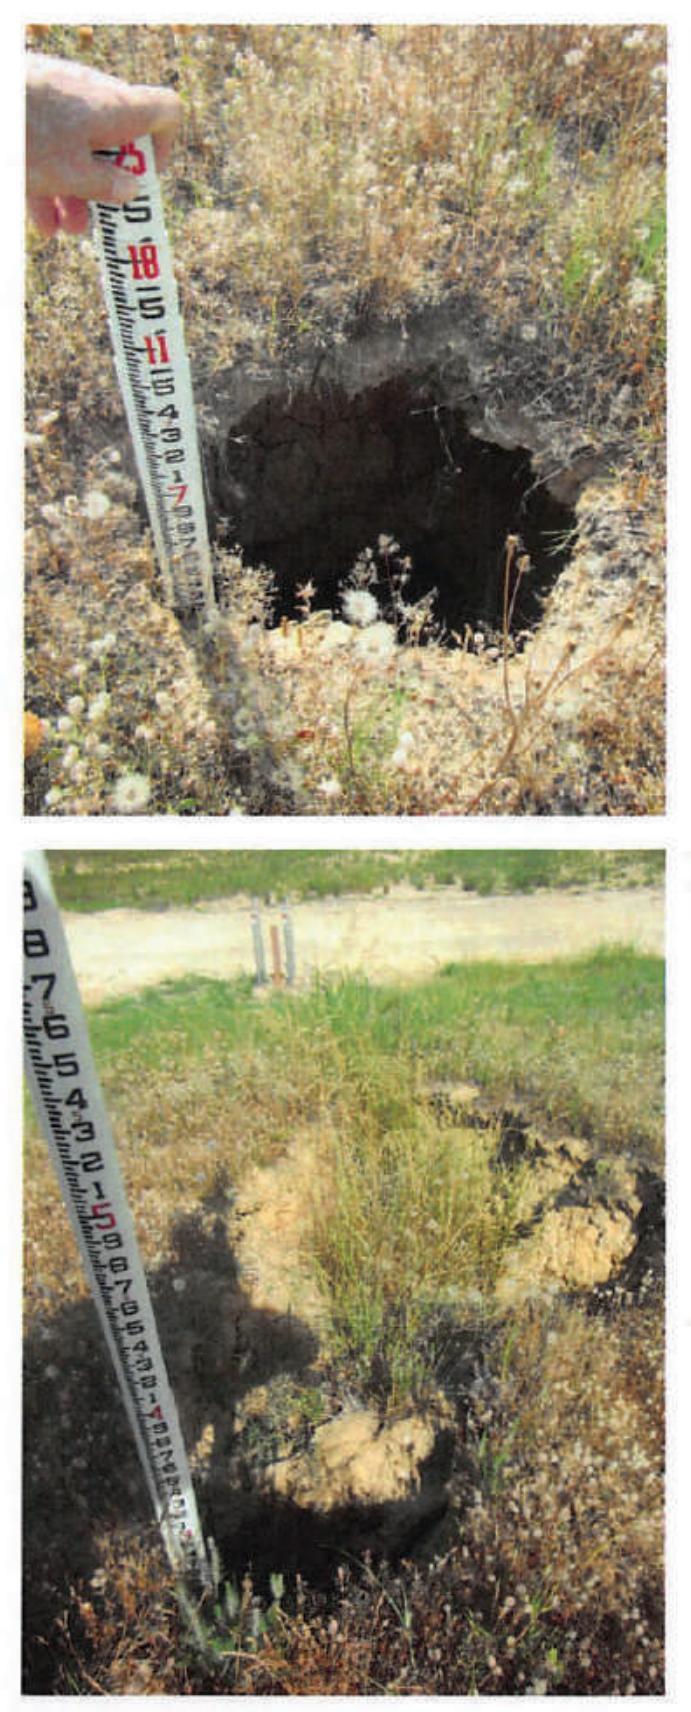
Photo No. 57. This hole is over 6 feet deep.

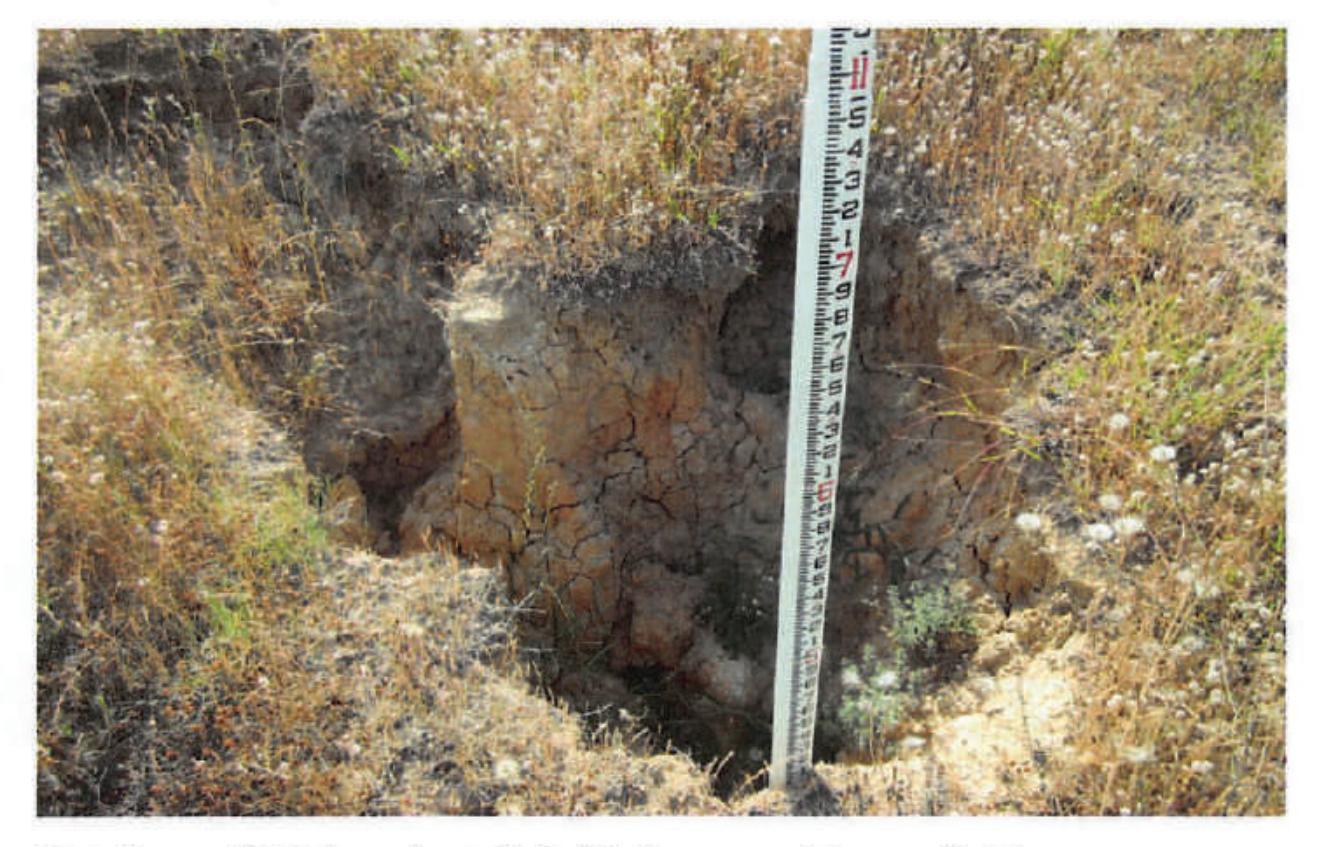
Photo No. 59. This hole was located left of Station 10+00. It is over 4 feet deep.

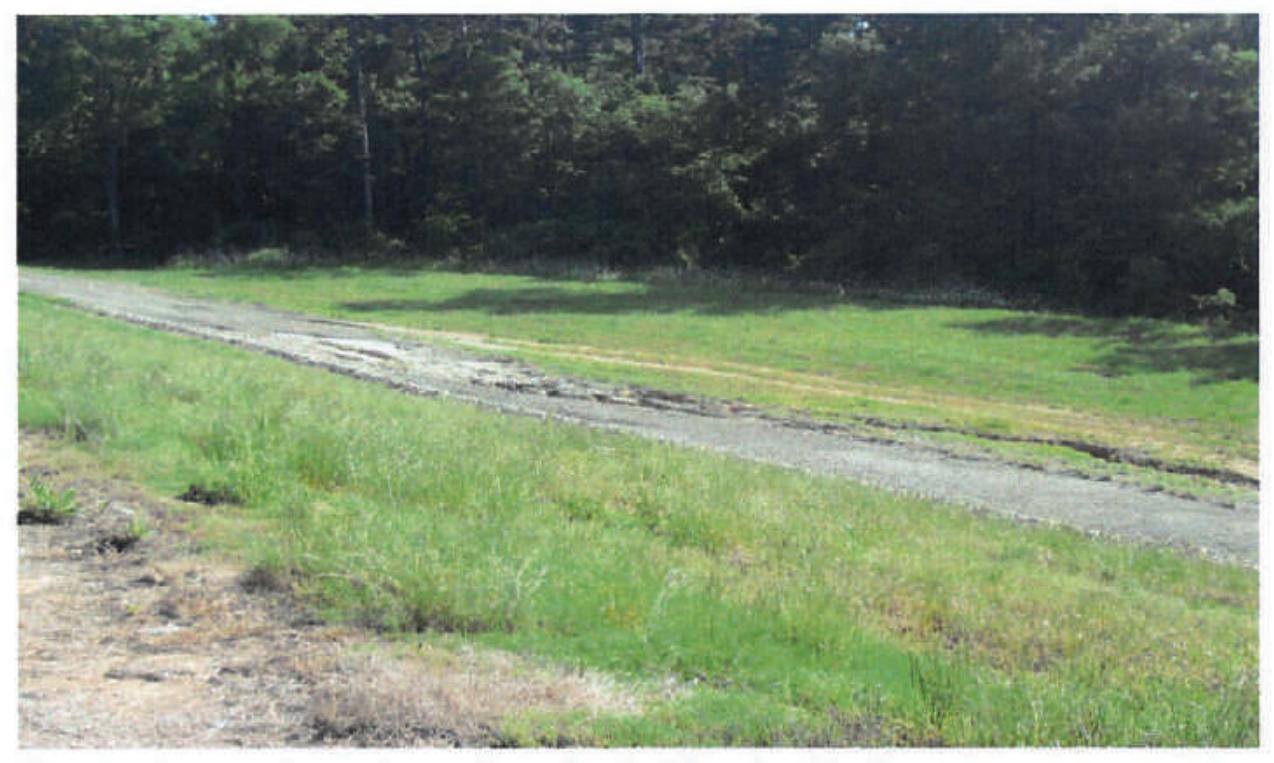
- In several areas, there appeared to be new holes forming.
- Cracks were located on the slope. See Photo No. 60. These cracks could lead to additional holes during periods of rainfall.
- The soil in the holes is compromised. See Photo No. 55 for an example.
- Material has washed off the slope and is covering the access road along the berm downstream. The material was an inch deep in one place.
- Erosion has also occurred on the downstream edge of the road.
- Erosion was also occurring at both groins. See Photos 61 and 62.

Photo No. 62. Note the erosion on the road at the left groin of the dam.

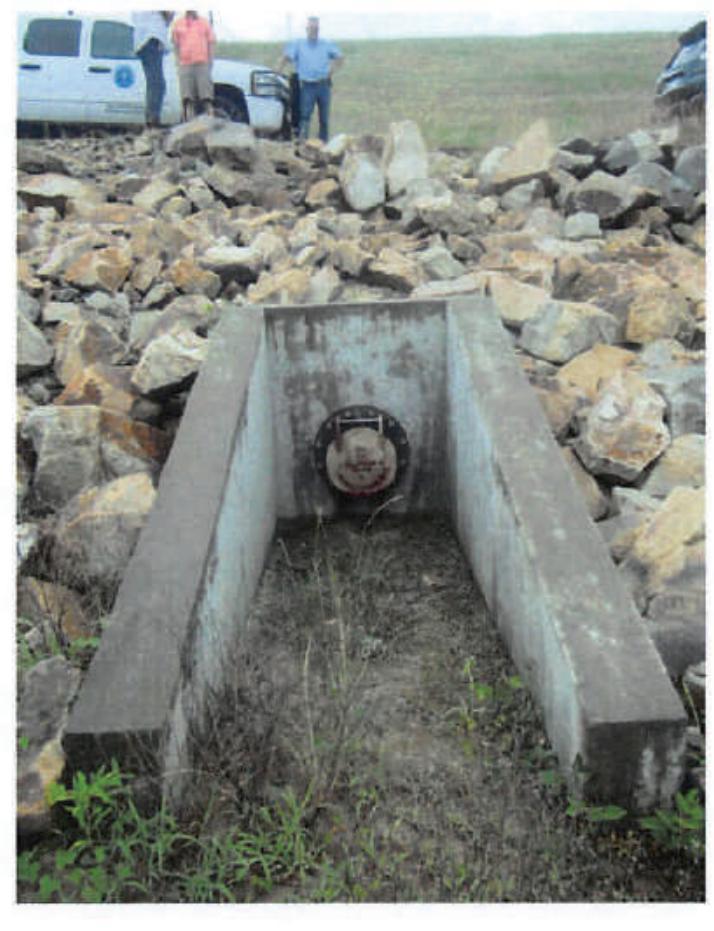
Photo No. 63. Station 35+50. The toe drain at

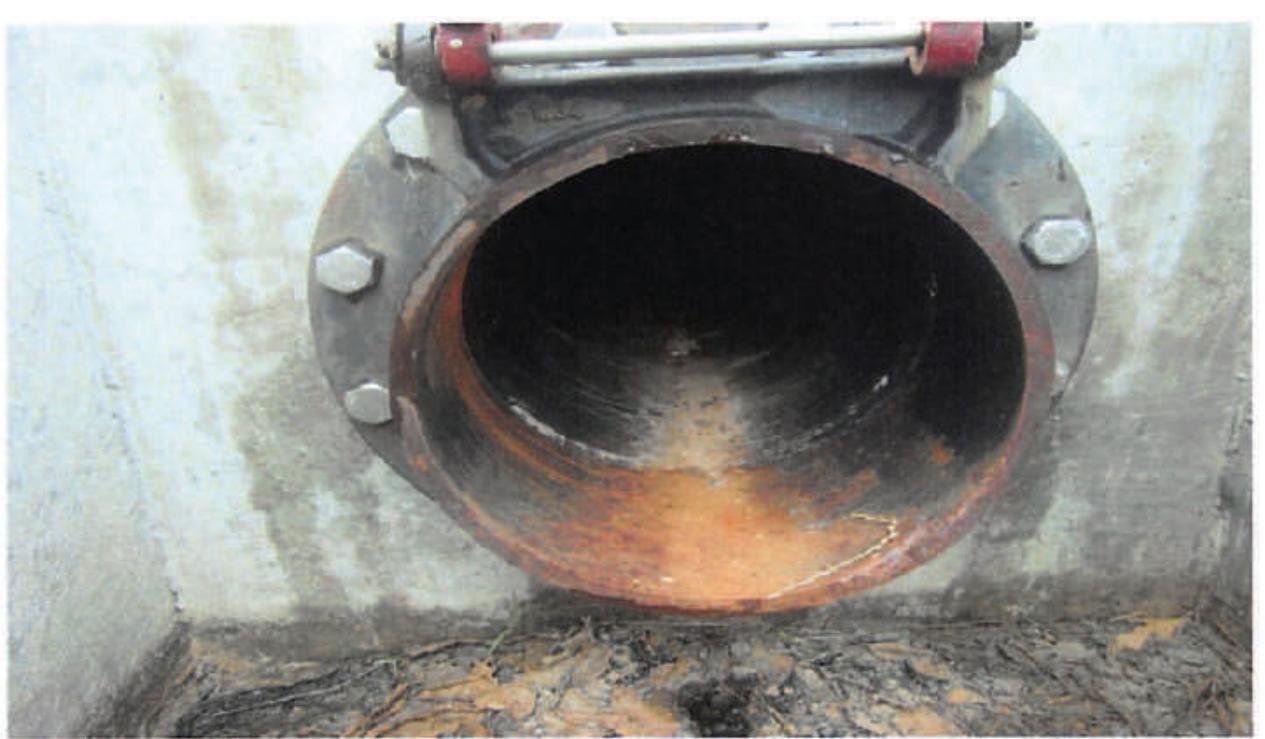
Photo No. 64. The drain in Photo No. 63 was dry.

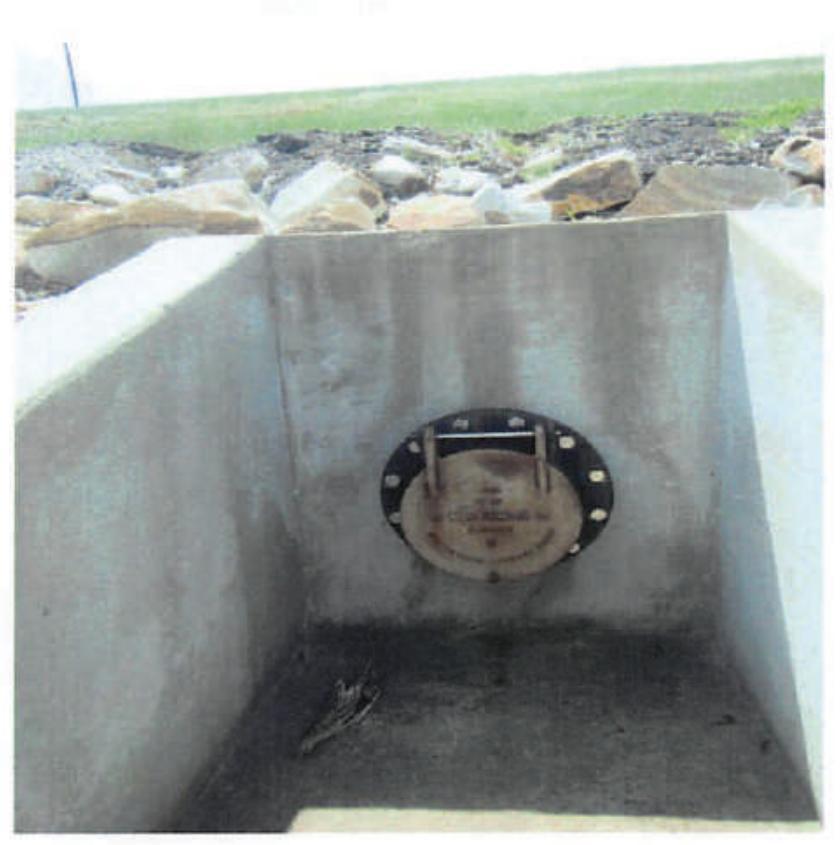
Photo No. 67. The drain at Station 20+00. This drain was dry.

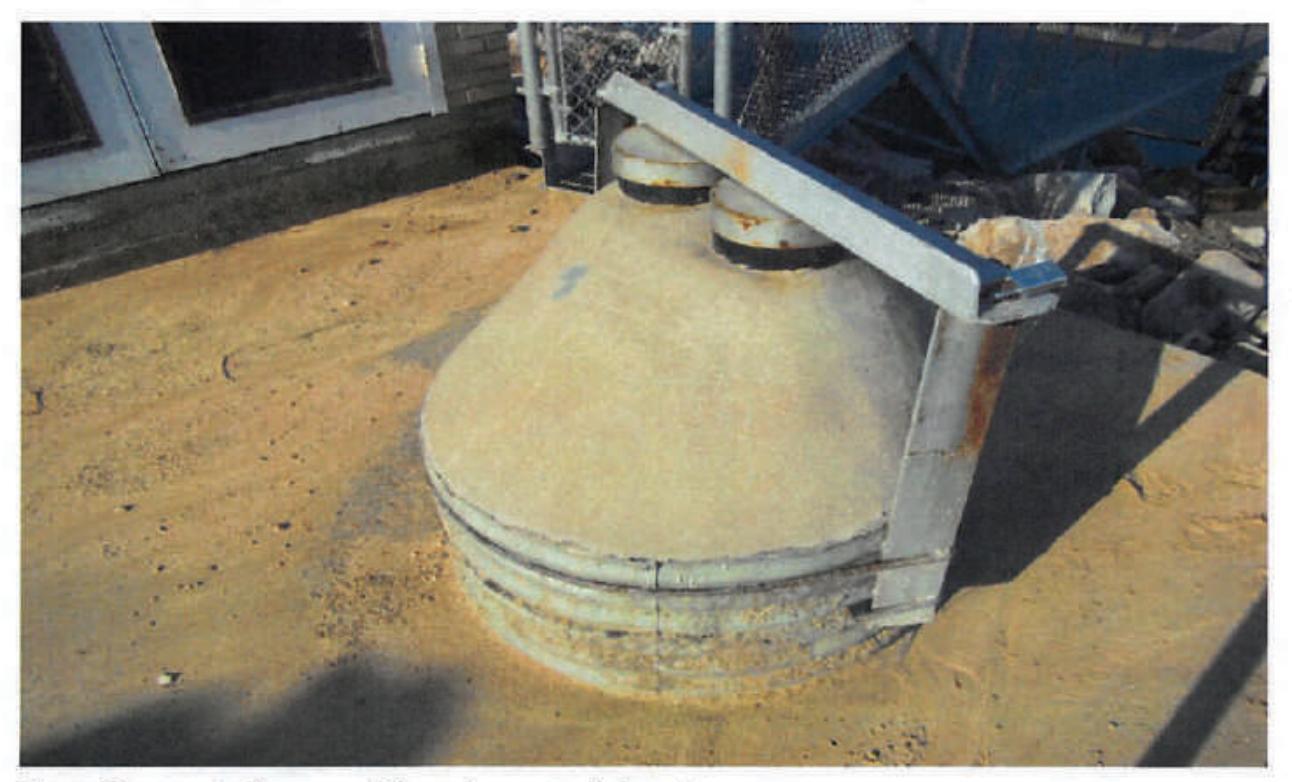
Photo No. 79. A close-up of the valve controls housing.
