Franklin County Water District Development of Alternatives to Restore Downstream Slope, Franklin County Dam

PRELIMINARY ENGINEERING REPORT

FINAL | February 2020

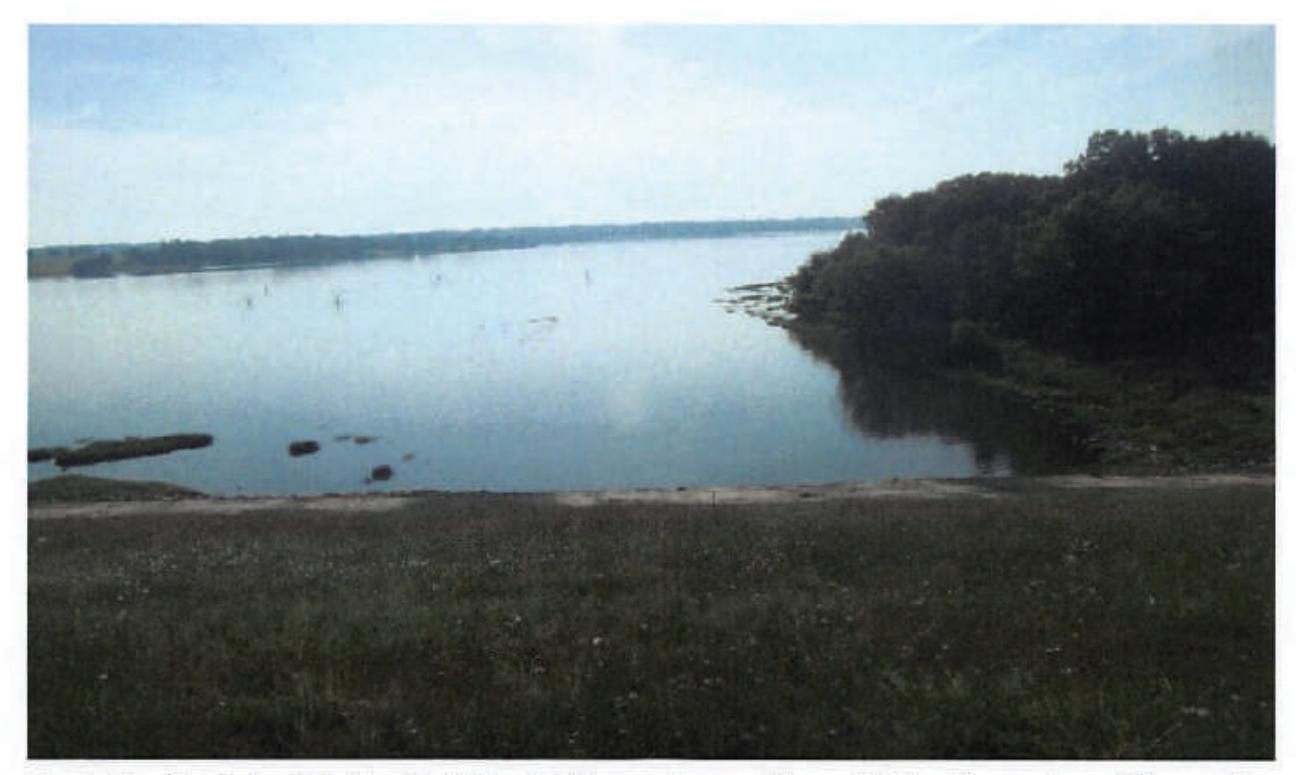
The downstream channel is Lake Bob Sandlin. There are no issues associated with this area. See Photo No. 80.

Photo No. 80. Lake Bob Sandlin is located downstream. The outlet for the service spillway exits in the center of the photo.

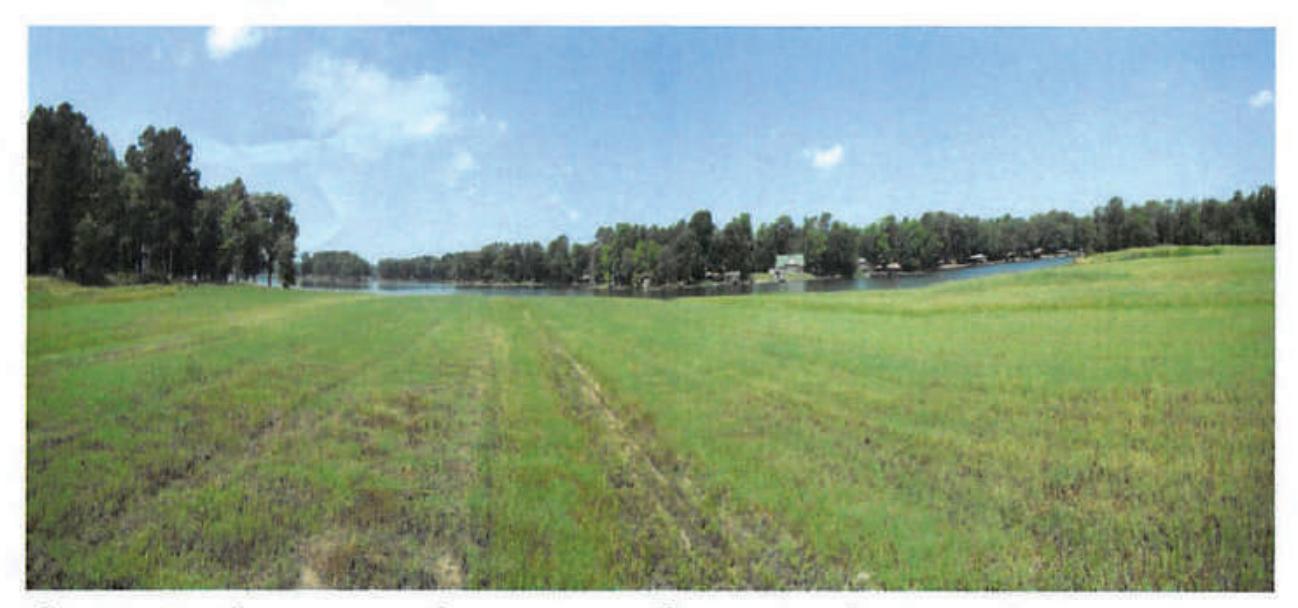
- The emergency spillway is located approximately  $\frac{1}{2}$  mile west of the left end of the dam.
- The emergency spillway is a 1,000-foot wide earthcut channel. County Road 3122 crosses the discharge channel.
- The emergency spillway has a good grass cover and was well maintained. The ditches along the roadway were clear and well maintained. See Photos 81 and 82.
- The emergency spillway was found to be in good condition.
- The emergency spillway was no longer being used for agricultural purposes.

Photo No. 81. The entrance to the emergency spillway. It is well maintained.
