FRANKLIN COUNTY WATER DISTRICT  
EMERGENCY SPILLWAY

# PRELIMINARY ENGINEERING REPORT

FINAL | January 2018

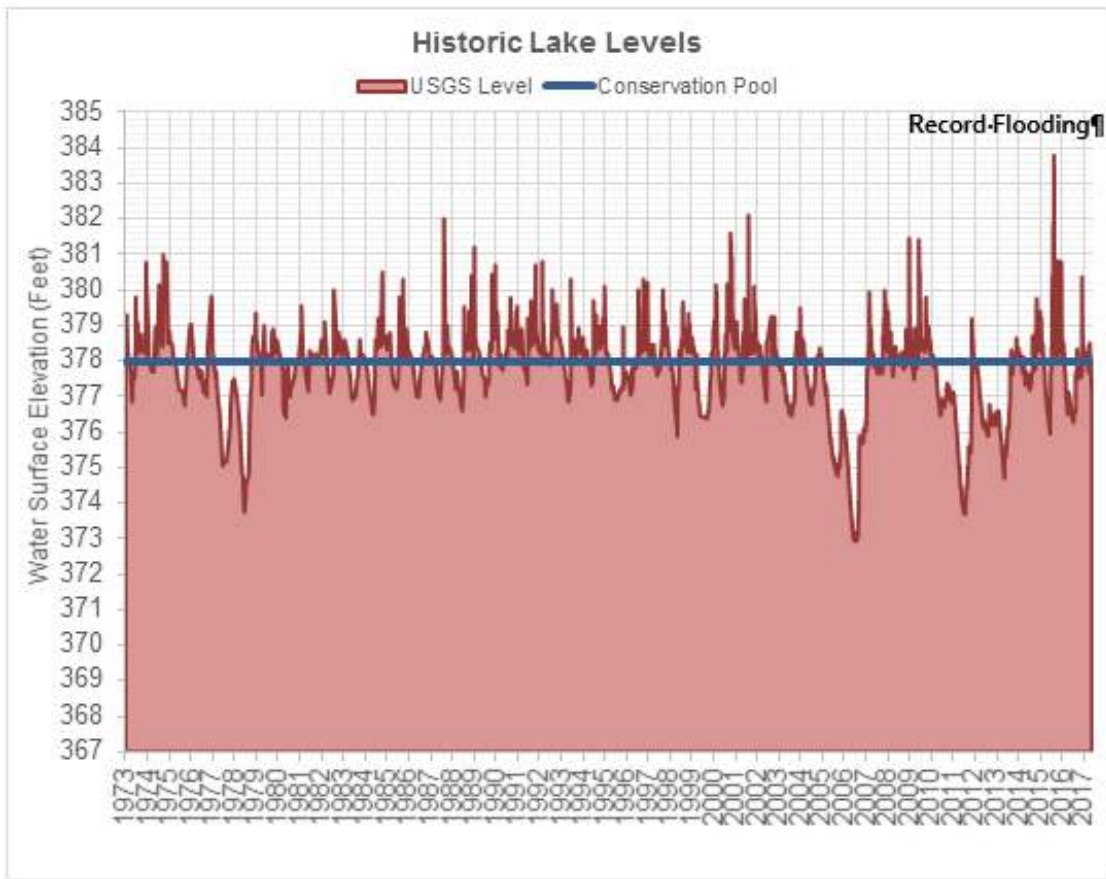
On December 27, 2015, the LCS watershed experienced a historic flooding event that caused lake waters to rise to record levels, as shown as "Record Flooding" in Graph 3 below. The WSE in LCS rose to a maximum of 383.92 feet above msl or 5.92 feet above the conservation pool of the reservoir set at 378.00 msl. As shown in Figure 4 below, and as presented in a Public Stakeholder Meeting for Flood Relief Alternatives (April 5th 2016), the reservoir experienced an approximated 350-year storm event.

Graph 3: [Historic Lake Levels](#)

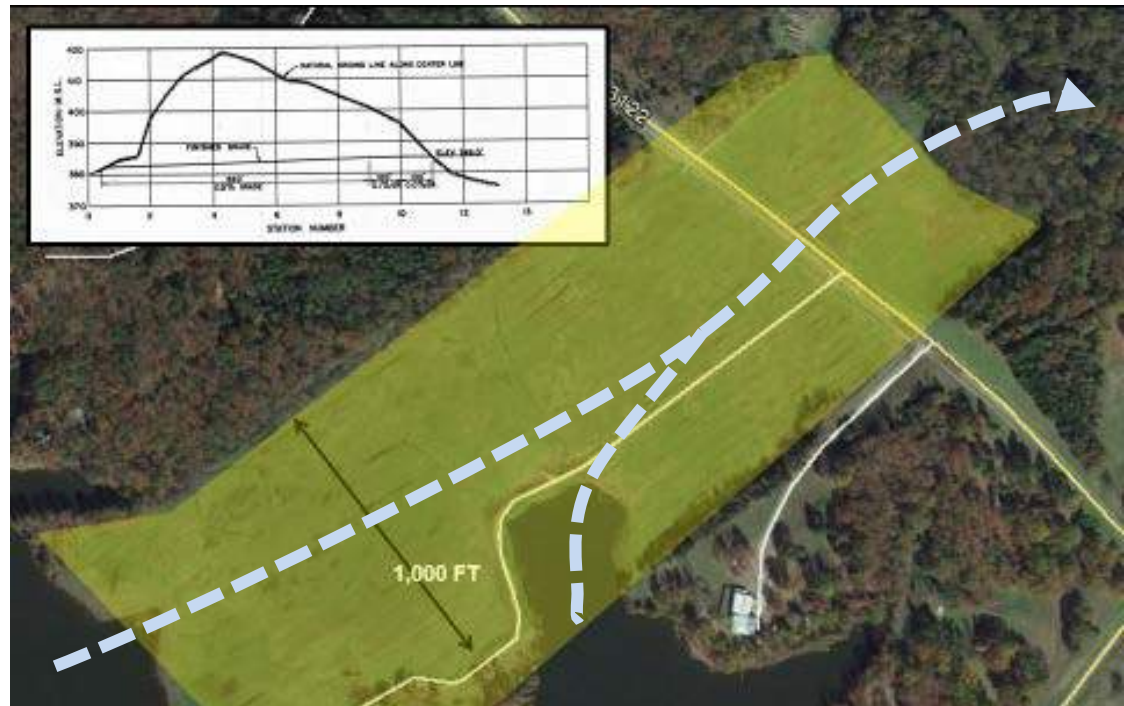
The Emergency Spillway was originally thought to be designed with FM 3122 acting as the highest elevation of 385.0 msl, which would make the roadway the governing hydraulic characteristic of the spillway (i.e. the weir). Further discoveries from the investigation of the design drawings actually show that FM 3122 was not designed to be perfectly perpendicular to the spillway, and thus is not the highest point along the entire cross section. Areas north-east and south-west of the roadway gradually slant to Andy's Creek and the lake respectively. An aerial of the emergency spillway is shown below in Figure 5.

Figure 5: LCS Emergency Spillway Diagram

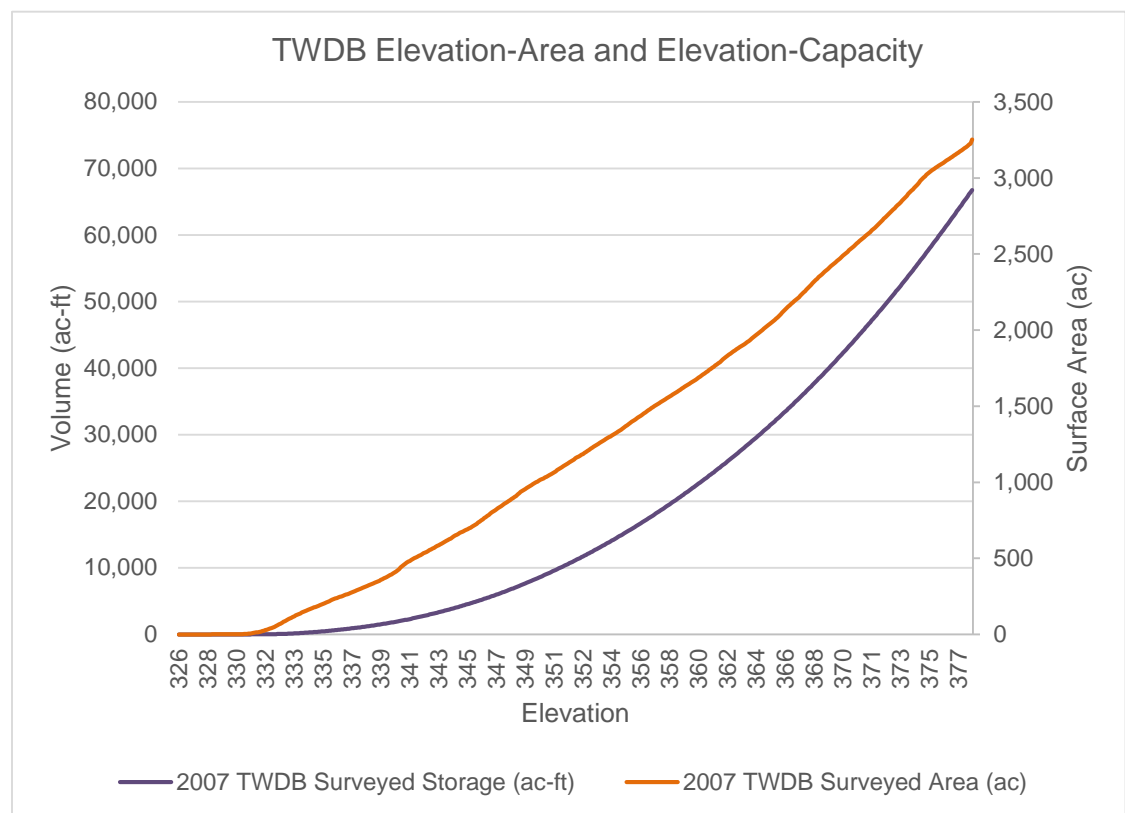
The report's elevation-capacity and elevation-area curves formed the foundation for the LCS models developed and described in this report. Graph 6 below shows the lake's volume relative to its elevation (left- y axis) and the lake's surface area relative to its elevation (right- y axis).

Graph 6: TWDB Elevation-Area and Elevation-Capacity Curves

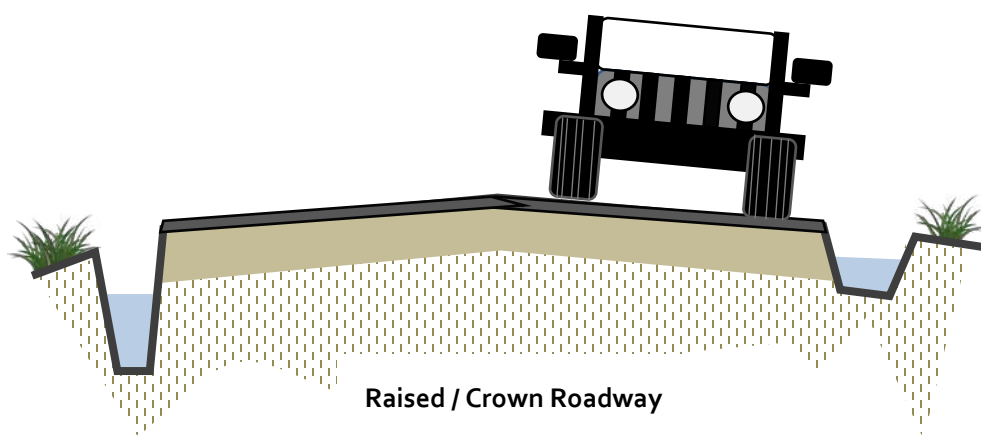
During the investigation process, it was discovered that the District has leased property adjacent to the emergency spillway on the south side (see Figure 8 below). This leased property itself is not located within the emergency spillway corridor, however a dirt road used to access the property is currently used that is located within the spillway. In the future, as a development for this property is planned and permitted with the District, it will be imperative to relocate the access roadway to a new location. As shown below, most asphalt-constructed roadways are crowned to allow for proper drainage. The crowing of a paved road in the middle of the emergency spillway could have a hydraulic effect and should be evaluated.

Although its current location and condition need not be moved, the construction of an elevated asphalt roadway must be considered from a hydraulic perspective. Two possible relocation scenarios are shown below in Figure 8, but each should be evaluated hydraulically by the District once planned and further designed.

Figure 8: LCS Emergency Spillway Cross Section

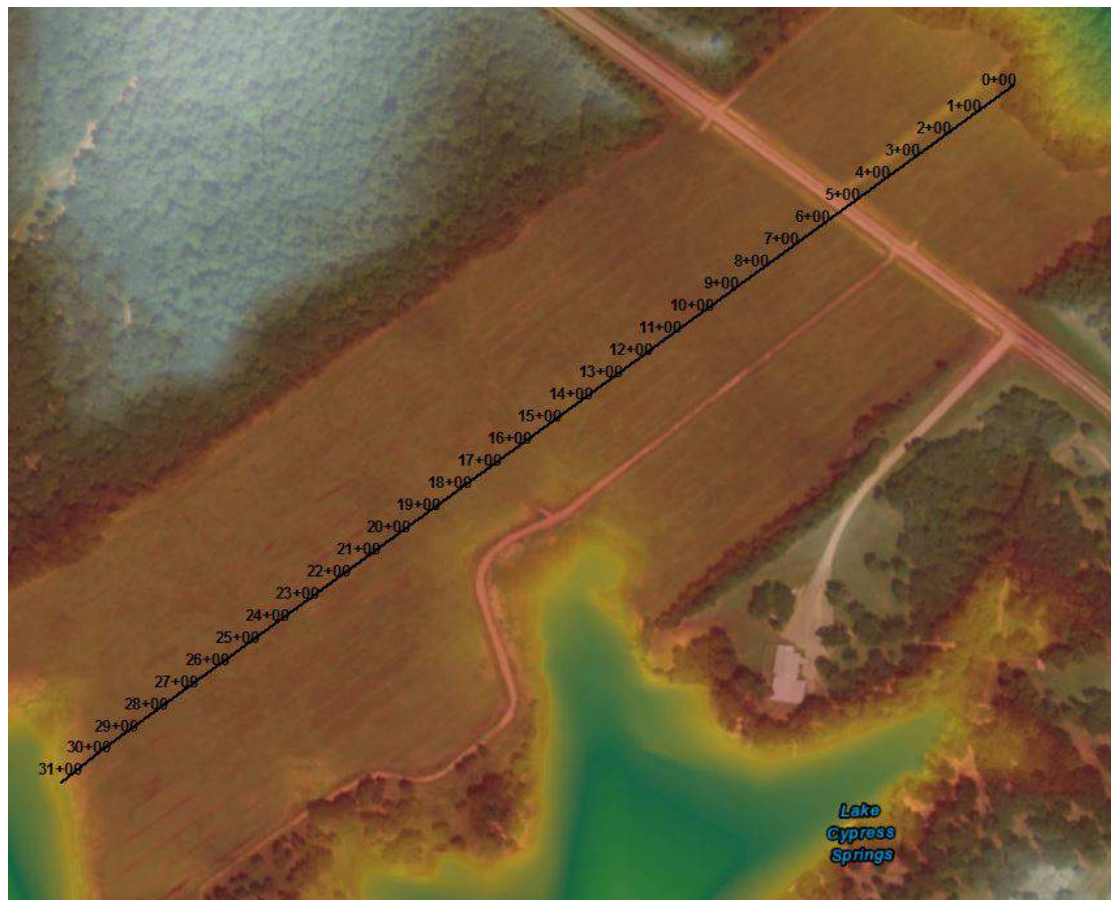
In looking at Alternative No. 2, Carollo was retained to determine if the emergency spillway currently exists as the design intended. Carollo utilized a survey that was completed in 2006 and compared it to the original dam plans completed in 1966 to determine if there has been additional fill accumulated on the spillway. As shown in Figure 10 below, the existing emergency spillway did exhibit, in most areas, an excess of fill above the designed ground elevation. The accumulation of fill ranges from approximately 0.5 feet near the center of the spillway to 2 feet in the outer locations. Additionally, the cross section, situated down the center of the emergency spillway, below in Graph 11, also shows the accumulation of fill, with the red line showing the existing ground surface elevation, and the blue line showing the designed surface.

Figure 10: LCS Emergency Spillway Elevation Comparison

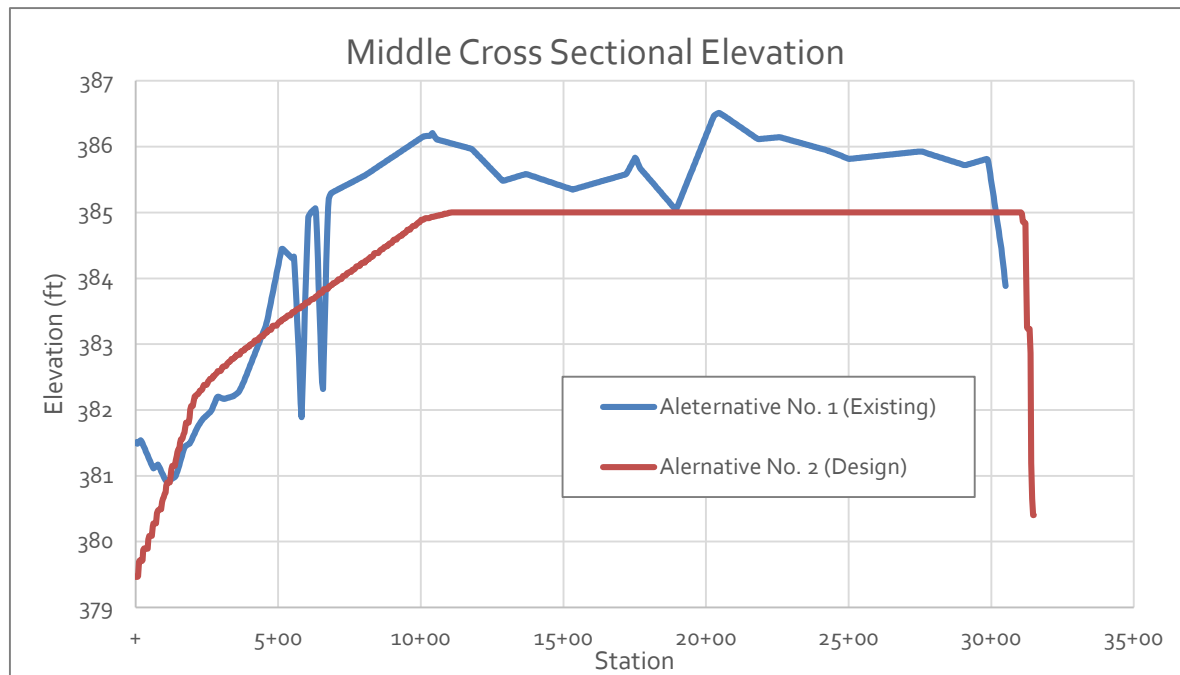
Graph 11: LCS Emergency Spillway Profile Line

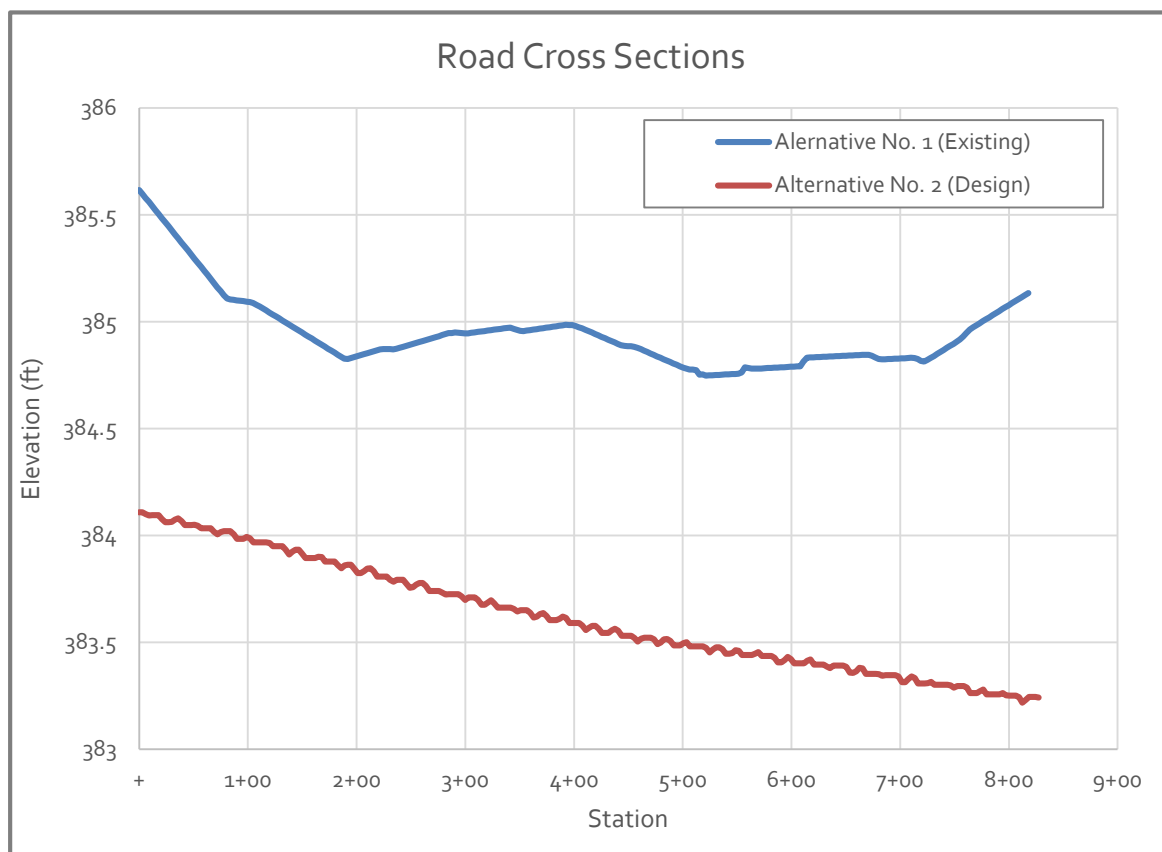
In addition to having excess fill material deposited throughout the Emergency Spillway, it was also discovered that the FM 3122 alignment differs in elevation from the 1966 design. As the station-elevation graph below showcases, FM 3122 appears to have been constructed at approximately 1+ feet higher in elevation than the 1966 design intended. It is unknown if road overlays, improvements, or rehabilitation is to blame for this difference. It is possible that the asphalt roadway was constructed after the spillway was built, thus adding a layer of compactable select-fill and inches of asphalt.

Graph 13: Road Profiles

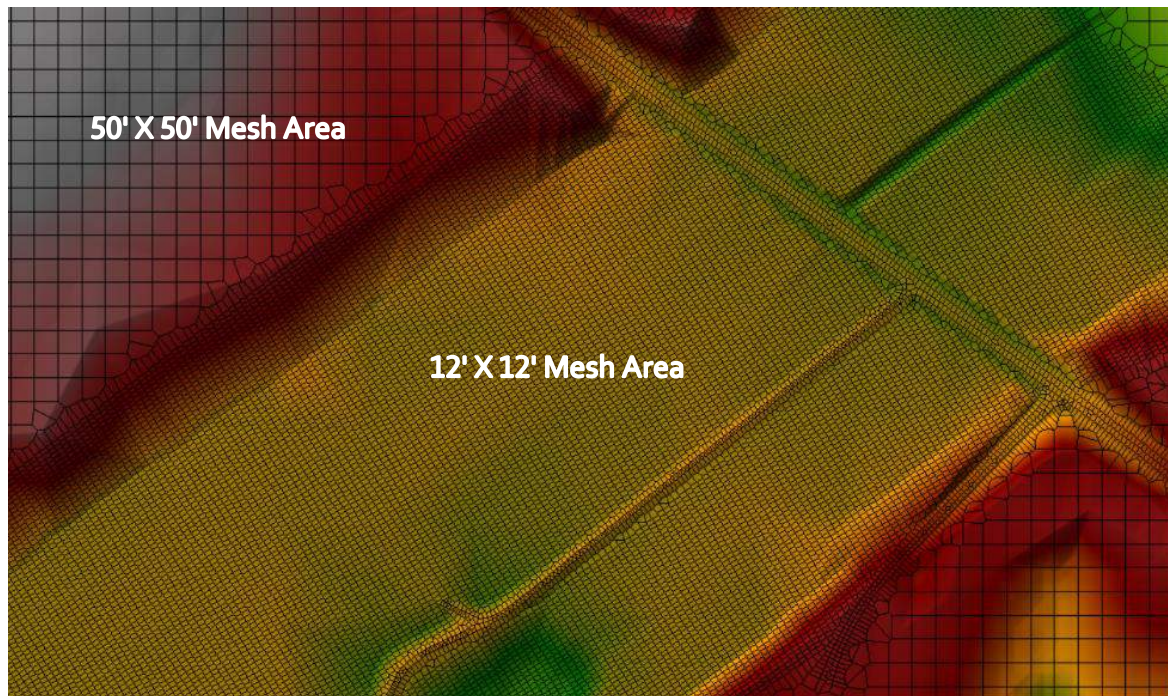
The 2D flow area uses a three dimensional mesh to discretize each terrain surface. The mesh is used in HEC-RAS to complete 2D finite volume hydrodynamic computations. The nominal mesh size is 50 feet by 50 feet for outlying areas. In the emergency spillway region, where velocities are higher and increased resolution of small-scale topographic structures was desired, a smaller mesh size of 12 feet by 12 feet was used. Break lines were used in HEC-RAS to set mesh size and to discretize roadways, ditches and other topographic features within the emergency spillway area. Increased resolution of the terrain allows for increased accuracy of velocity and depth results in regions of potential scour. Figure 14 shows a portion of the mesh on the existing emergency spillway.

Figure 14: HEC-RAS 50x50 and 12x12 Mesh over a Portion of the Emergency Spillway and FM 3122

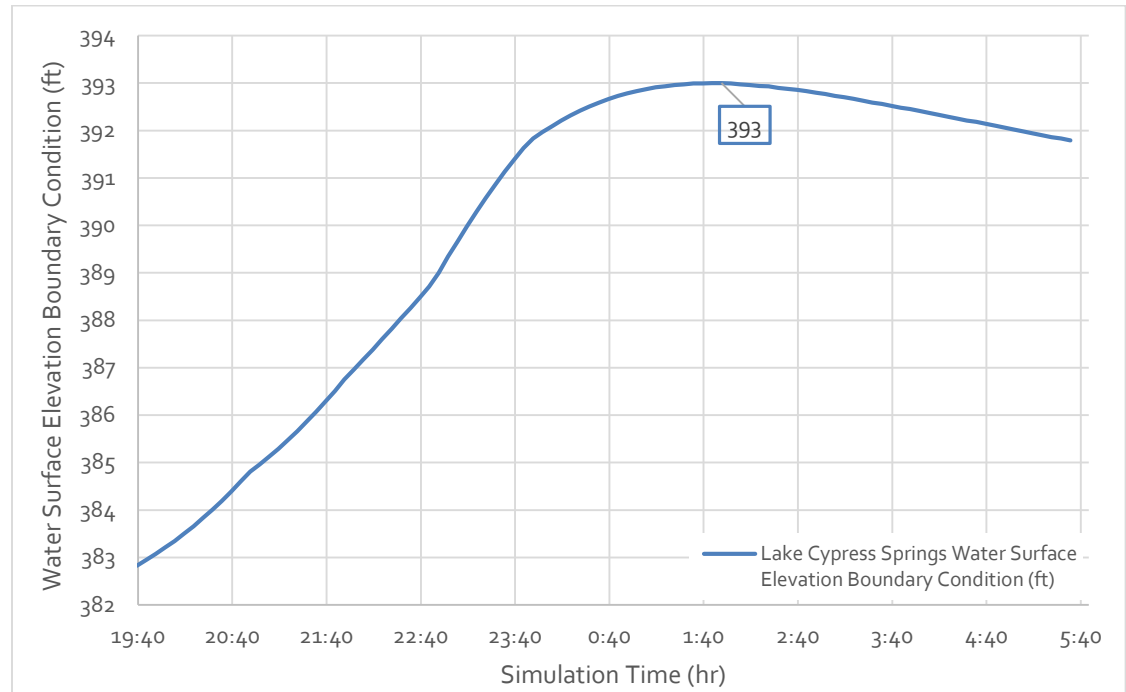
The Lake Cypress Springs boundary condition is a water surface elevation timeseries, shown in Figure 26. The rise and fall rate of the water surface timeseries is based on the Freese & Nichols PMF inflow HEC-RAS 1D model of Lake Cypress Springs. The water surface elevation timeseries used in the model starts at an elevation below the emergency spillway and rises to a maximum elevation of 393 feet. This maximum water surface elevation was chosen because it provides two feet of freeboard for the Franklin County Dam. The model's timestep was set at two seconds for model stability and to properly capture the high velocities on the emergency spillway. A summary of the model inputs are listed in Table 27.

Graph 26: Lake Cypress Springs Water Surface Elevation Timeseries Boundary Condition

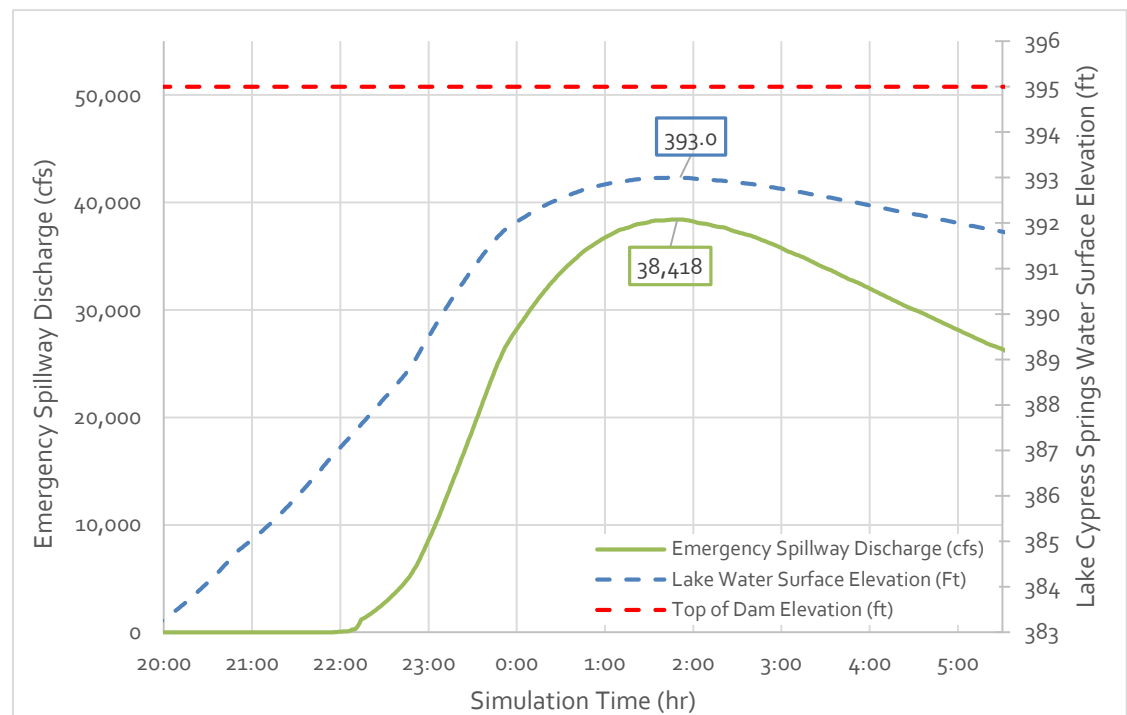
Graph 28: Lake Cypress Springs water surface elevation (dashed line), emergency spillway discharge, and top of Franklin County Dam for Alternative 1 (Existing) surface.

Model results show that the peak flow rate over the emergency spillway is 38,418 cfs at time 25:52 (day 2, 01:52). This time corresponds to boundary condition peak water surface elevation in the 2D Flow Area at 393.0 feet (Graph 28). Again, this water surface elevation is chosen because it allows 2.0 feet freeboard below the crest of the Franklin County Dam.

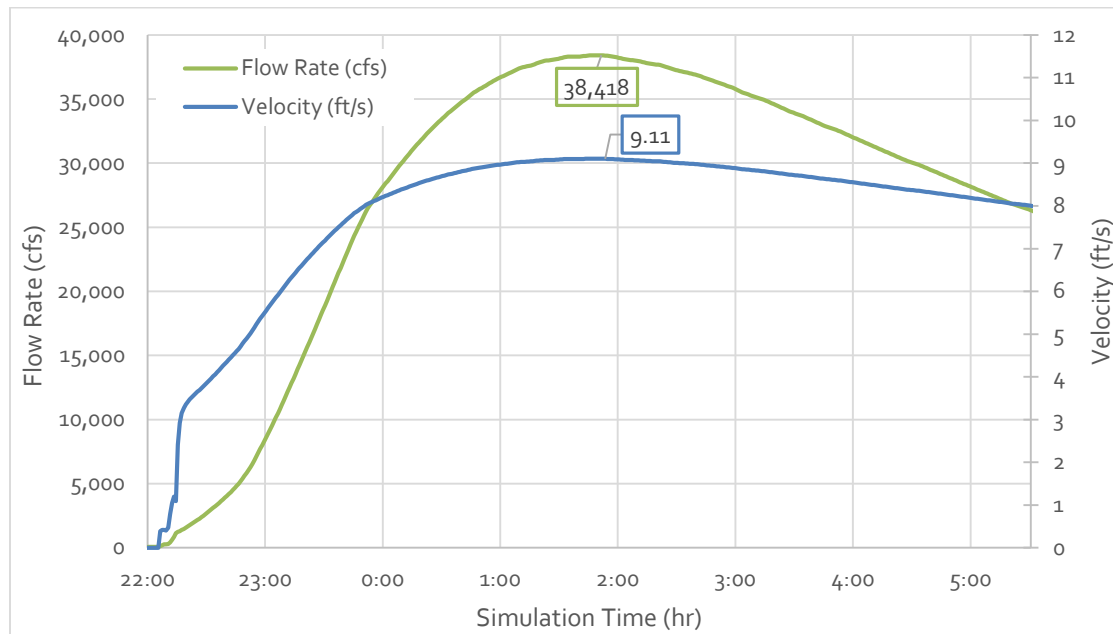
Graph 29: Time series of flow rate and velocity on FM 3122 roadway perpendicularly crossing emergency spillway for the Alternative 1 (Existing) surface.

A timeseries of flow and velocity over the emergency spillway at the location of FM 3122 (Graph 29) reveals maximum velocity of approximately 9.1 feet/s over the road. A spatial map of velocity and particle tracking at the peak flow rate and other flow conditions are shown in Figure 30 and Figure 31. In Figure 32 a view of the peak flow rate velocities are shown over the unsurfaced driveway to the lease which runs perpendicular to FM 3122 and parallel to water flowing within the emergency spillway. Velocities of approximately 5.5 feet/s are exhibited perpendicular to that driveway in certain portions.

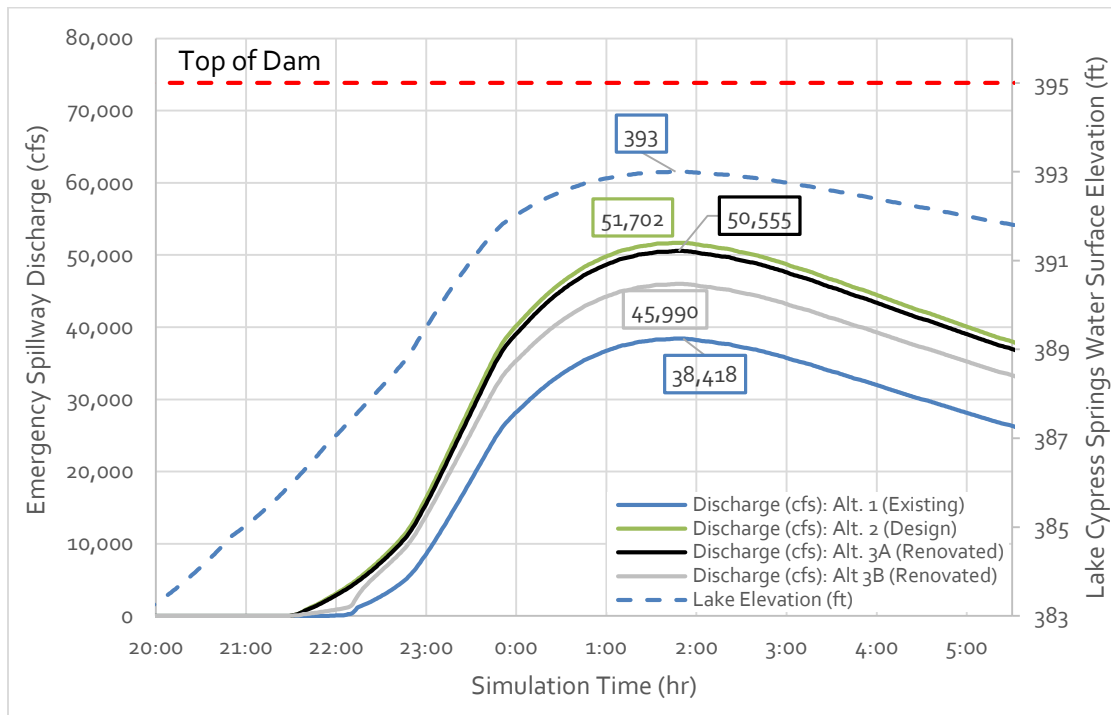
Graph 36: LCS water surface elevation and emergency spillway discharge for the Alternative 1, 2, 3A, and 3B surfaces. The peak discharges are labeled for each alternative and are color coded.

Graph 36 and 37 are two of the most important graphs in the analysis. They depict the model results for Alternatives 1, 2, 3A, and 3B surfaces. For the existing condition (Alternative 1), the emergency spillway discharge is from 7,570 to 13,280 cfs lower than the original design or renovated conditions. This is expected because of the proposed decrease in the emergency spillway's elevation in regions that likely restrict flow.

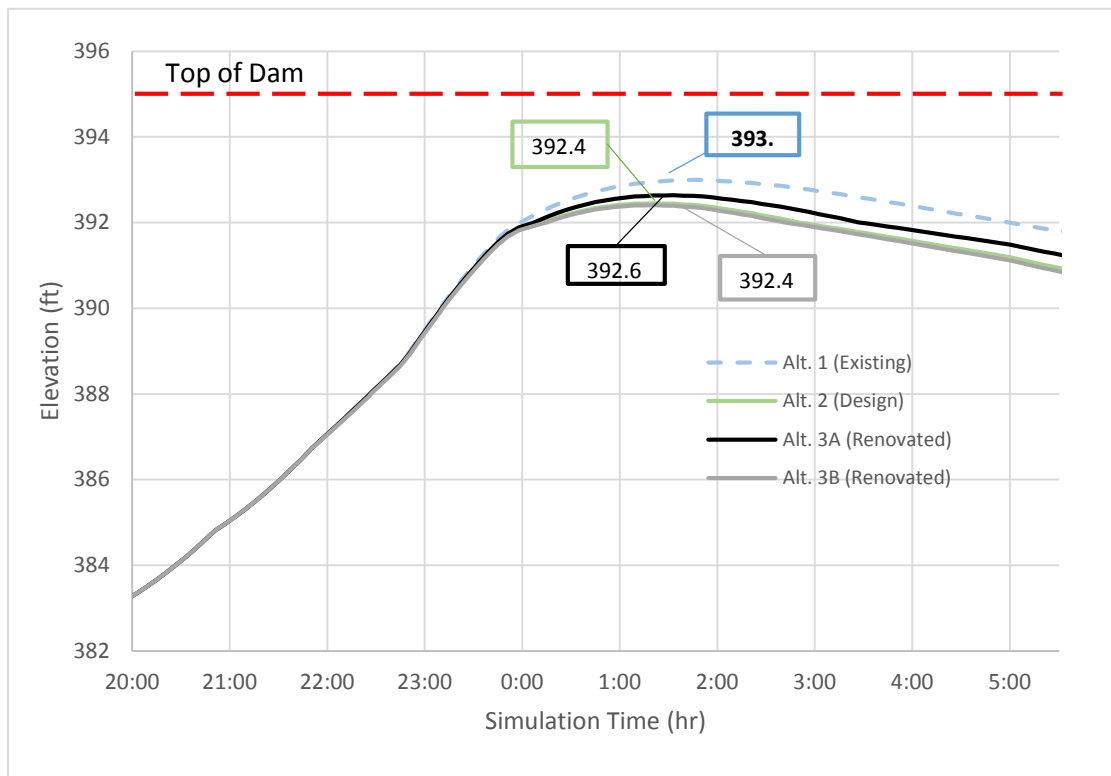
Graph 37: LCS Water Surface Elevation Over the Model Time.

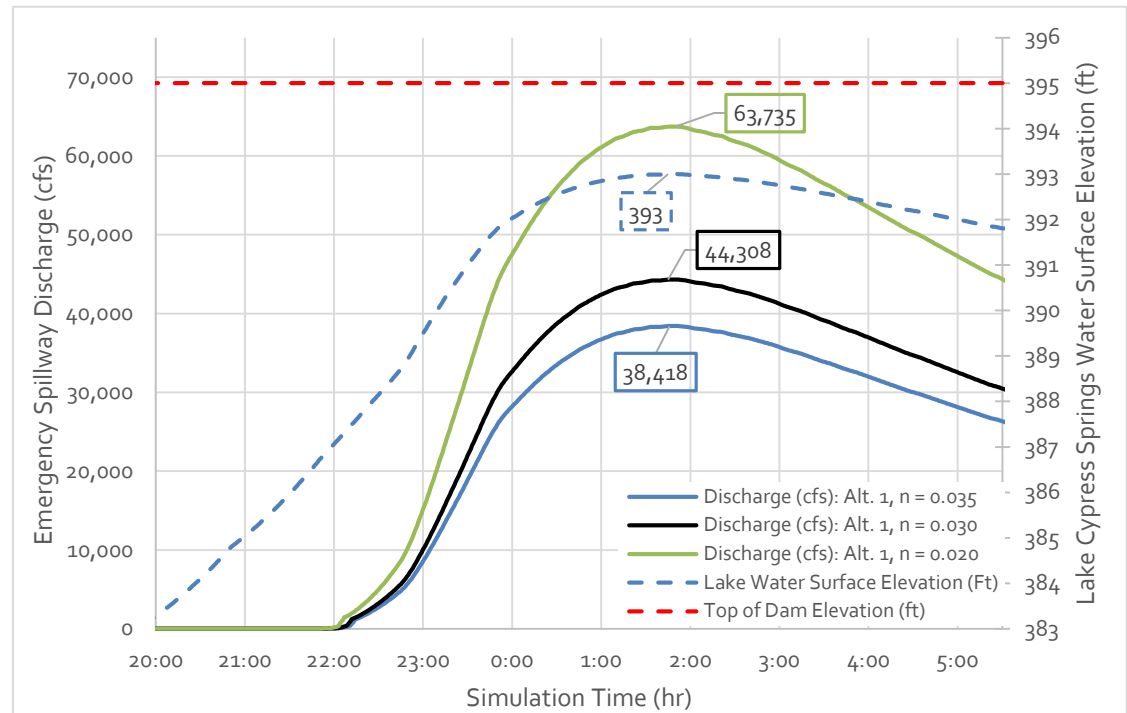
Graph 42: Manning’s roughness sensitivity analysis emergency spillway discharge timeseries for the Alternative 1 (Existing) surface.

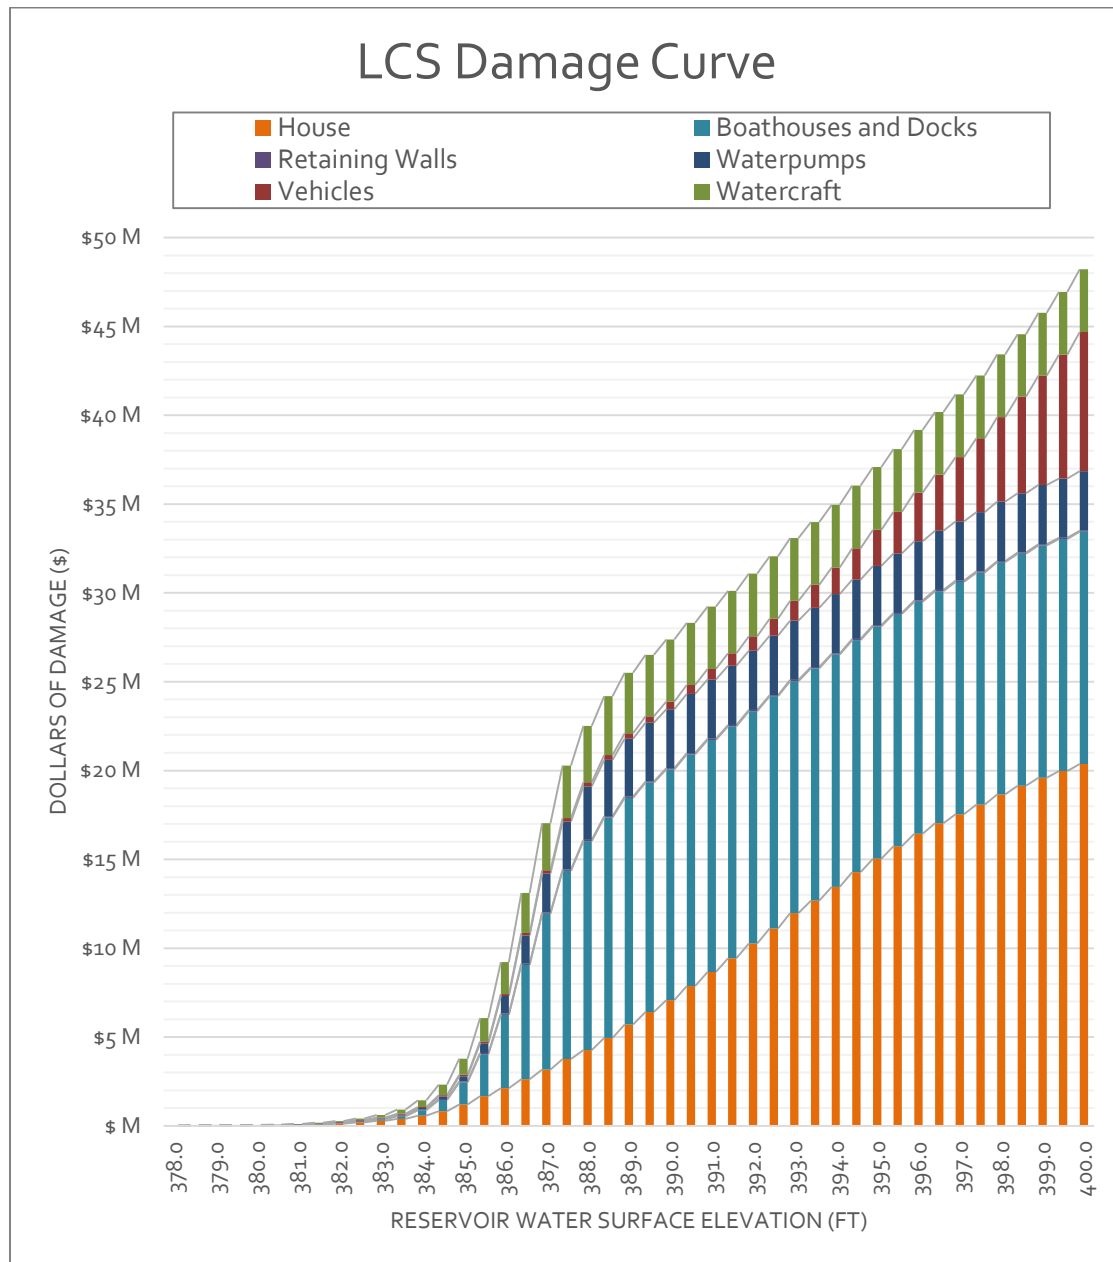
Graph 48 below shows the total damage curve created from an accumulation of the damage curve elements, depicting the amount of damage in dollars at different WSEs in the reservoir. The graph shows the approximated cost of damage to houses, boathouses and docks, retaining walls, water pumps, vehicles, and watercraft at each water surface elevation around the lake.

Graph 48: Total LCS Damage Curve

According to the figure, damage begins when the WSE rises to 380' msl. However, it does not significantly increase until 385' msl. At that point, the reservoir will experience much greater damage per foot of WSE rise.

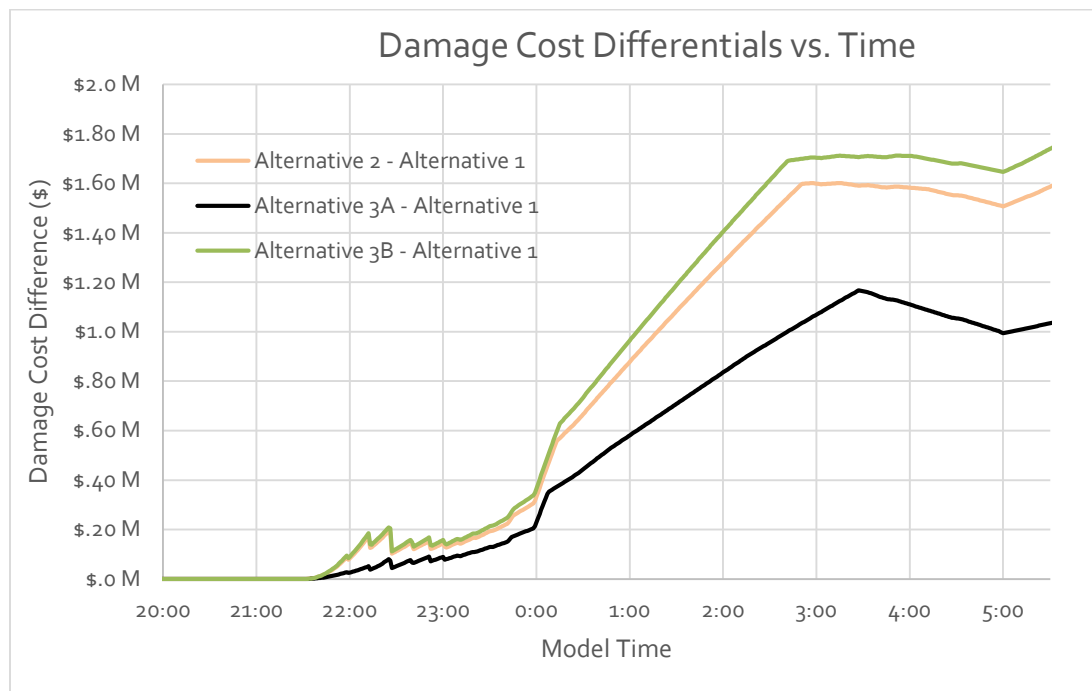
Graph 50: [Damage Cost Differentials](#)

This graph depicts the elevation differences between the surfaces. This data helps to highlight the increase in elevation due to storm events of each surface which is directly related to the damage amount.

Differences in damages between the alternatives were only significant in larger storm events where the water surface elevation in LCS rose significantly. To zoom in on the differences, a Damage Cost Difference graph was created to illustrate the beneficial potential of each surface (Graph 50 below). This graph shows the Damage cost differences of each surface (Alternative 2, 3A, and 3B) compared to the existing conditions surface (Alternative 1).

By plotting each surface's Time vs. Damage Cost graph against one another, the damage cost differentials became apparent. As expected the Alternative 2, 3A, and 3B surfaces, through the course of the simulation, accrued less damage cost than the existing surface.

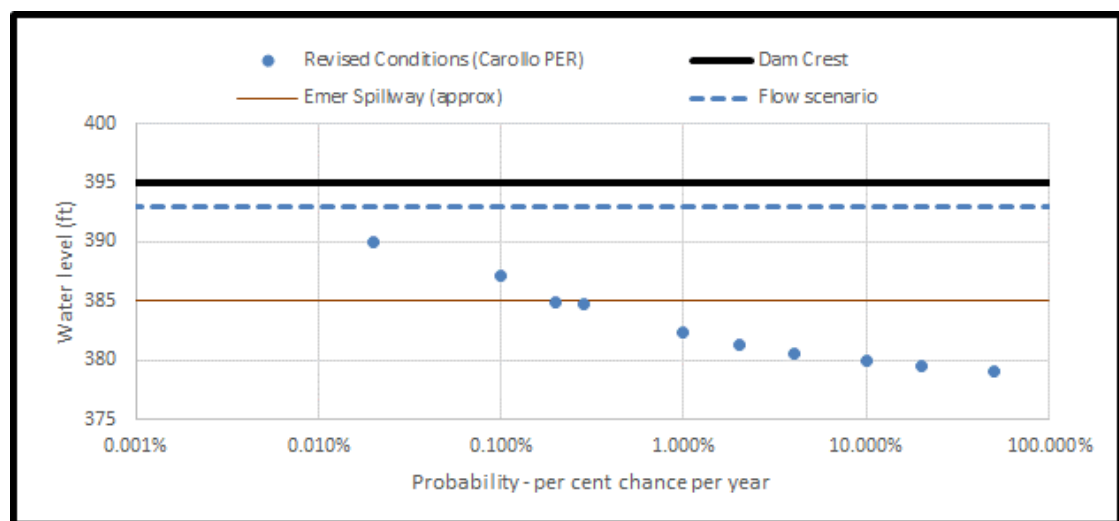
Figure 57: Probability of lake levels with relevant elevations for Emergency Spillway, Dam Crest and hydraulic model scenario for evaluating flow conditions with renovated terrains.

The probability of storm events was previously summarized as part of a December 2016 PER, and the PER. The values used in this report and shown in Table 56 below were plotted along with other elevations including the approximate emergency spillway crest, the crest of the dam and the elevation 393 feet that was used to evaluate flow conveyance for scenarios of spillway terrain renovation (Figure 1).

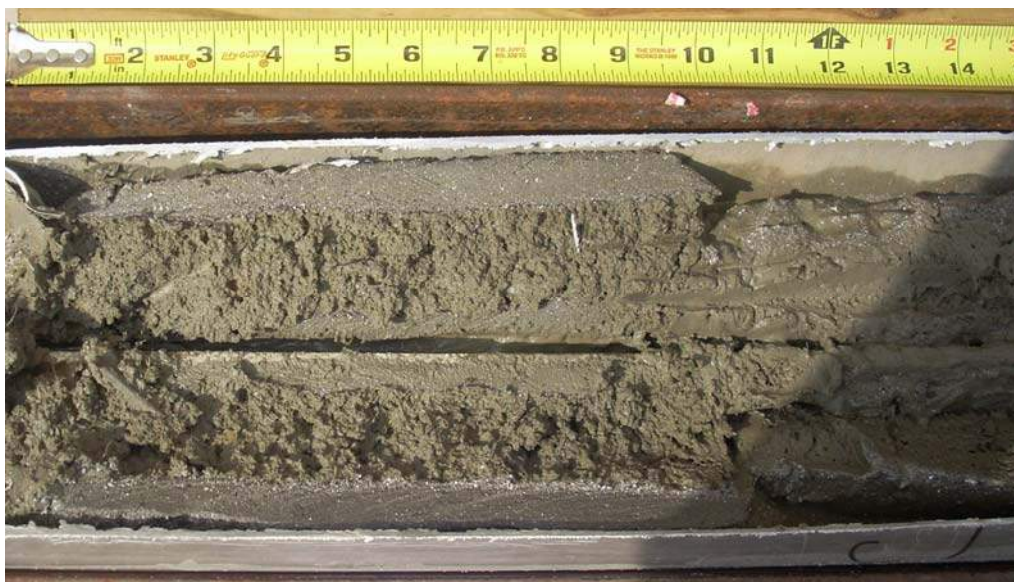
*Figure E2 – Upper portion of core #1 from Lake Cypress Springs, showing the pre-impoundment boundary 10” above the base of the core (left).*

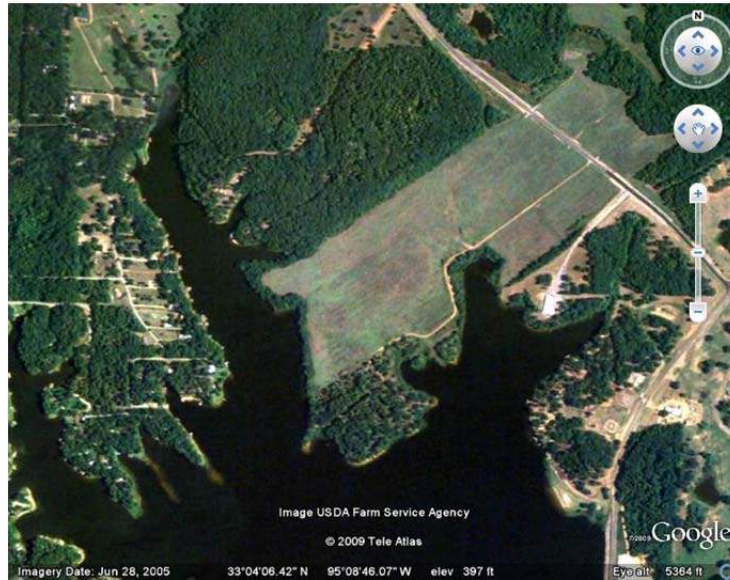
Photo 12: Aerial view of the emergency spillway.
