FRANKLIN COUNTY WATER DISTRICT
EMERGENCY SPILLWAY

PRELIMINARY ENGINEERING REPORT

FINAL | January 2018

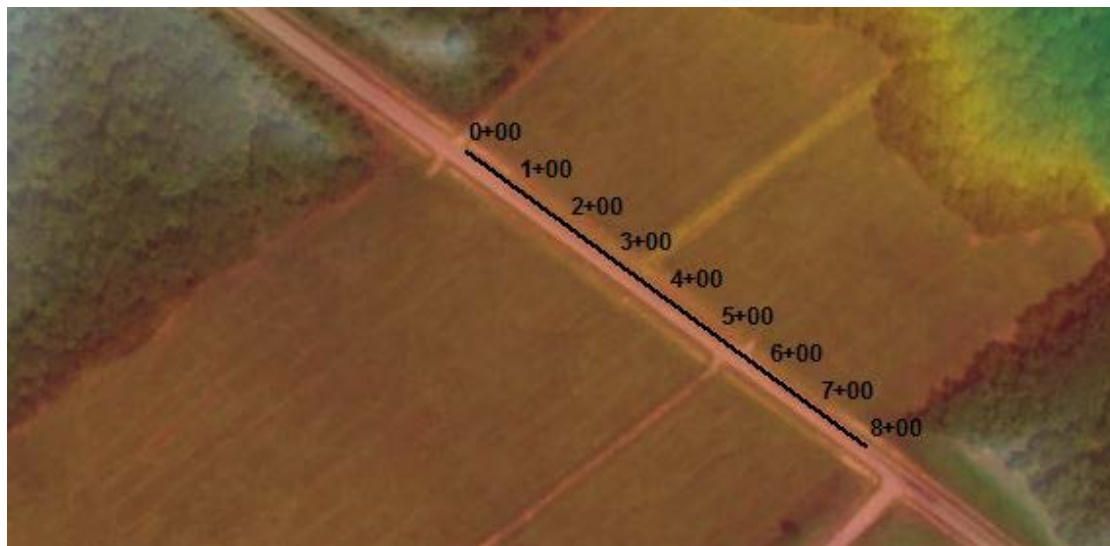
Figure 12: FM 3122 and stations across section

Figure 12 below shows a stationed cross-section across the roadway at the dam, and Graph 13 shows the difference in elevations.

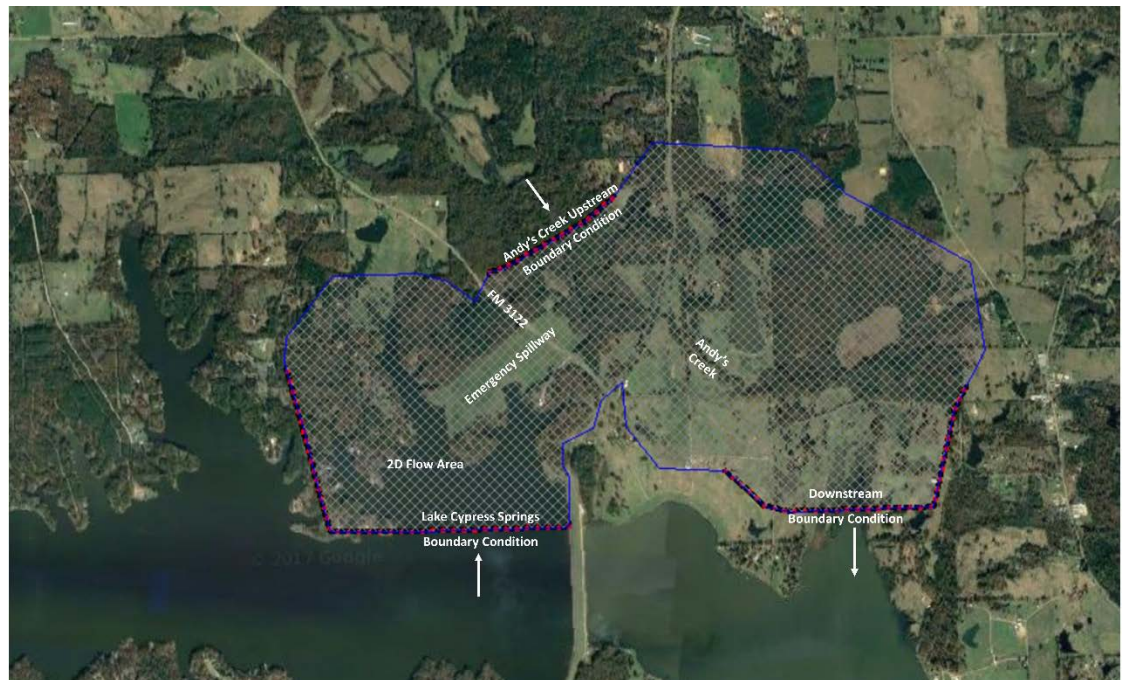
Figure 25: HEC-RAS Model Components

HEC-RAS v5.0.3 was used to perform the emergency spillway modeling and the modeling components are shown in Figure 25. The one major component in the model is the 2D Flow Area, which that extends from the north-eastern cove of Lake Cypress Springs, over the emergency spillway, along Andy's Creek, and ending above Lake Bob Sandlin (Figure 25). The 2D Flow Area has the following connections:

- The Lake Cypress Springs boundary condition (upstream from the west)
- Andy's Creek inflow (upstream from the north)
- Downstream boundary condition at the end of Andy's Creek (downstream to the southeast)

The 2D flow area connections include the Lake Cypress Springs boundary condition, an upstream boundary condition for Andy's Creek inflow, and a downstream boundary condition at the termination of Andy's Creek. The Lake Cypress Springs boundary condition is a water surface elevation timeseries and described further below. Andy's Creek upstream inflow was assumed to be 10,000 cfs throughout the modeling time period, which was a conservative assumption. The downstream boundary condition at Andy's Creek terminus was set as a normal depth, with a friction slope value of 0.0025. The purpose of including Andy's Creek flow in this model is to evaluate whether high flow in the creek impacts operation of the emergency spillway.

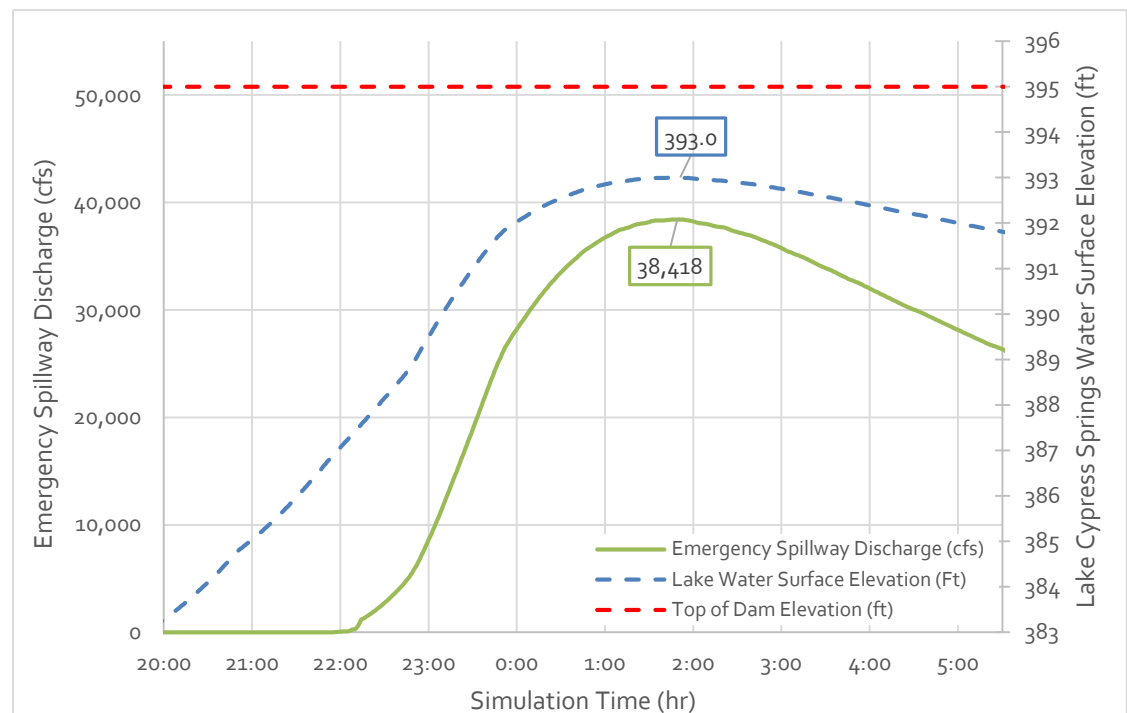
Graph 28: Lake Cypress Springs water surface elevation (dashed line), emergency spillway discharge, and top of Franklin County Dam for Alternative 1 (Existing) surface.

Model results show that the peak flow rate over the emergency spillway is 38,418 cfs at time 25:52 (day 2, 01:52). This time corresponds to boundary condition peak water surface elevation in the 2D Flow Area at 393.0 feet (Graph 28). Again, this water surface elevation is chosen because it allows 2.0 feet freeboard below the crest of the Franklin County Dam.

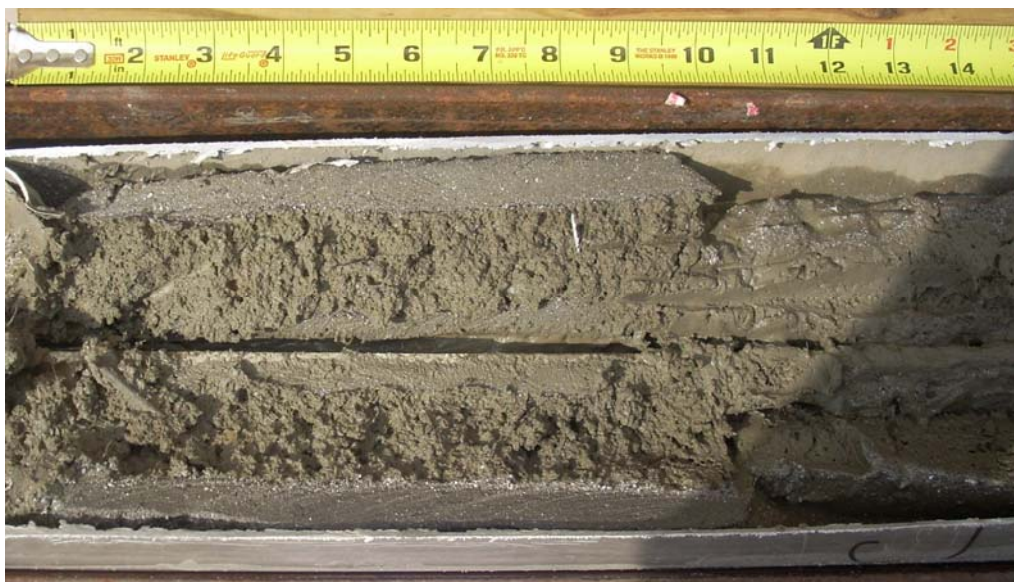
Figure E2 – Upper portion of core #1 from Lake Cypress Springs, showing the pre-impoundment boundary 10” above the base of the core (left).

Within DepthPic, the current surface is automatically determined based on the signal returns from the 200 kHz transducer. The pre-impoundment surface must be determined visually based on the pixel color display and any available core sample data. Based on core sample #1, it is clear that the pre-impoundment bathymetric surface for this cross-section may be identified as the base of the bright-colored blue pixels in the DepthPic display. The top of the sediment layer is also clearly identifiable as the band of red and green pixels (Figure E3).

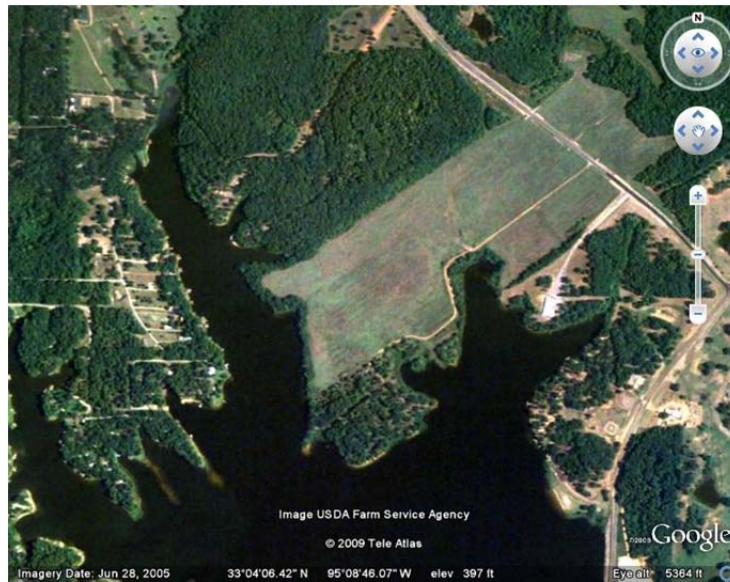
Photo 12: Aerial view of the emergency spillway.
